PRE-RENOVATION HAZARDOUS MATERIALS ASSESSMENT
FOR
ASBESTOS AND LEAD CONTAINING MATERIALS

County of Mendocino
Administration Center – South Wing Roof and HVAC Replacement
851 Low Gap Road
Ukiah, CA 95482

November 16, 2017

Project No. 3084.2002

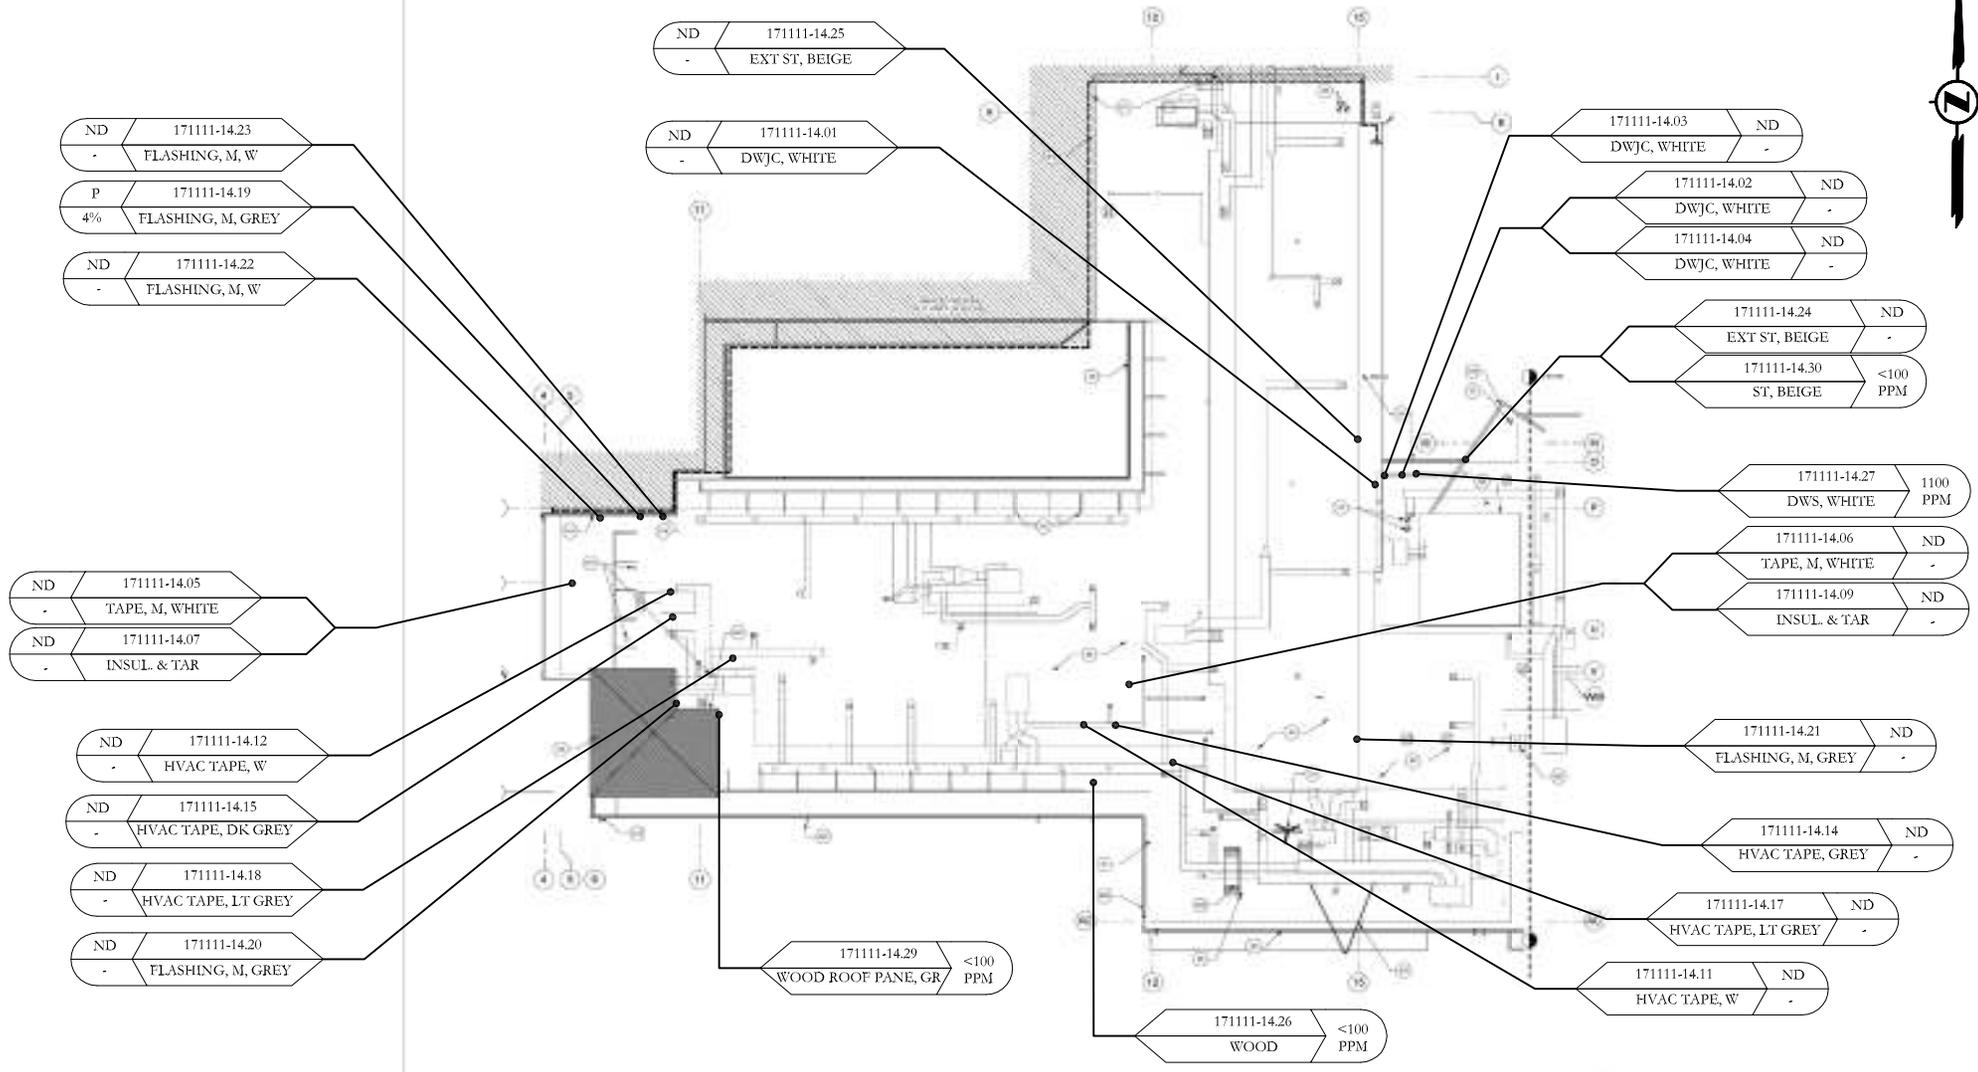
SCALE: N.T.S.	FOR	ADMINISTRATION CENTER- SOUTH WING ROOF AND HVAC REPLACEMENT
DATE: 11/16/17	TITLE	SAMPLE LOCATION PLAN
DRWN: BG	APPROVED:	JOB NO. 3084.2002
CHECKED: JV		DWG. NO. FIGURE-1

P 171111-14.19
4% FLASHING, M, GREY

171111-14.27 1100
DWS, WHITE PPM

Based on the analytical results the following materials have been identified as ACM and shall be removed as asbestos containing materials in accordance with Cal-OSHA and Mendocino Air Quality Management District regulations prior to disturbance in areas included in the scope of work:

Based on the analytical results the following materials have been identified as LCP and shall be handled in accordance with CCR Title 8 Section 1532.1 Lead in Construction Standard.

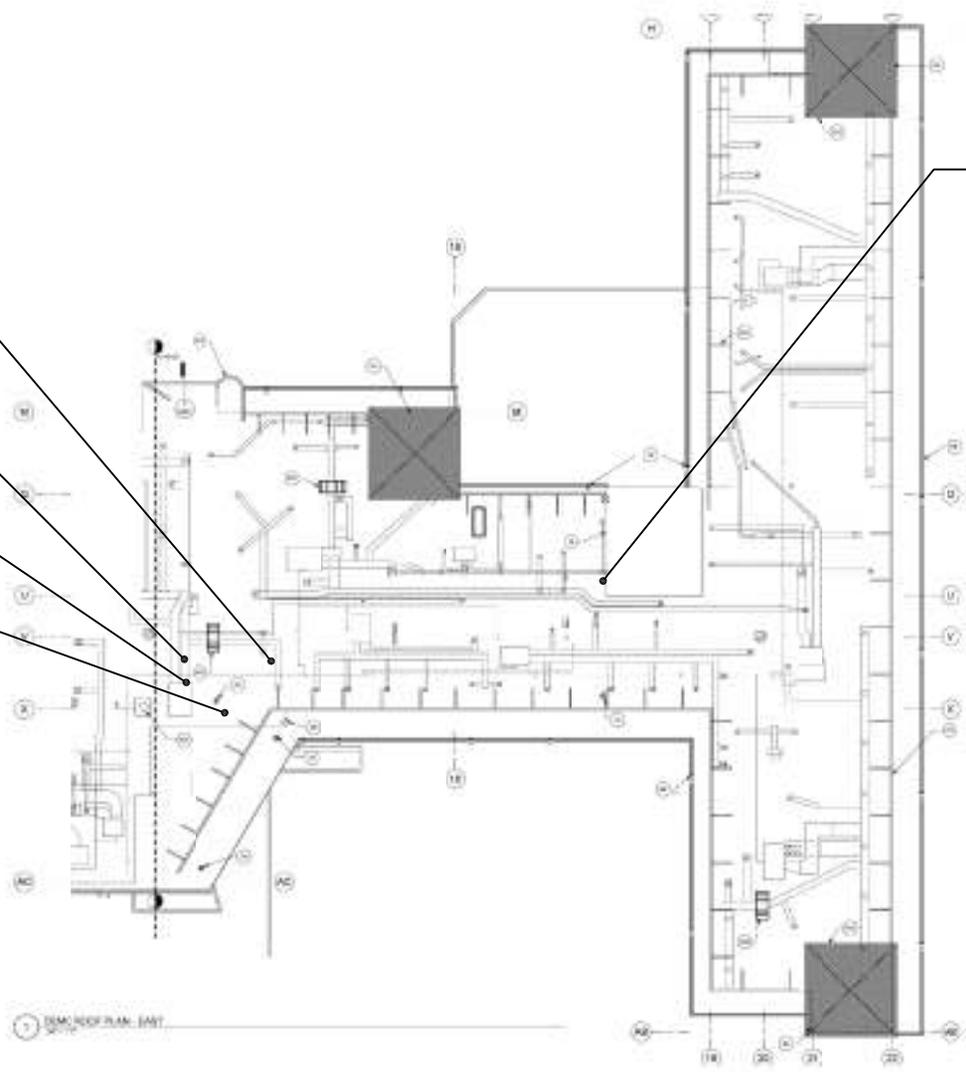
SCALE: N.T.S.	FOR	ADMINISTRATION CENTER- SOUTH WING ROOF AND HVAC REPLACEMENT
DATE: 11/16/17	TITLE	SAMPLE LOCATION PLAN
DRWN: BG	APPROVED:	JOB NO. 3084.2002
CHECKED: JV		DWG. NO. FIGURE-2

- ND 171111-14.10
- HVAC TAPE, W
- ND 171111-14.13
- HVAC TAPE, GREY
- ND 171111-14.16
- HVAC TAPE, LT GREY
- ND 171111-14.08
- INSUL. & TAR

171111-14.28
WOOD ROOF, BEIGE <100 PPM
