October 24, 2017 CAInc File No. 16-337.4

Subject: **Geotechnical Memorandum**

Mountain View Road (CR 510) Failure at MP 16.62

Mendocino County, California

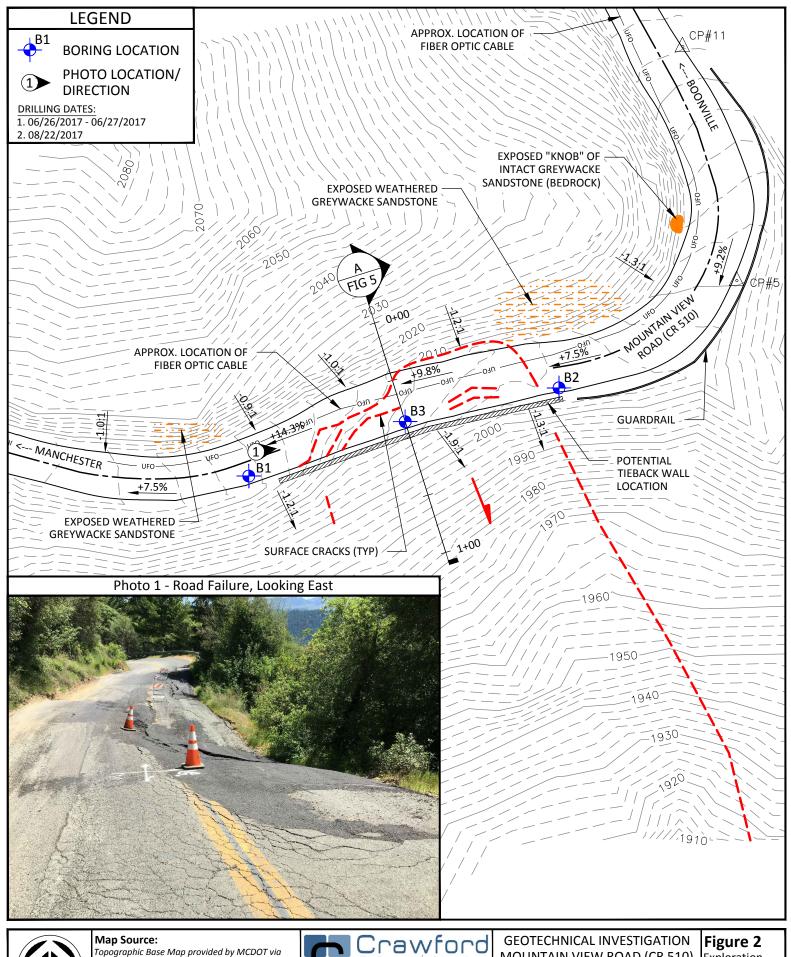
Figure 2
Exploration
Location Map

The subject road failure is approximately 100 feet in length and involved a 2-3 foot "slump" of the outboard (eastbound) lane. Additionally, a portion (approximately 40-50 feet) of the inboard (westbound) lane at the east end of the failure, slumped about 1-2 feet. No definitive headscarp was

developed due to this failure. Surface cracks were evident within the slumped road surface as well as running down slope along the eastern side of the failure. No surface cracks were evident upslope. An underground fiber optic cable, which runs down the center of the inboard lane, was not disrupted by the failure, based on conversation with the Level3 USA marker. A photo of the failure is included within the attached Figure 2.
