AWS 2221
July 20, 2018

**RE: Hazardous Materials Inspection Report
Mendocino County Yokayo Center – Exterior and Roof
747 South State St, Ukiah, CA**

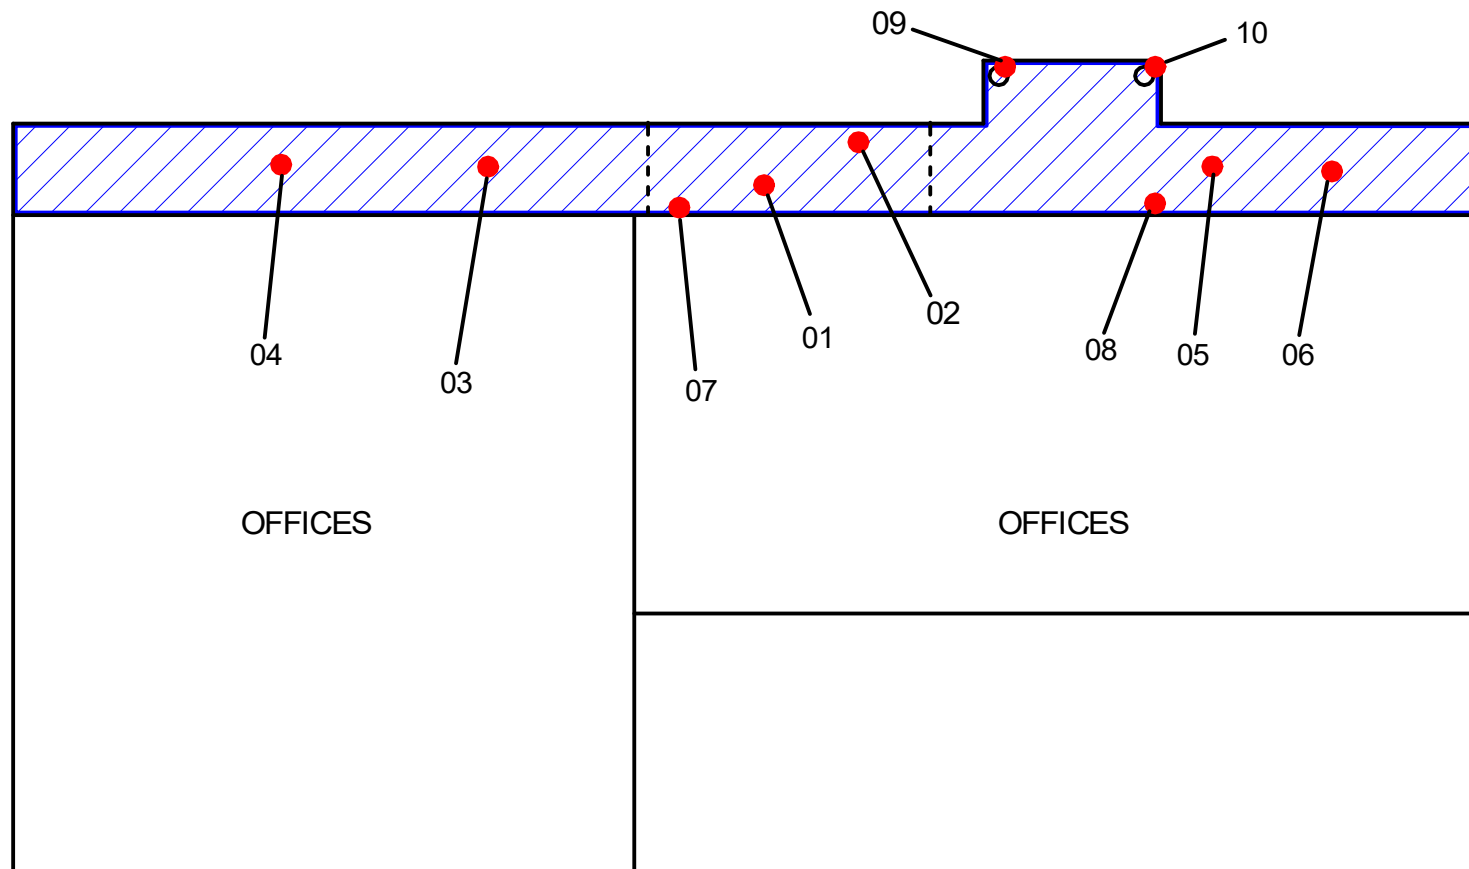
- = EXTERIOR LEAD BASED PAINT BELOW OVERHANG
- = ASBESTOS SAMPLE LOCATION
