AWS 1817
May 17, 2017

**RE: Microbial Investigation Report
Mendocino County Behavioral Health and Recovery Services Building
1120 S. Dora St., Ukiah, CA**

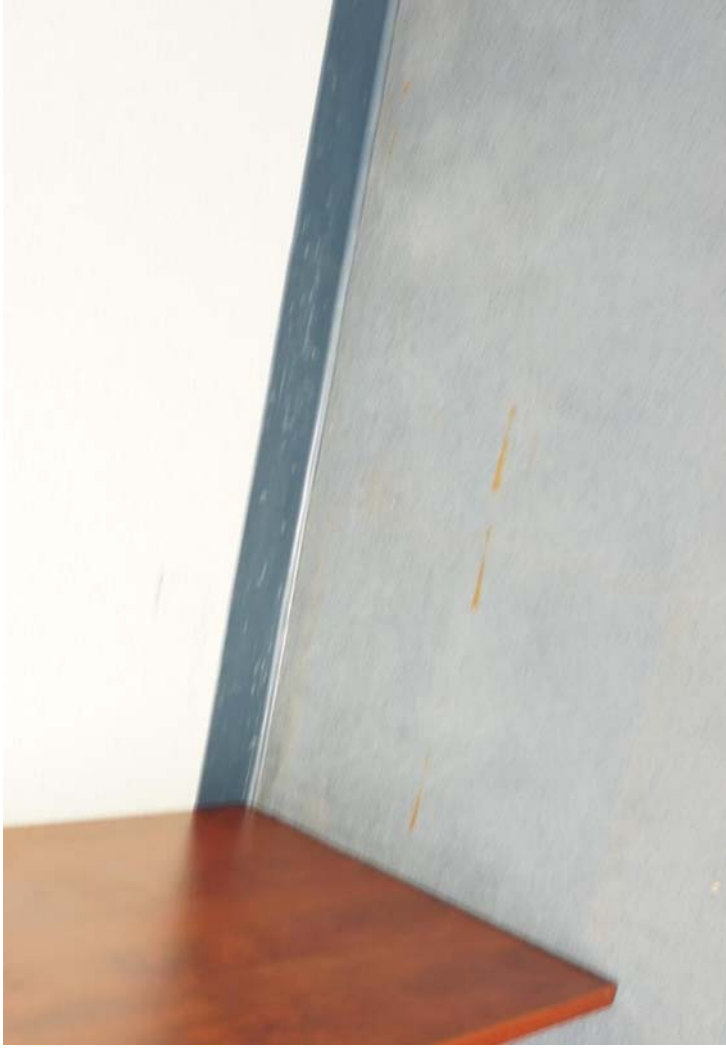
- Water damage and rust was observed on the carpet.
- Microbial growth was observed on the wall behind the base coving.
- Elevated moisture concentrations were measured in the drywall along the atrium wall and sides of the structural column.

Room 145, rust on carpet along west wall

- Remove the base coving from the affected walls.
- Remove the wall materials to a height of two feet (2').
- Continue to remove water damaged wall materials a minimum of 2' beyond the last observed water damages.
- Remove and discard all exposed insulation.
- The carpets should be steam cleaned and treated with IAQ 2000.

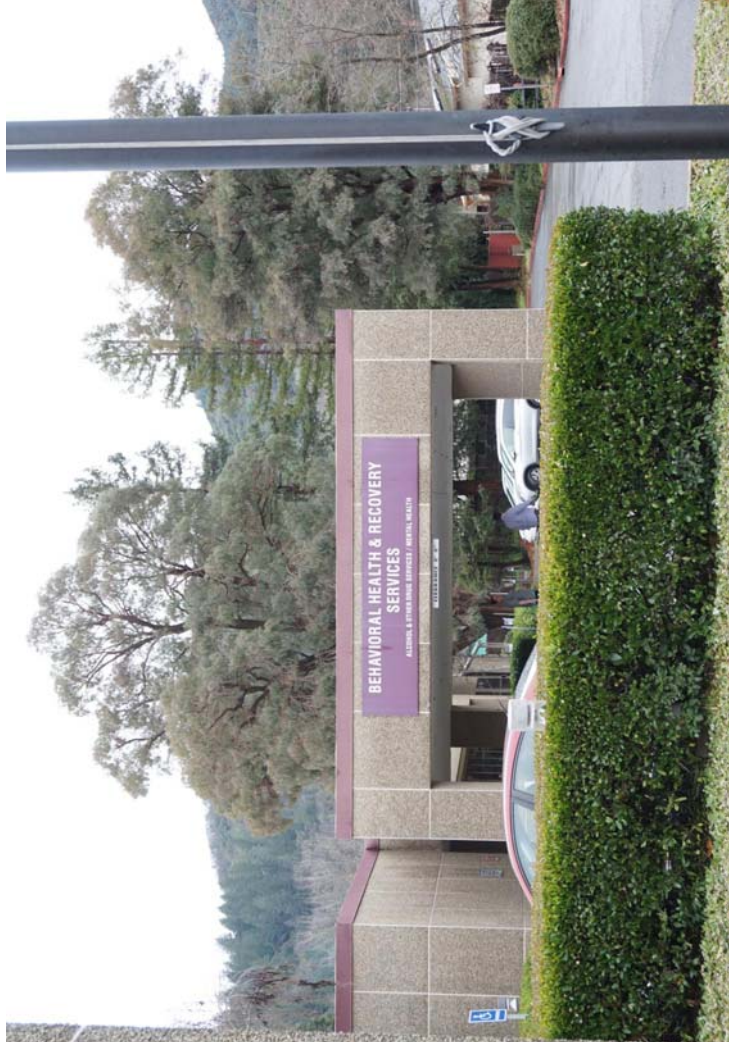
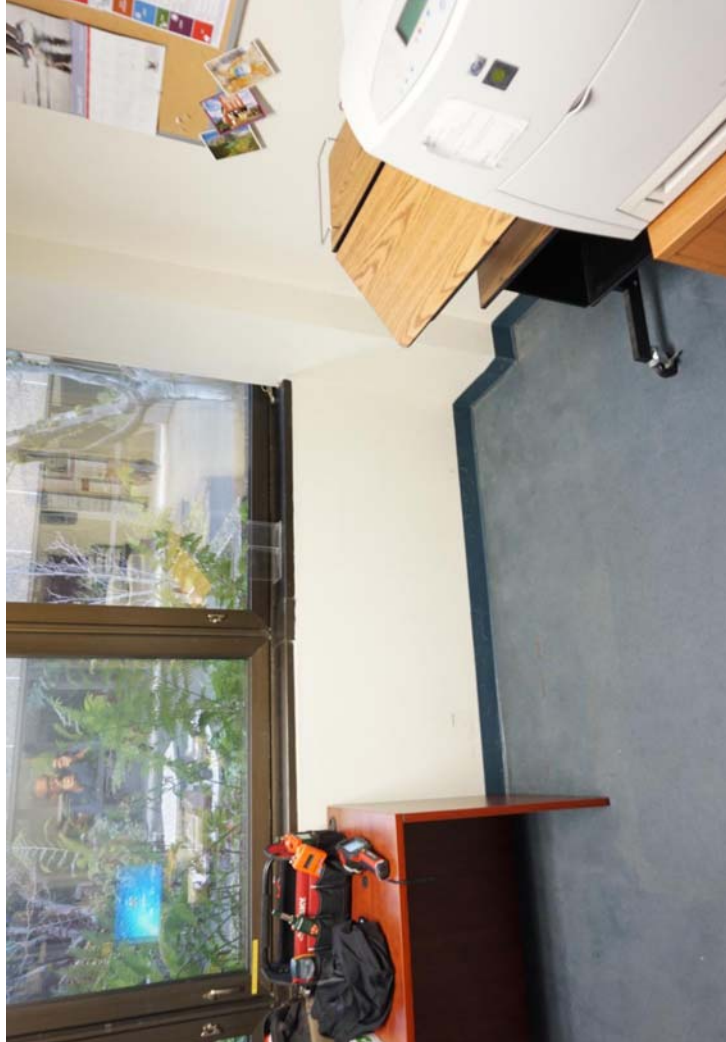
rust and water damage observed to carpeting

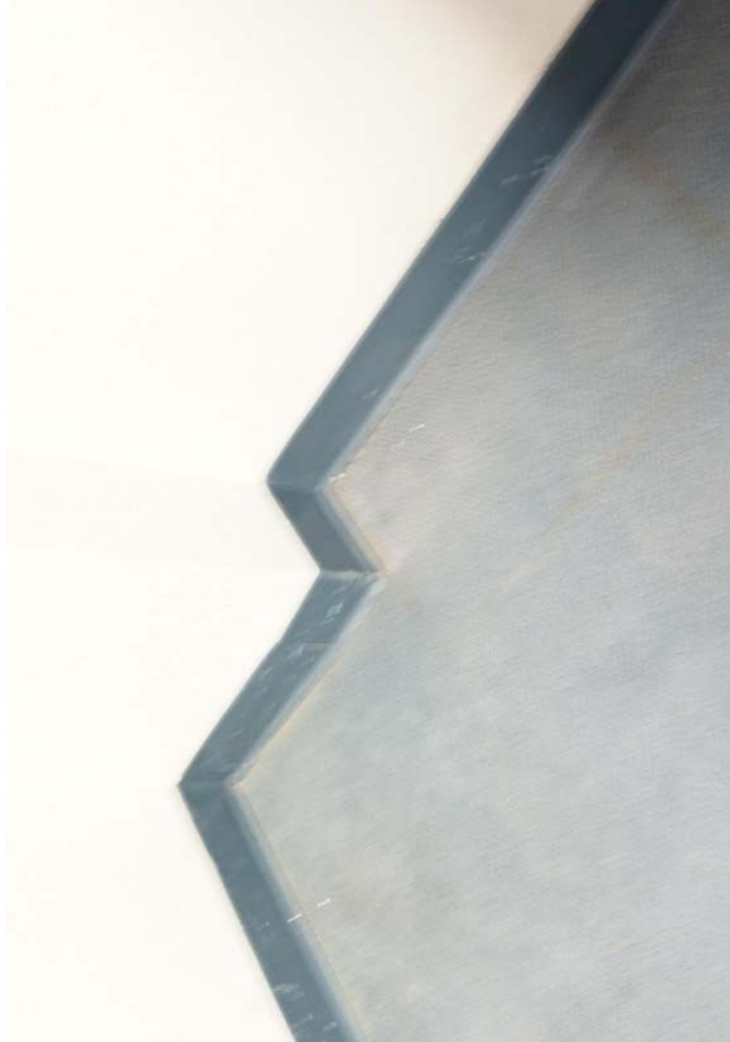
corner of Room 145, water staining on carpet

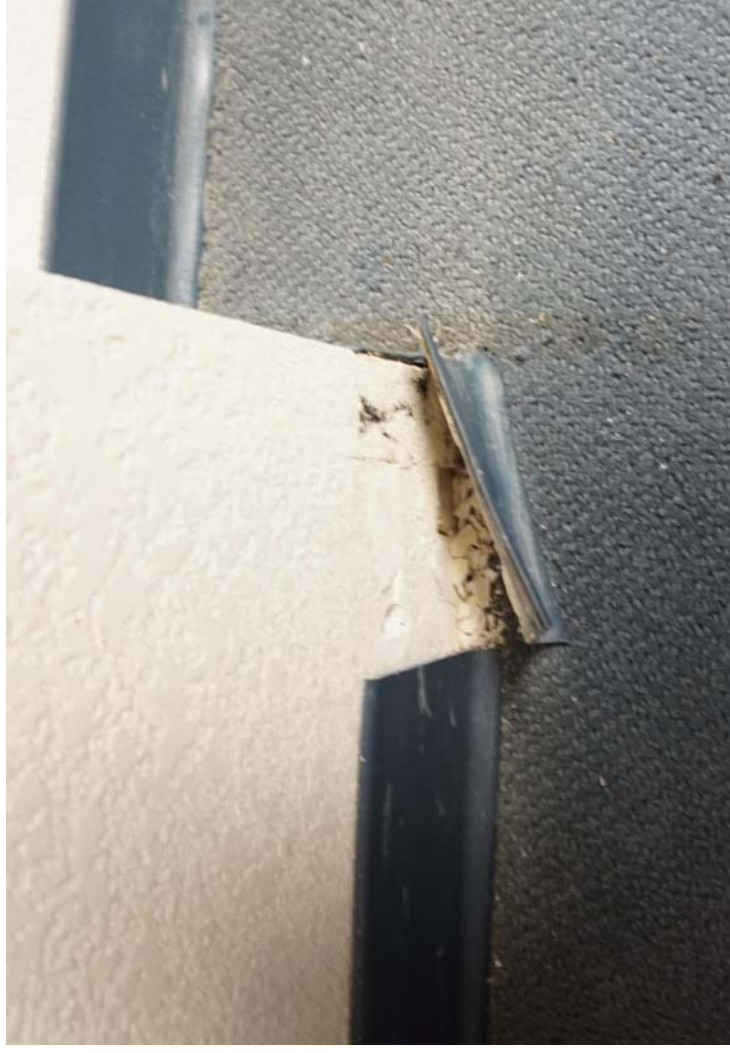
- TS-1 – Very heavy growth (4+) of *Stachybotrys chartarum*.

Water damage occurred in Room 145 and 143 due to a leaking downspout either in the column or on the exterior of the building. There is a buildup of soil on the exterior and water is seeping likely at the junction between the wall and concrete slab. Elevated moisture levels were measured along the atrium wall and on the sides of the column.

Room 145, NW corner, mold growth on wall at column

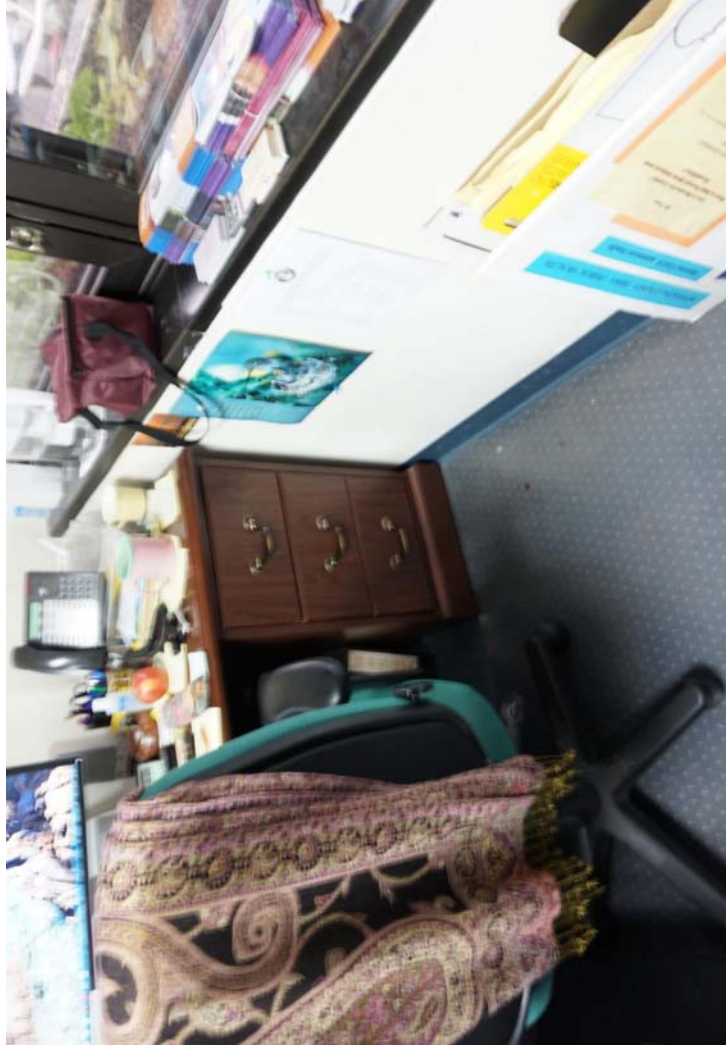
- A desk was located in the corner of wall adjacent to the water damage in Room 145. Wall materials and flooring could not be reached for testing.
- Elevated moisture concentrations were measured in the wall materials past the desk.

Room 143, SW corner, elevated moisture measured in West wall just beyond the desk.

- Remove the base coving from the affected walls.
- Remove the wall materials to a height of 2'.
- Continue to remove water damaged wall materials a minimum of 2' beyond the last observed water damages.
- Remove and discard all exposed insulation.
- The carpets should be steam cleaned and treated with IAQ 2000.
