AWS # 1675
May 18, 2016

**RE: Lead In Paint Inspection Report
120 W. Fir St, Fort Bragg, CA**

Site Location: 120 W. Fir St, Fort Bragg

Building: Office Building (Planning Offices)

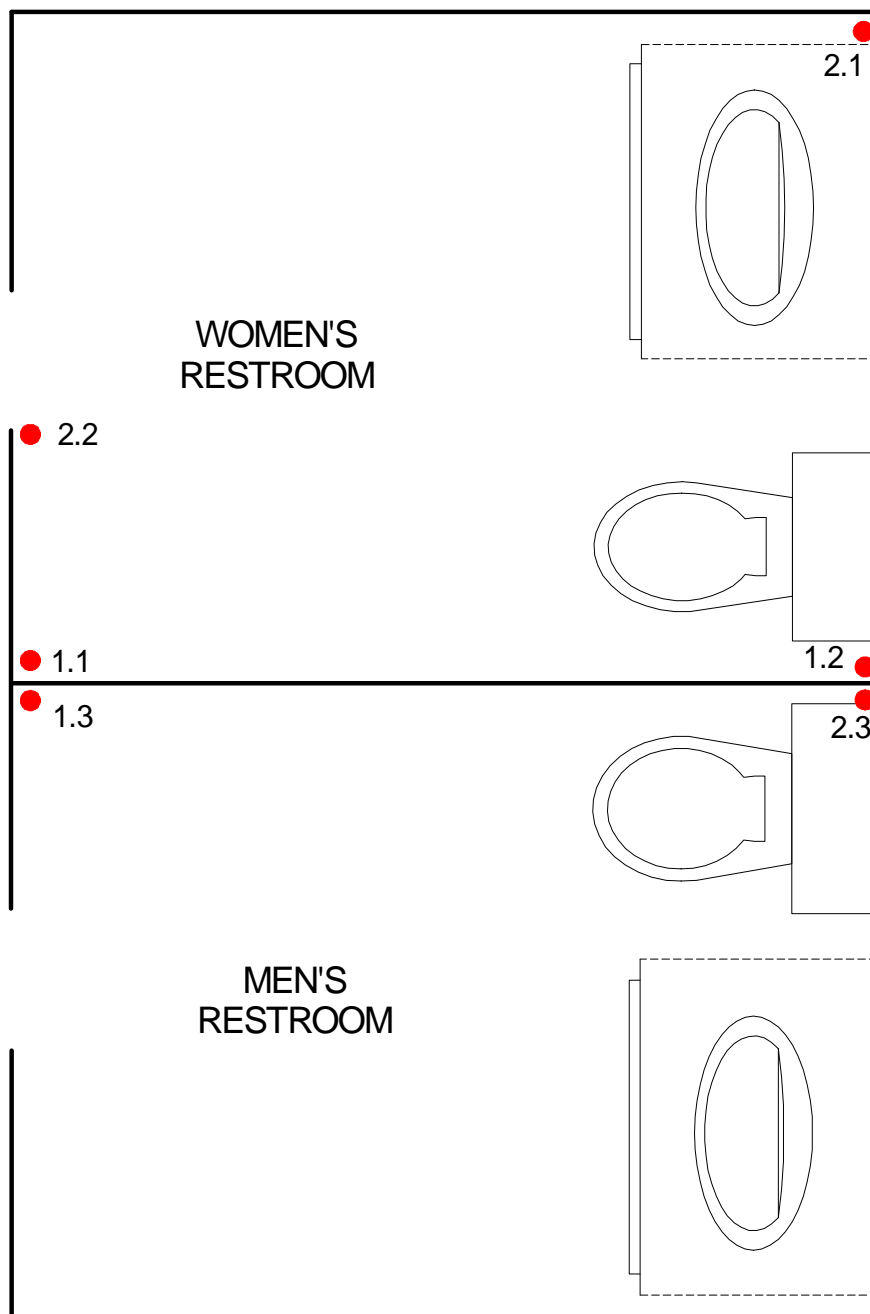
Not to Scale

- **Lead containing paint was identified in the gray ceramic baseboard tiles in both the men's and women's bathrooms.**

Any proposed renovation, which may involve the removal of building materials with lead based or lead containing painted surfaces, should include provisions to minimize the potential for airborne release of lead contaminated dust. It is recommended, as a minimum, that demolition of building materials which have lead based and/or lead containing paints be conducted with the materials kept in a wetted state and removed in sections, as feasible, to reduce the potential for airborne lead emissions.
