May 19, 2017  
CAInc File No. 16-337.3

Subject: **Geotechnical Memorandum**  
Orr Springs Road (CR 223) Slide at MP 39.20 – Permanent Repair  
Mendocino County, California

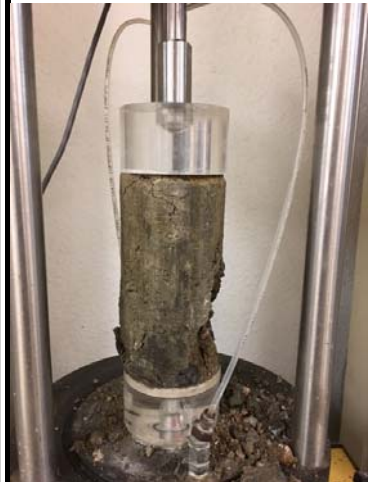
Boring Number	B1-2
Sample Depth (feet)	11.00
Material Description	Dark olive Clayey SAND

Height (inch) average of 3	4.86
Diameter (inch) average of 3	2.39
Moisture Content (%)	7.7
Dry Density (pcf)	123.9
Estimated Specific Gravity	2.7
Saturation (%)	58.1

Strain Rate (%/min)	0.9925
Major Principal Stress at Failure (psf)	4310
Strain at Failure (%)	4.0

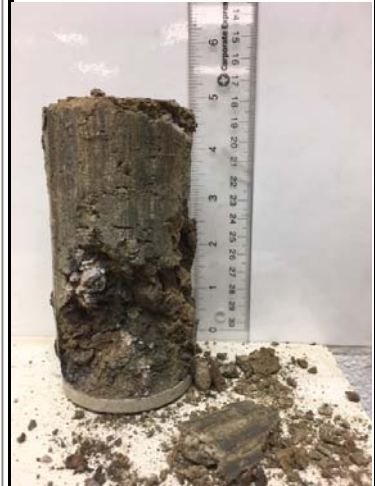
Boring Number	B1-6
Sample Depth (feet)	30.00
Material Description	Dark gray lean Clay with gravel

Height (inch) average of 3	4.65
Diameter (inch) average of 3	2.40
Moisture Content (%)	9.8
Dry Density (pcf)	132.7
Estimated Specific Gravity	2.7
Saturation (%)	98.7

Strain Rate (%/min)	1.0003
Major Principal Stress at Failure (psf)	1100
Strain at Failure (%)	10.6

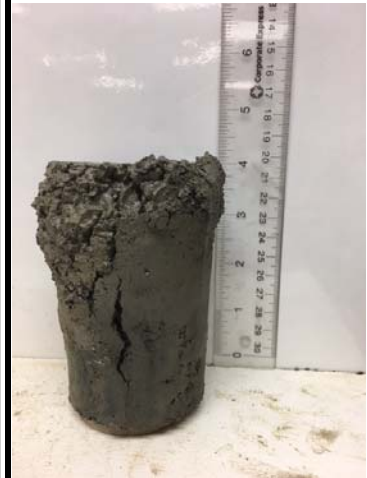
Boring Number	B2-2
Sample Depth (feet)	11.00
Material Description	Olive lean CLAY with gravel

Height (inch) average of 3	4.73
Diameter (inch) average of 3	2.41
Moisture Content (%)	8.5
Dry Density (pcf)	130.1
Estimated Specific Gravity	2.7
Saturation (%)	77.5

Strain Rate (%/min)	0.9789
Major Principal Stress at Failure (psf)	9040
Strain at Failure (%)	2.0

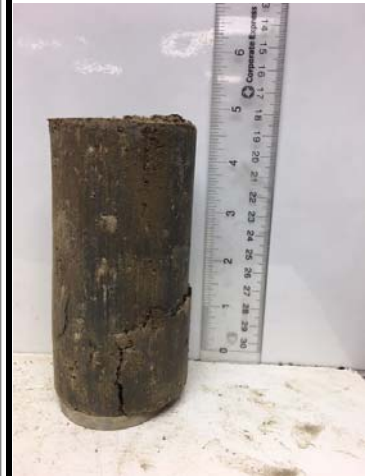
Boring Number	B3-1
Sample Depth (feet)	6.00
Material Description	Black and dark yellowish brown lean CLAY

Height (inch) average of 3	5.00
Diameter (inch) average of 3	2.39
Moisture Content (%)	15.1
Dry Density (pcf)	114.8
Estimated Specific Gravity	2.7
Saturation (%)	87.2

Strain Rate (%/min)	0.9691
Major Principal Stress at Failure (psf)	3470
Strain at Failure (%)	2.3
