**COUNTY OF MENDOCINO**  
**DEPARTMENT OF PLANNING AND BUILDING SERVICES**  
860 NORTH BUSH STREET • UKIAH • CALIFORNIA • 95482  
120 WEST FIR STREET • FT. BRAGG • CALIFORNIA • 95437

**CASE#:** REC\_2018-0001

**REQUEST:** Reclamation Plan Renewal and Modification to extend existing hillside quarry mining operation for an additional 5 years. The proposed modification is to remove Bench 1 at a 1:1 slope angle to elevation 25ft. ASML, creating an 50± ft. high (1:1) slope at the bottom of the quarry; consistent with Benches 4 and 6. The operation, for which a vested right has been granted; includes the extraction of up to 40,000 cy of material per year, and the processing (screening and washing) of 51,000± cy per year.

**LOCATION:** In the Coastal Zone, 8± miles north of Fort Bragg, 3.5± miles east of State Highway 1 (SH 1), accessed via a private logging road 2.5± miles east of the State Hwy 1 intersection with Camp 2 Ten Mile Road (CR 428), lying on the south and east sides of the Ten Mile River (APNs: 015-140-51, -75, -78, & -87).

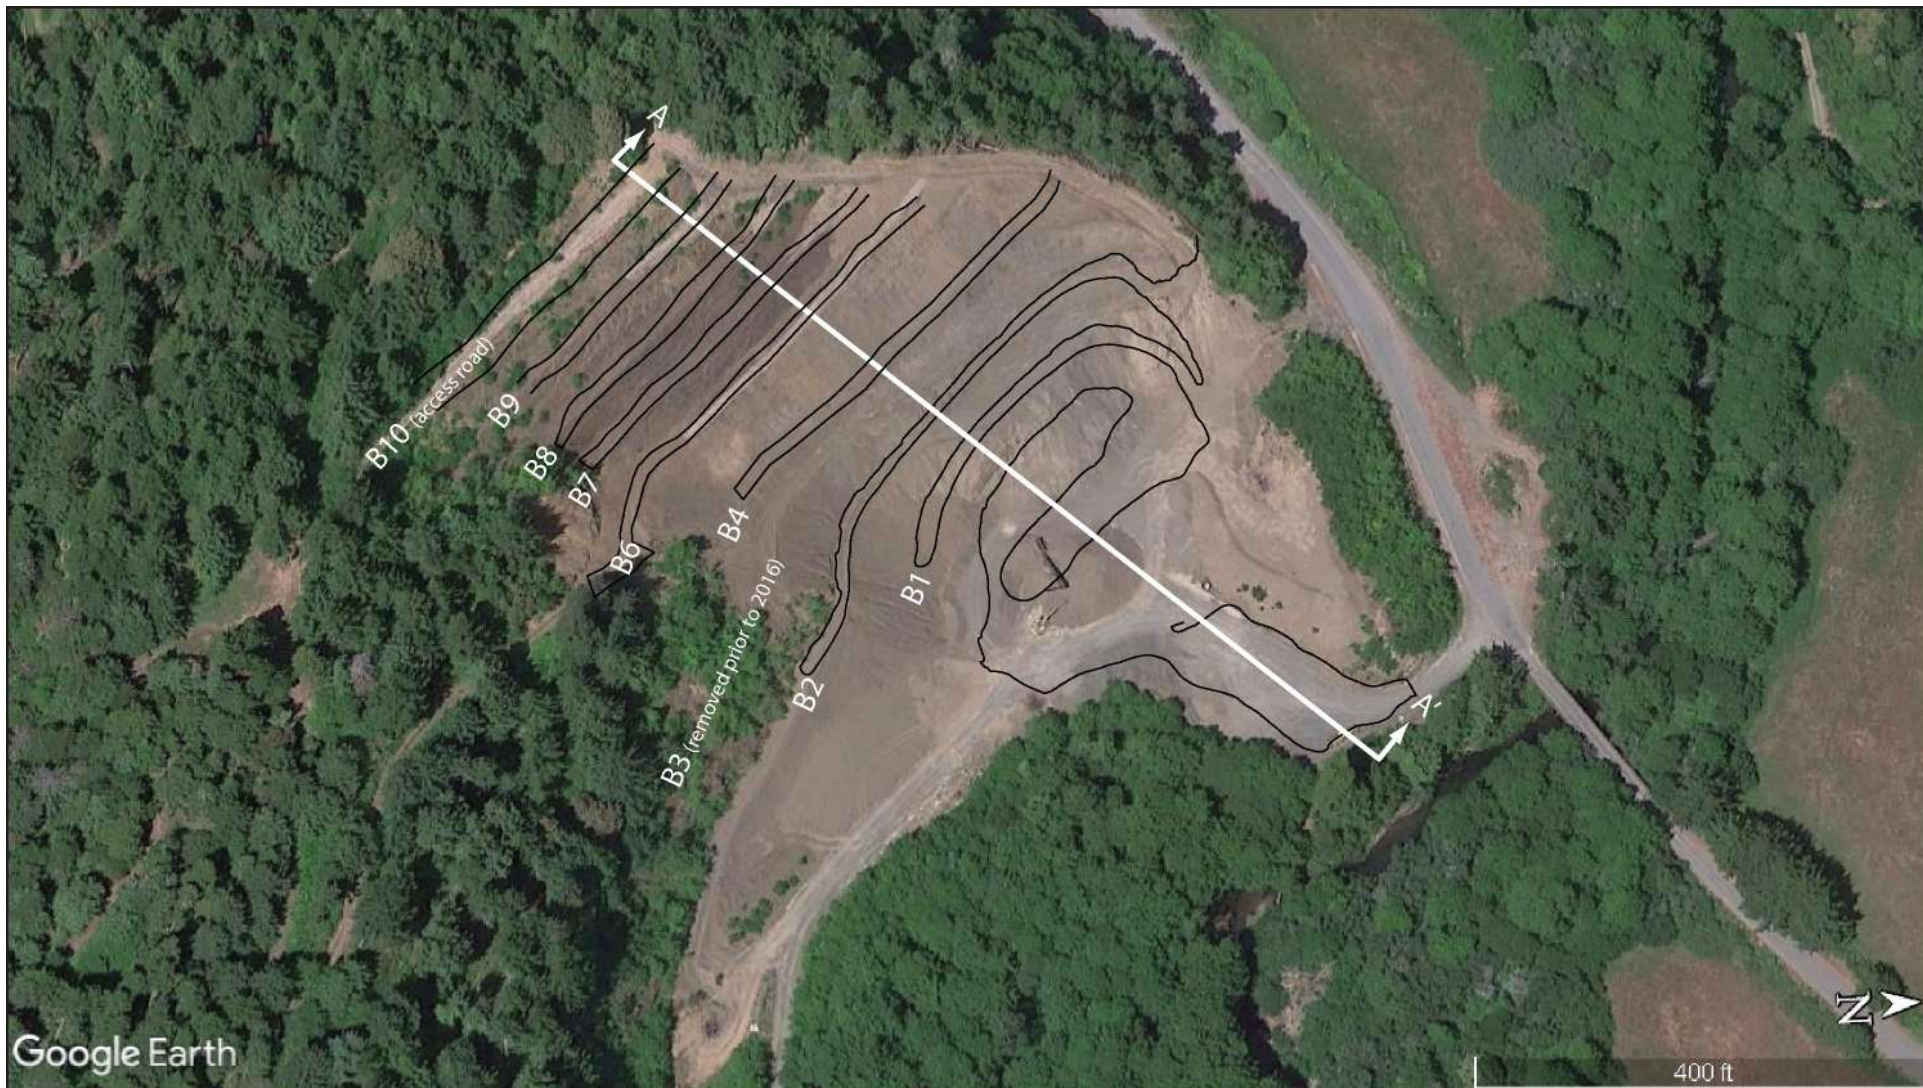
Figure 1

Site visits to the quarry were conducted by JLGC on 11/14/2018 and 12/14/2018. The benches were surveyed on 12/14/2018 with a Trimble Geo 7x handheld GPS unit (site transverse shown in Figure 1). Cross section work and site modeling was conducted in the CAD mining software package SURPAC under licensed sentinel #32309.

survey transverse

location of observed benches

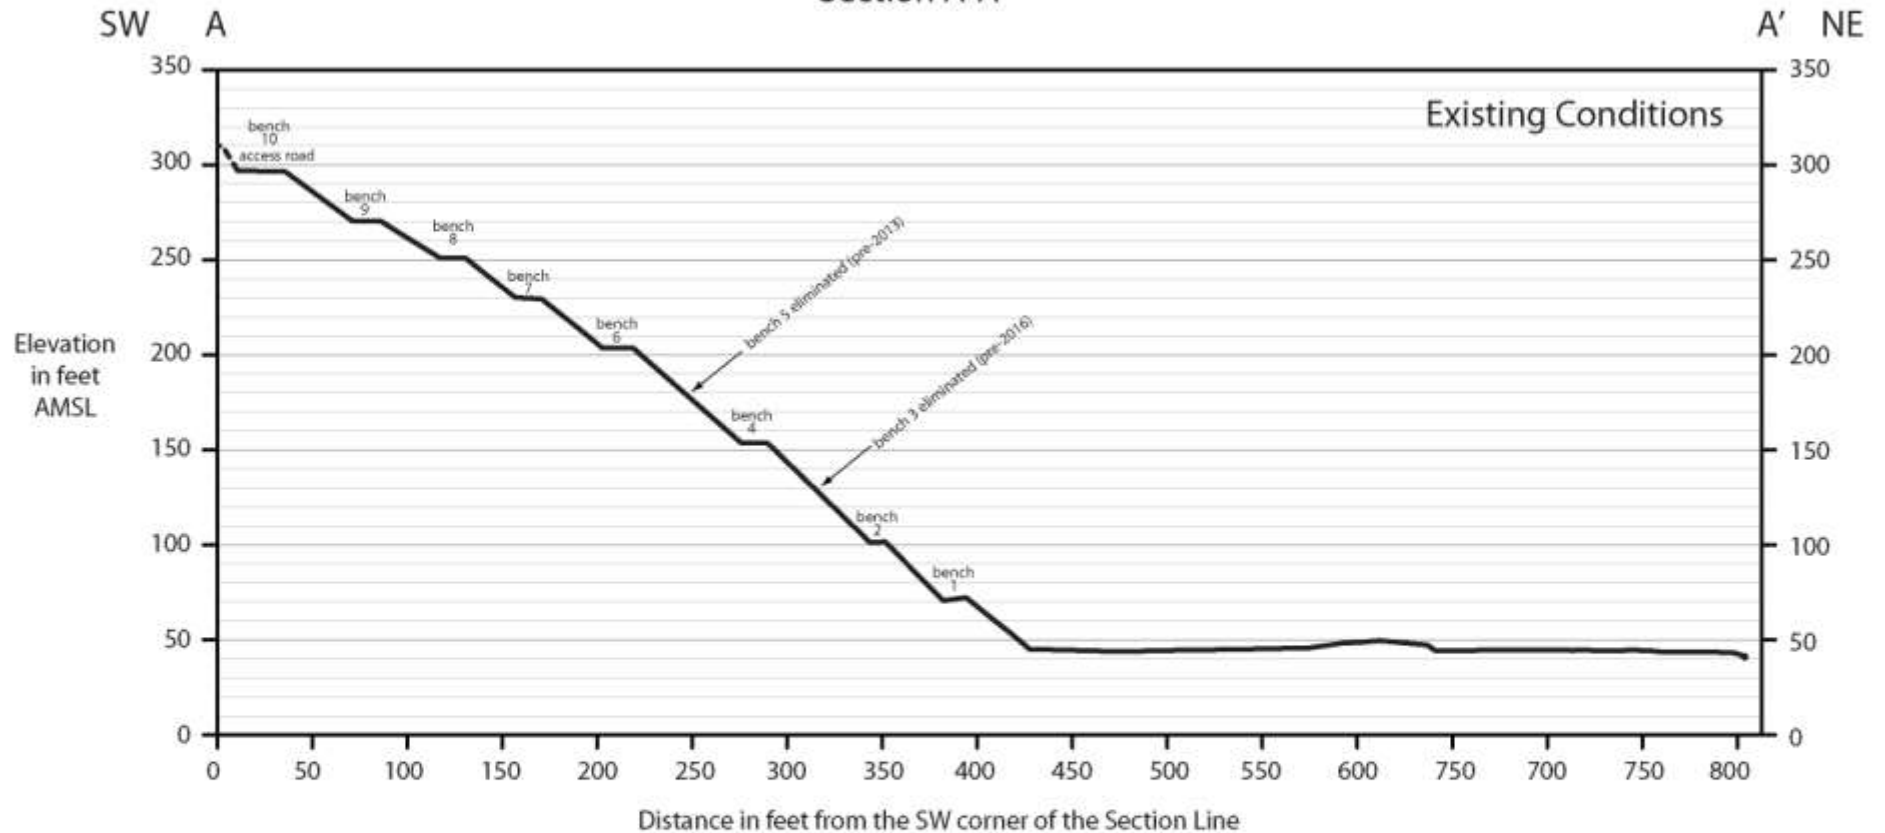
Existing Conditions  
Cross Section A-A'  
Ten Mile Second Crossing Quarry  
Mendocino County, CA.  
CA Mine ID# 91-23-0028

There are two sections of the highwall where a 25' tall bench has been removed to create a single 50' high bench. Figure 2 shows where benches 3 and 5 have been excavated out. Reese and Associates also notes that Bench 5 had been removed pre-2013 and recommends in 2017 that Bench 3 be removed. The resulting 50' tall benches, 4 and 6 in Figure 2, appear stable. There was no observed bench cracking or bulging or any water seeps or ponding evidence in benches 4 or 6.

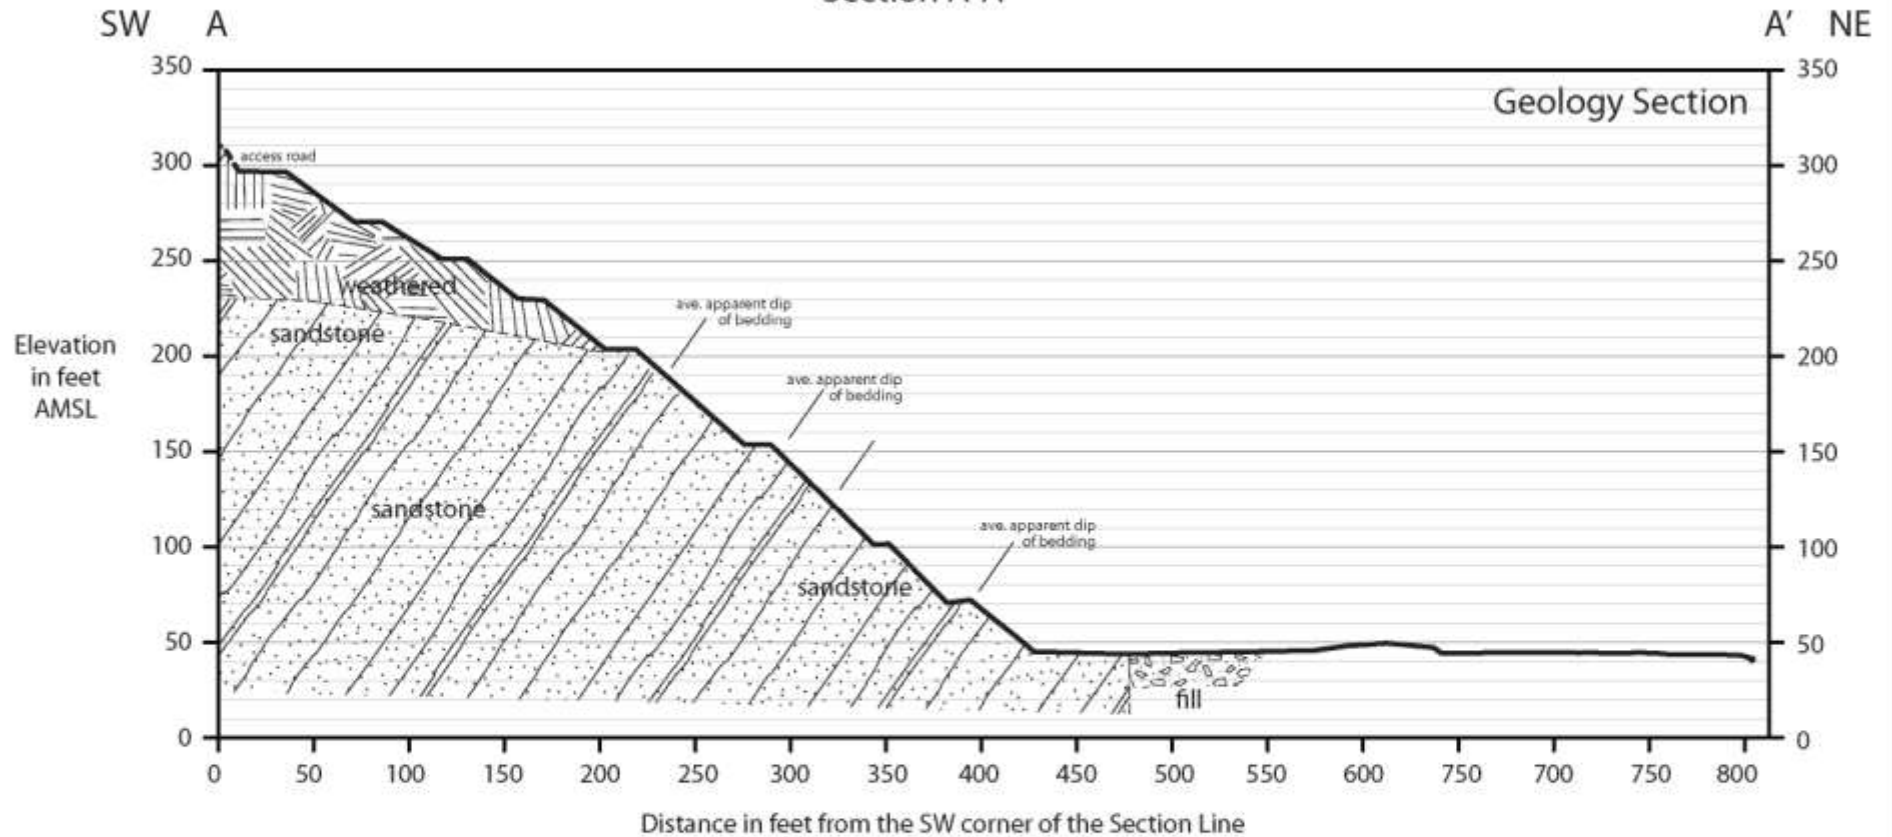
Figure 3

Geology Section  
Cross Section A-A'  
Ten Mile Second Crossing Quarry  
Mendocino County, CA.  
CA Mine ID# 91-23-0028

The geology, bedding and discontinuity orientations described by Reese and Associates in two separate reports 2013 and 2017 at the quarry are consistent with JLGC observations. The main body of the quarry consists of a meta-sandstone with a slight to highly weathered section sitting on top of the deposit (Figure 3). The main sources of structural weakness to the rock are bedding planes. The strike and dip of bedding planes and discontinuities observed along the quarry benches are consistent with those recorded by Reese and Associates. These structures trend to the north and dip 60-70 degrees to the west. This orientation is favorable to the stability of the quarry walls (Figure 3).

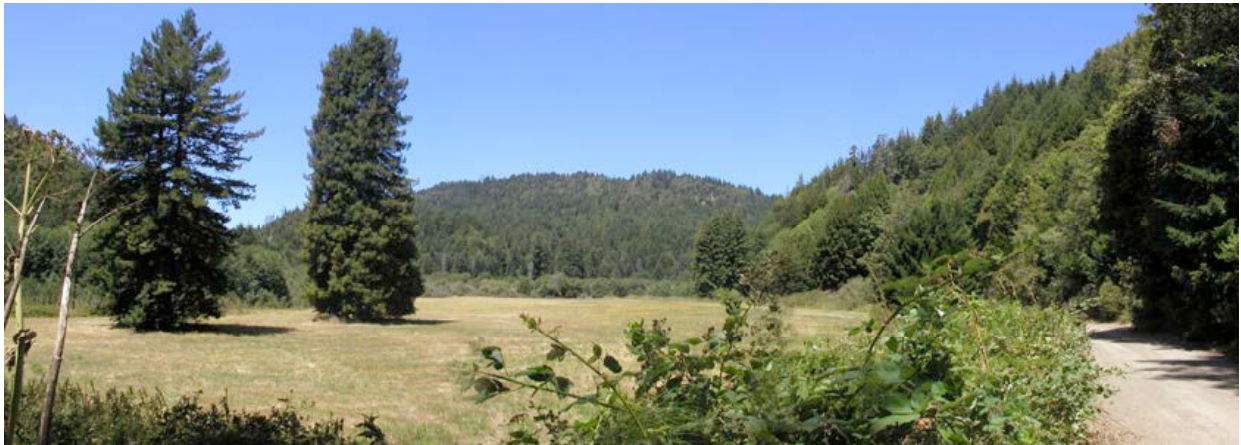
PHOTO: Typical meadow where sediment basin fines from the screening plant have historically been spread and seeded.

Grassland revegetation with sediment basin fines has taken place for many years. Fines have been spread on upstream meadows at the request of the property owner (example illustrated in the photo below). Douglas Fir and Toyon will be used for the screening vegetation at the Second Crossing Quarry site. Both of these species are naturally abundant in the area and self propagate.

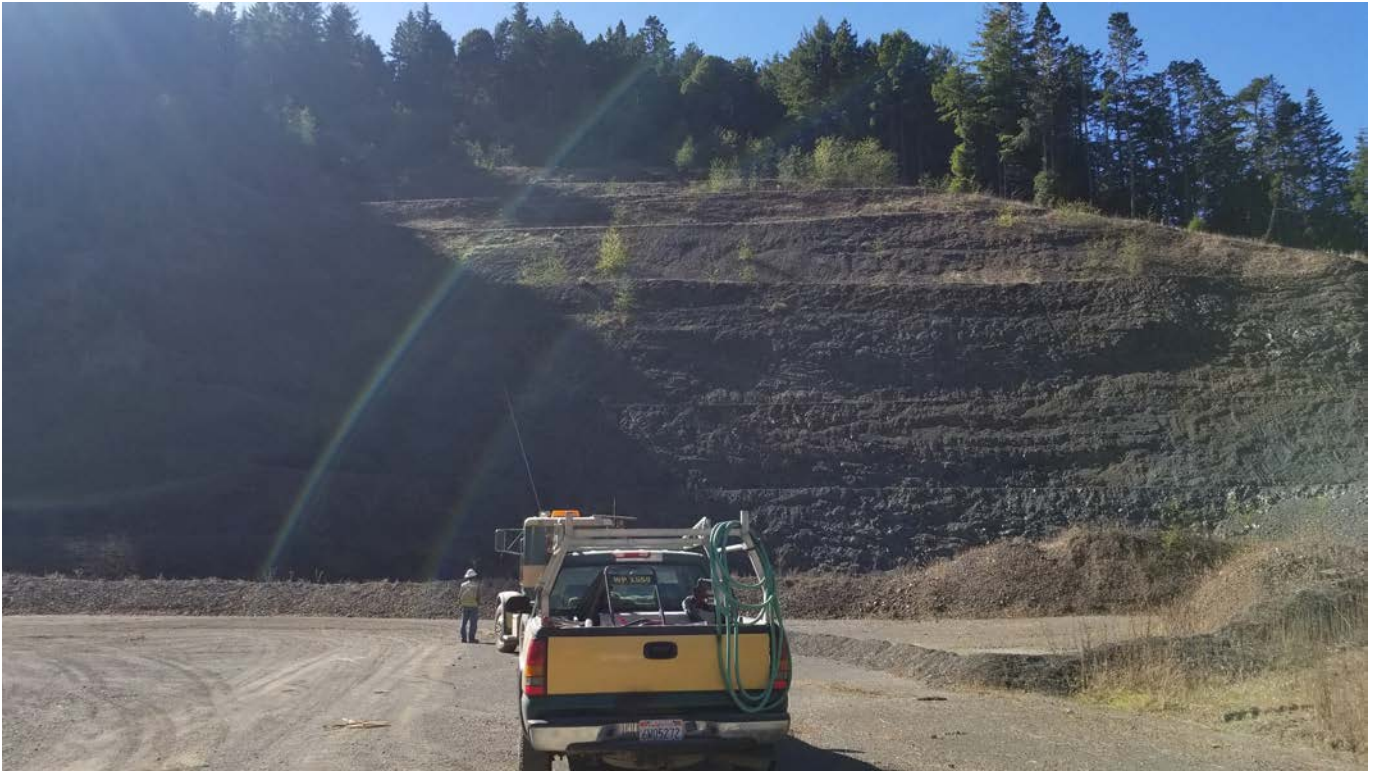
Photo #1 - View from quarry floor, looking southwest. Quarry face with multiple benches, and some vegetation on upper section observed.

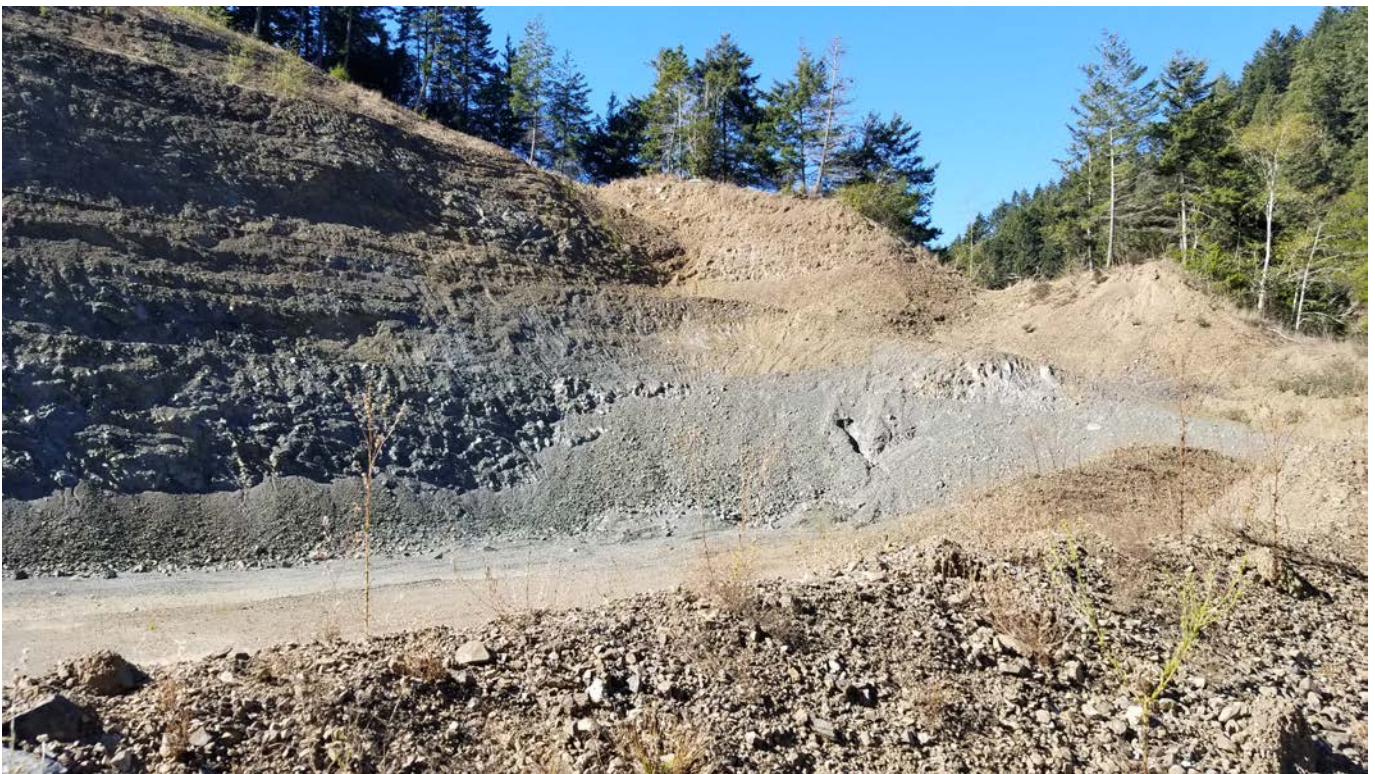
Photo #2 - View from quarry floor, looking west. Details on lower face slopes and mounds to be re-contoured on the right shown. Aggregate stockpile at the bottom of the picture.

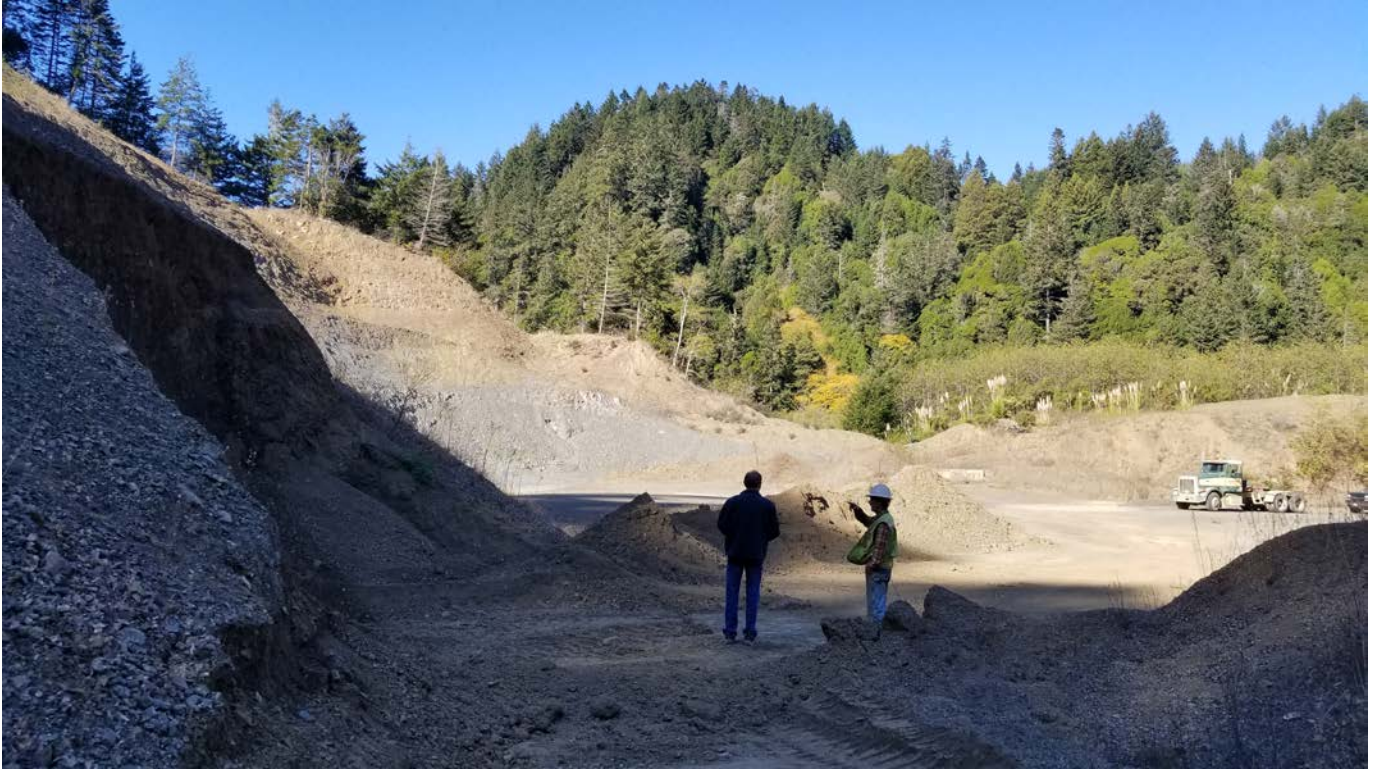
Photo #3 - View closer to the quarry face, looking northwest. Slopes grade, small aggregate stockpiles, a stationary 3-axle truck shown, and some pampas grass (invasive species) shown.

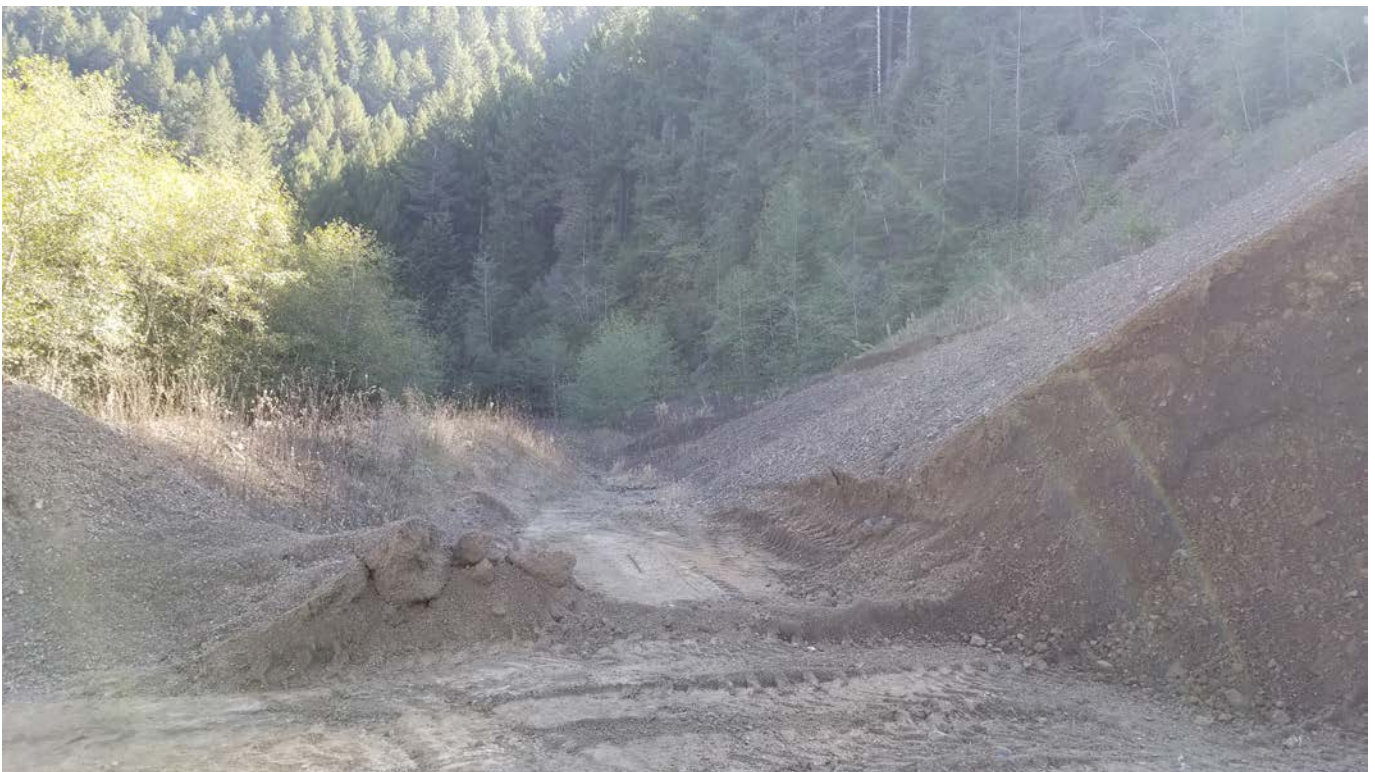
Photo #4 - View from quarry floor and close to quarry face, looking southeast. Proper lower quarry face and stockpile slopes observed.

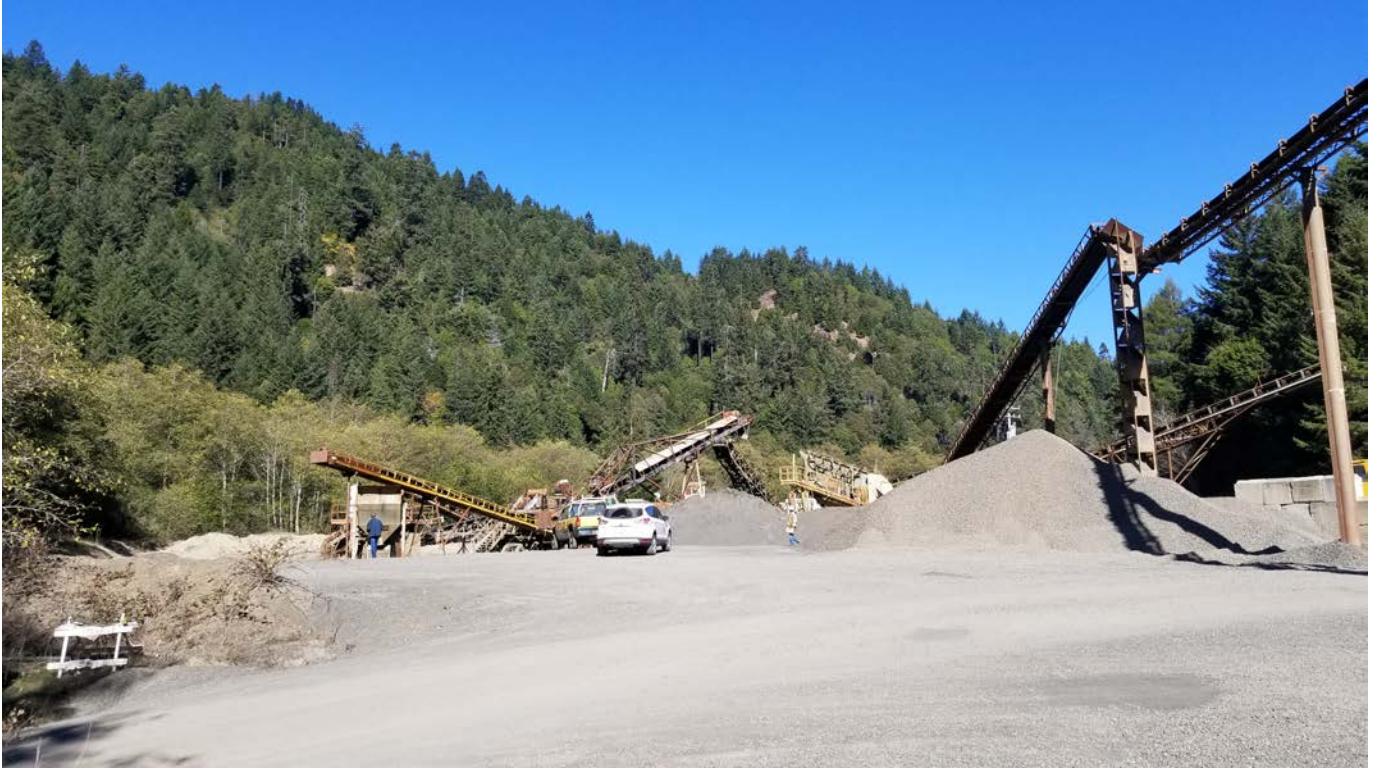
Photo #5 - View from wash plant, looking northwest. Processing equipment and stockpiles with adequate sloping observed.

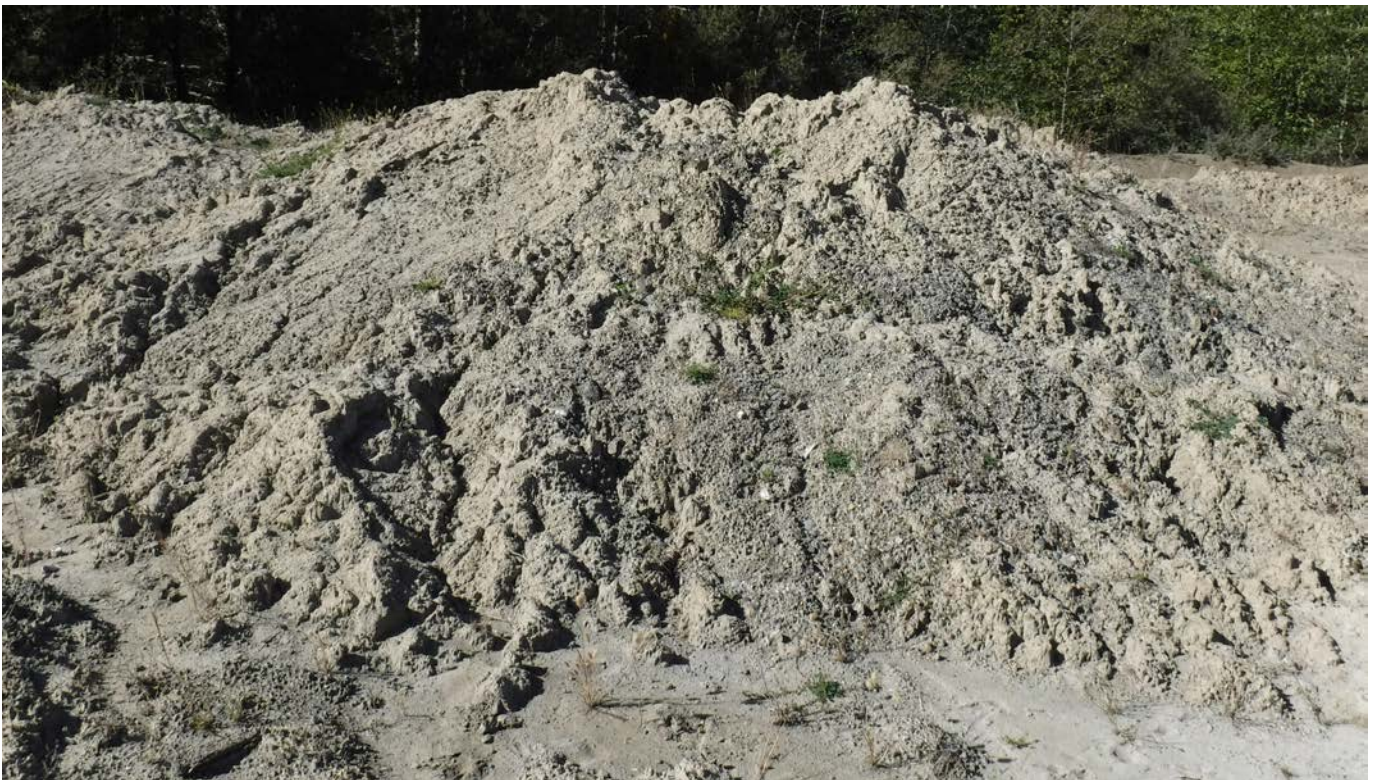
Photo #6 - Stockpiled sediments removed from sediment settling pond observed at pond's perimeter. As discussed in Sections VIII-5 and IX, it was recommended to spread hay on it. Compare with post-inspection photos by operator dated 11/20/2018.

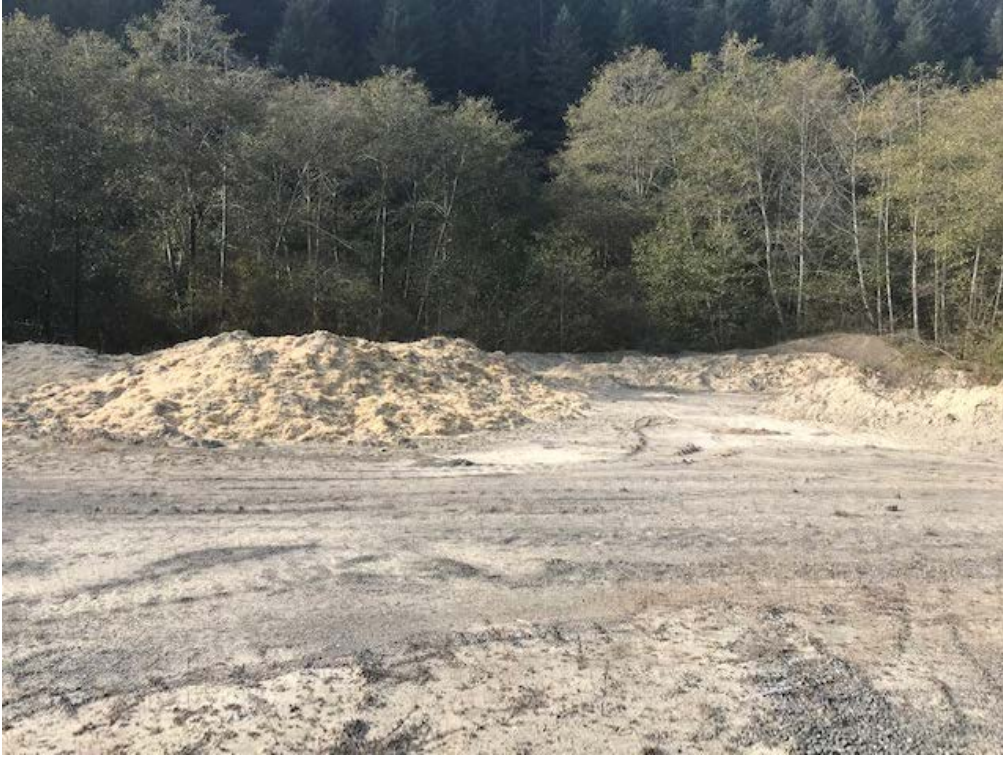
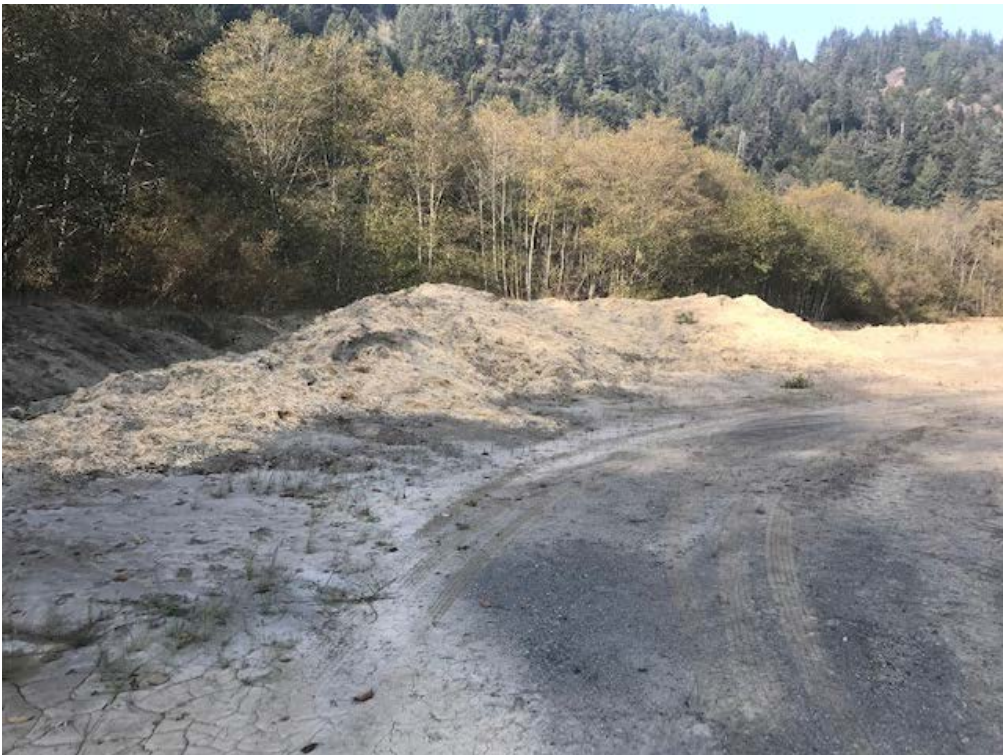
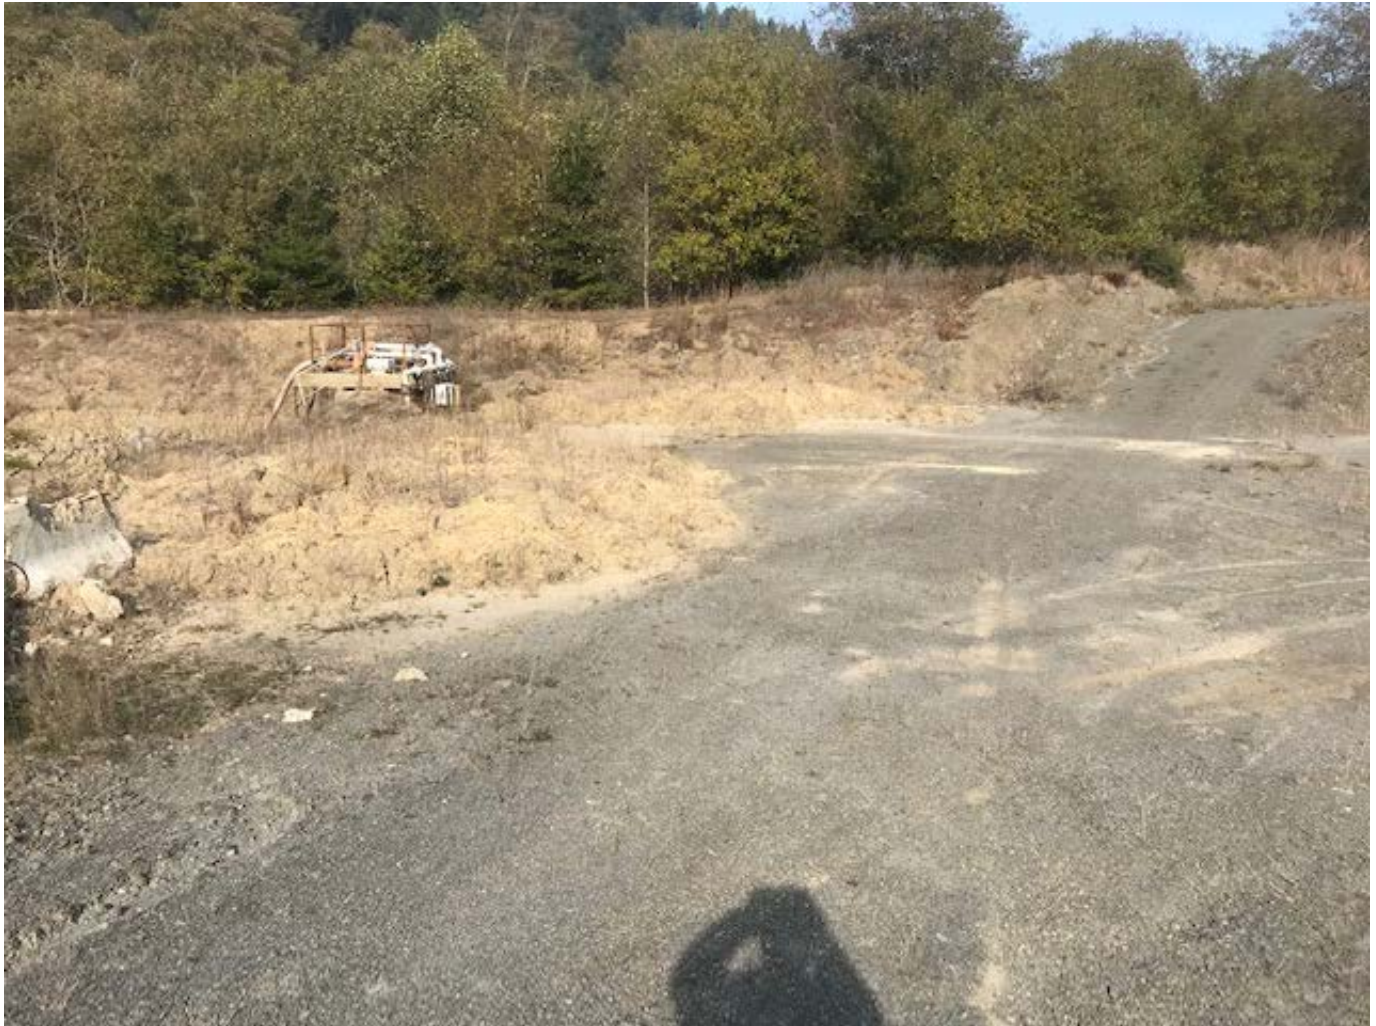
## Ten Mile Second Crossing - Post-2018 Inspection Photos by Operator

**From:** Steve Thiesen <steve@geoagg.net>  
**To:** "Eduardo Hernandez" <hernandeze@mendocinocounty.org>  
**Date:** 11/20/2018 7:53 AM  
**Subject:** Pond diggings. Here is the pics sorry about the delay  
**Attachments:** IMG\_0632.jpg; IMG\_0633.jpg; IMG\_0634.jpg

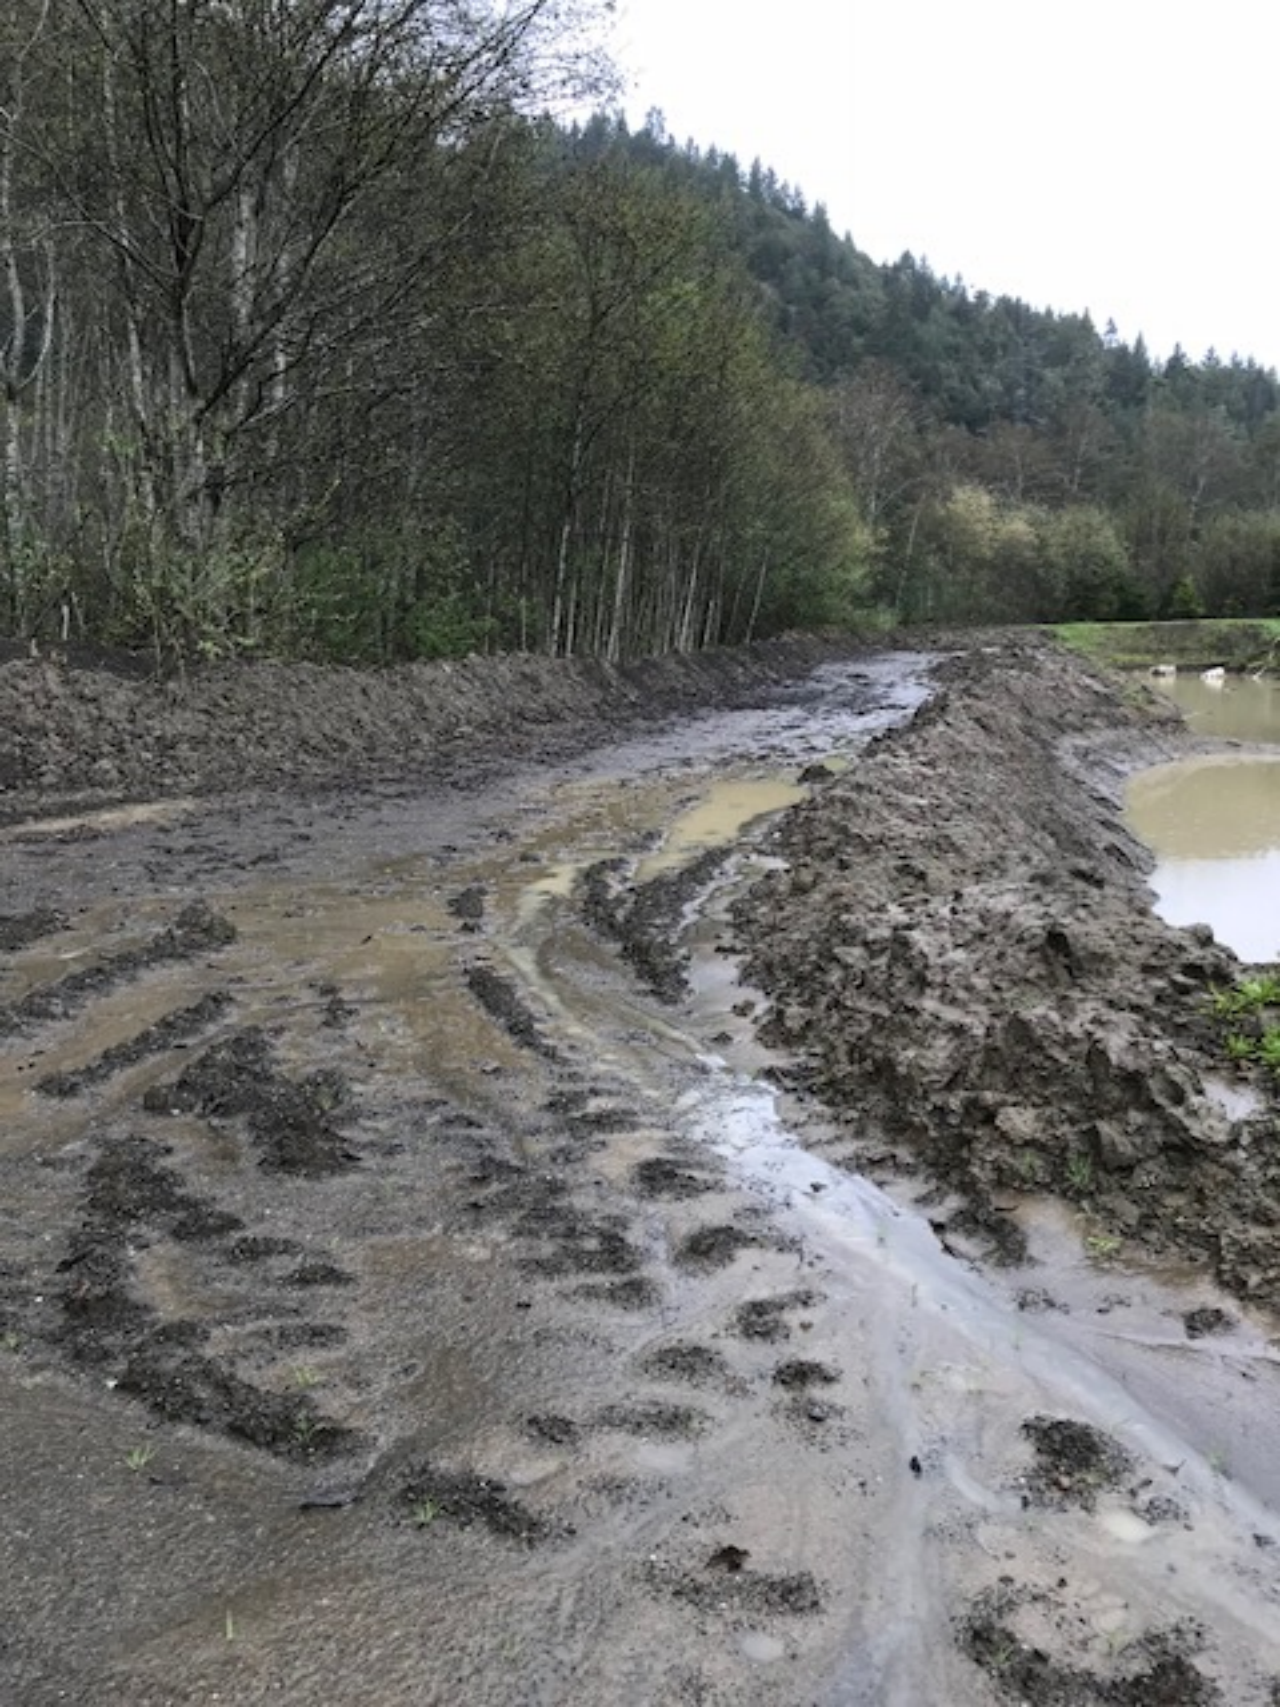
As you can see we move the pond mud off the levy. As you can see the mud will drain back into the pond. Let me know if you got this email.
