COUNTY OF MENDOCINO DEPARTMENT OF PLANNING AND BUILDING SERVICES

CASE#: CDP_2019-0049 **DATE FILED**: 12/6/2019

REQUEST: Standard Coastal Development Permit request to construct a single-family residence and ancillary

BIOLOGICAL SCOPING, WETLAND DELINEATION, LOTIS BLUE, BEHREN'S SILVERSPOT BUTTERFLY & BOTANICAL SURVEY REPORT

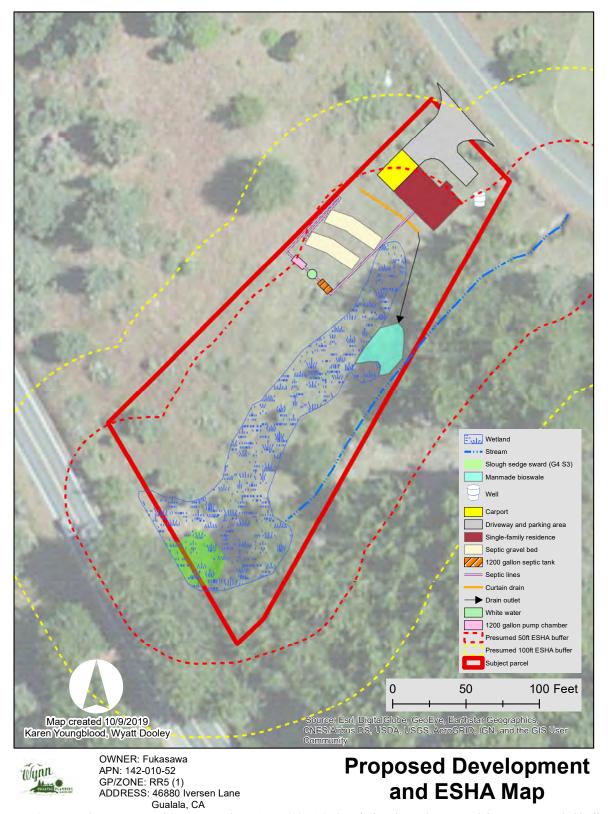
Figure 2. Potential Environmental Sensitive Habitat Areas (ESHAs) identified in the study area and their recommended buffers.

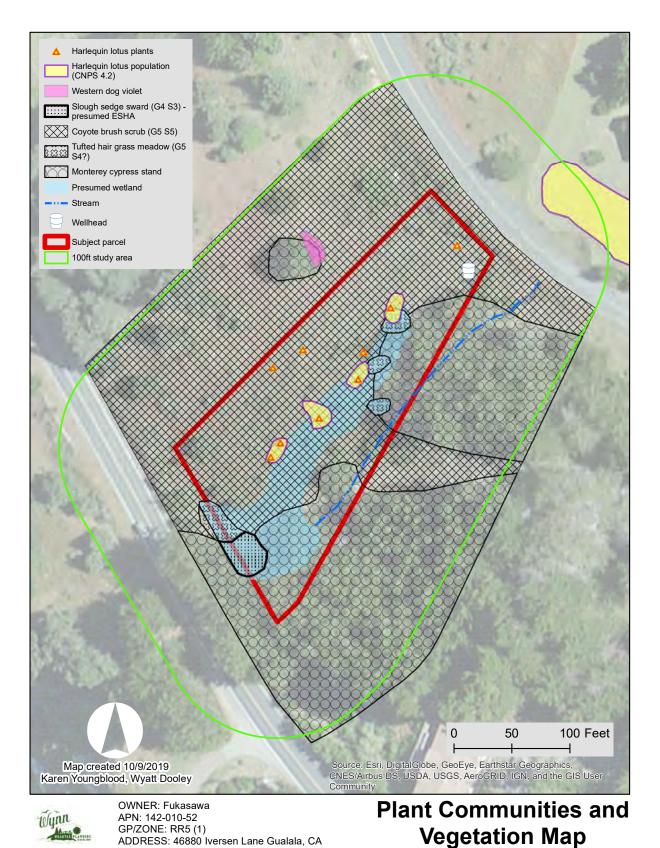
Figure 3. Plant communities map & other vegetation.

Within this one-acre parcel, Wynn Coastal Planning & Biology biologists identified four plant communities, one of which is special status and presumed ESHA – **Slough Sedge Swards** (*Carex obnupta* **Herbaceous Alliance G4 S3**). The other plant communities identified were Monterey Cypress Stand (*Hesperocyparis macrocarpa* Semi-Natural Alliance), Coyote Brush Scrub (*Baccharis* pilularis Shrubland Alliance G5 S5), and Tufted Hairgrass Meadow (*Deschampsia cespitosa* Herbaceous Alliance G5 S4?). The plant communities are described in detail in Survey Results (**Section 5.2**) and are shown in **Figure 3**.

Lotis Blue Butterfly's (*Lycaeides argyrognomon lotis*) (LBB) presumed host plant harlequin lotus was observed at the site (**Figure 3**). Because of the proximity of harlequin lotus to the proposed development, surveys were performed for both the host plant and butterflies.

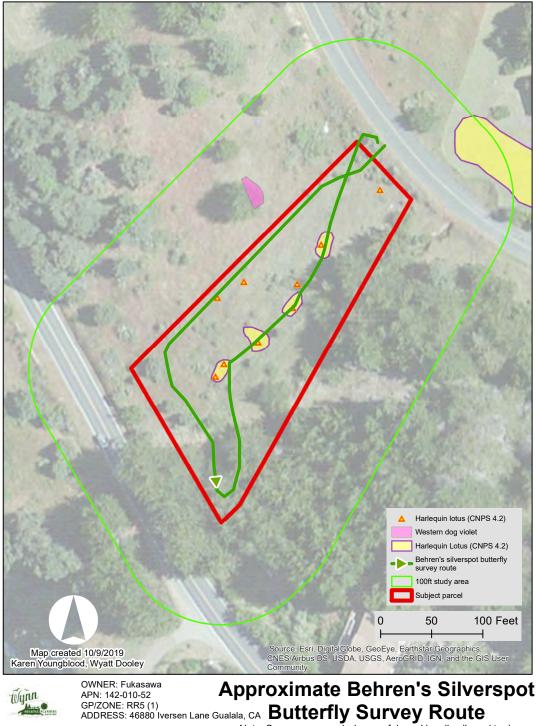
Note: Surveys occurred where safely and legally allowed to do so. Figure 6. The route used for the Behren's silverspot butterfly surveys.

A pre-determined set route was designated to cover the majority area of the parcel and to walk near host plants and potential nectar plants. The pre-determined route is shown in (**Figure 6**). Surveys occurred in appropriate weather conditions as outlined on the data sheets in **Appendix G**. Surveys occurred on August 17, 23, and 31, 2018.

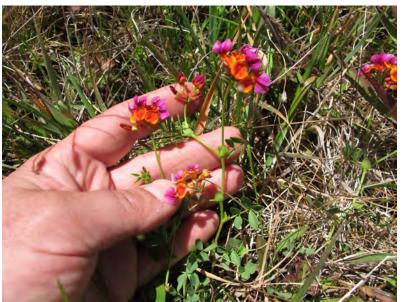
Figure 7. Harlequin lotus within the study area.

Formerly known as *Lotus formosissimus*, this plant is the presumed larval host plant of the Lotis blue butterfly. Harlequin lotus was observed in many locations in grassland habitat around the edges of the wetlands that occurred within the study area. Four larger patches of plants were observed onsite with several smaller populations (**Figure 3**). Because the proposed development will occur within 50ft of these populations, technical assistance from the USFWS was performed for the lotis blue butterfly. Results of Lotis blue butterfly surveys are presented in **Section 5.5**.

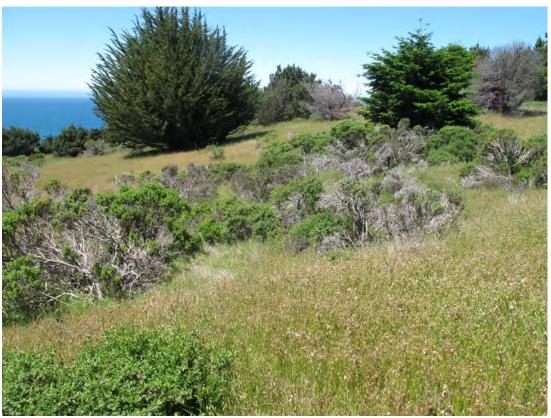
Figure 8. Coyote brush scrub as viewed from road looking west.

The majority of the parcel and neighboring properties were vegetated by coyote brush scrub (**Figure 8**, **Figure 9**, **Figure 10**). Coyote brush was dense at the lower end of the parcel by the highway and patchy throughout. Associated plants within the coyote brush scrub included coffee berry (*Frangula californica*), *Cotoneaster* sp., golden aster (*Heterotheca sessiflora* ssp. *bolanderi*), seaside daisy (*Erigeron glaucus*), California blackberry (*Rubus ursinus*), sweet vernal grass (*Anthoxanthum odoratum*), greater quaking grass (*Briza maxima*), velvet grass (*Holcus lanatus*), and purple-awned wallaby grass (*Rytidosperma penicillatum*). Other plants within the community included self-heal (*Prunella vulgaris*), English plantain (*Plantago lanceolata*), Italian thistle (*Carduus pycnocephalus*), bull thistle (*Cirsium vulgare*), rough cat ears (*Hypochaeris radicata*), yarrow (Achillea millefolium) and California poppy (*Eschscholzia californica*).

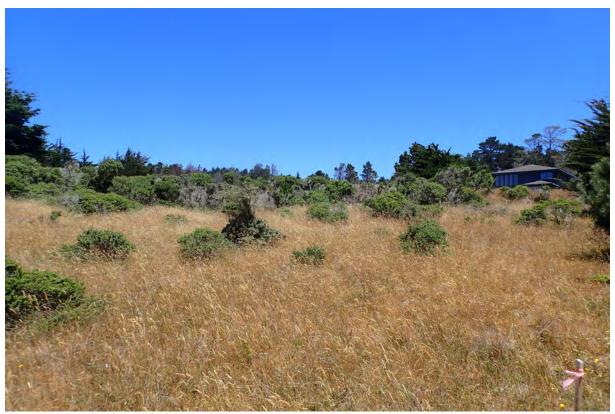
Figure 9. Coyote brush scrub looking north east.

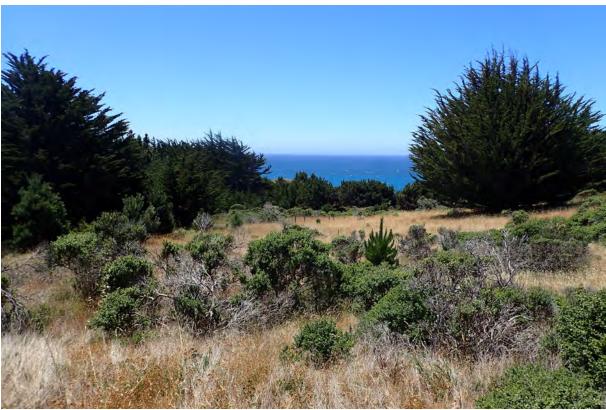
Figure 10. Coyote brush scrub as viewed from road looking south west.

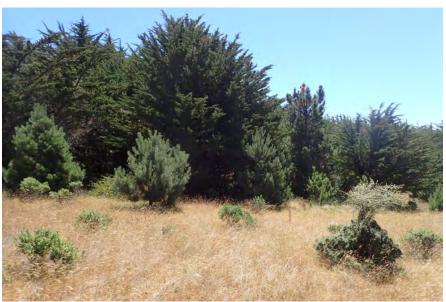
Figure 11. Coyote brush scrub habitat (foreground) meeting Monterey cypress stand (background).

Monterey Cypress Stands occupied the southern boundary of the property and provided shade and overstory to the channel. The cypress stand was dominated by Monterey cypress but included some young bishop pine (*Pinus muricata*) seedlings and saplings (**Figure 11**). Understory vegetation was sparse (**Figure 12**) and included: wax myrtle (*Morella californica*), pennyroyal (*Mentha pulegium*), rough cat's ear (*Hypochaeris radicata*), sweet vernal grass (*Anthoxanthum odoratum*), sword fern (*Polystichum munitum*), huckleberry (*Vaccinium ovatum*), and common bog rush (*Juncus effusus*).

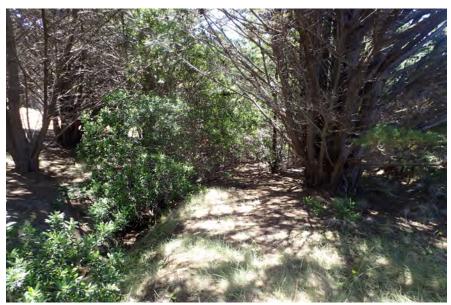
Figure 12. The sparse understory of the Monterey cypress stand with stream channel through bottom left corner.

South of the Coastal Act Wetland, along the southern property boundary, is a constructed channel (**Figure 12**) that has been treated as a stream for the purpose of this report. An 18" culvert was observed extending approximately 4ft from beneath Iversen Lane into the channel. No defined stream occurs on the upslope side of the culvert east of the road, the culvert and channel appears to be primarily for the drainage of surface water runoff of the area northeast of the parcel across Iversen lane. The stream channel is cut 4 ft deep at Iversen Lane and is approximately 290 ft long. The depth of the channel becomes shallower toward the southwest until at its lower end water is conveyed into the lower end of the Coastal Act Wetland and the stream channel is no longer discernable. There are no distinct riparian zones along the stream. Overstory trees surrounding the channel are primarily Monterey

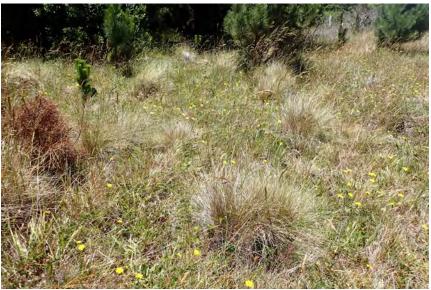
Figure 13. Tufted hairgrass clumps mixed with other vegetation.

A tufted hairgrass meadow was observed with in the delineated wetland onsite. On the Mendocino coast, tufted hairgrass (Deschampsia caespitosa ssp. holciformis) communities often indicate moist soils and are correlated with wetlands. Also, often when tufted hairgrass dominates an area, other lower growing plants are able to grow between the cespitose clumps allowing for more species diversity than might be found in the taller invasive grass meadows. Other vegetation found in the area dominated by tufted hairgrass includes blue eyed grass (Sisyrinchium bellum), iris leaved rush (*Juncus xiphiodes*), self-heal (*Prunella vulgaris*), Harlequin lotus (*Hosackia gracilis*), bird's foot trefoil (*Lotus corniculatus*), rough cat's ear, California blackberry (*Rubus ursinus*), and wonder woman sedge (*Carex gynodynama*).

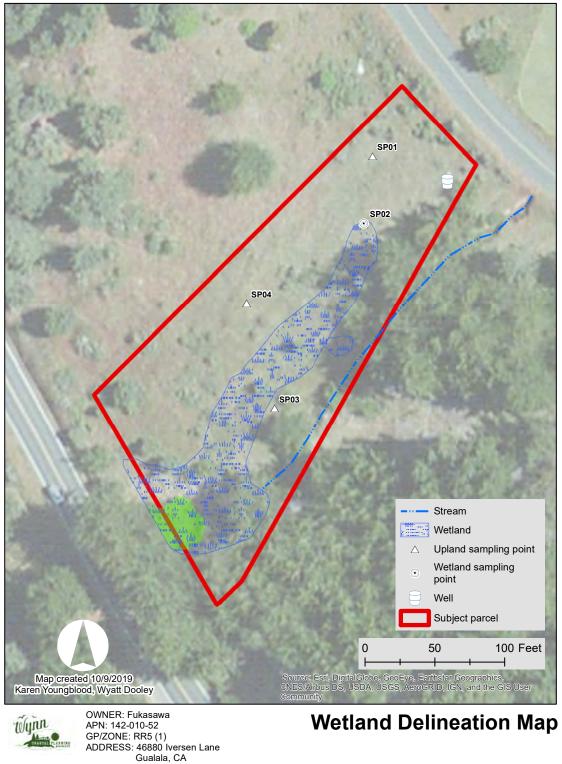
Figure 14. Wetland delineation map depicting wetland Sample Points, presumed wetlands and stream.

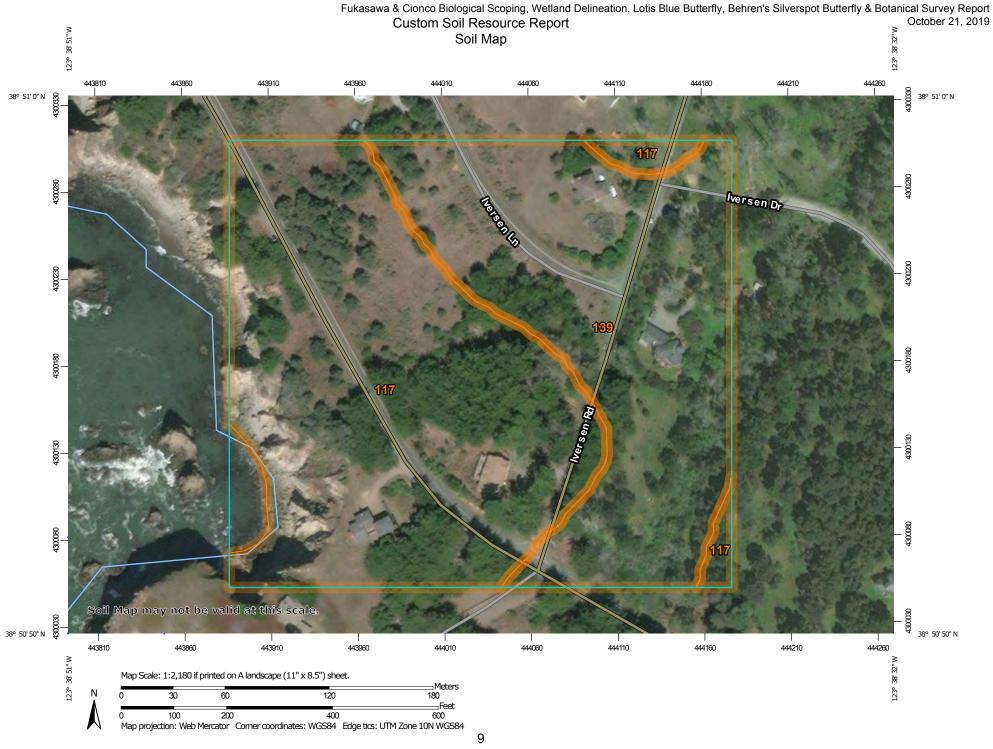
Soil Map

The soil map section includes the soil map for the defined area of interest, a list of soil map units on the map and extent of each map unit, and cartographic symbols displayed on the map. Also presented are various metadata about data used to produce the map, and a description of each soil map unit.

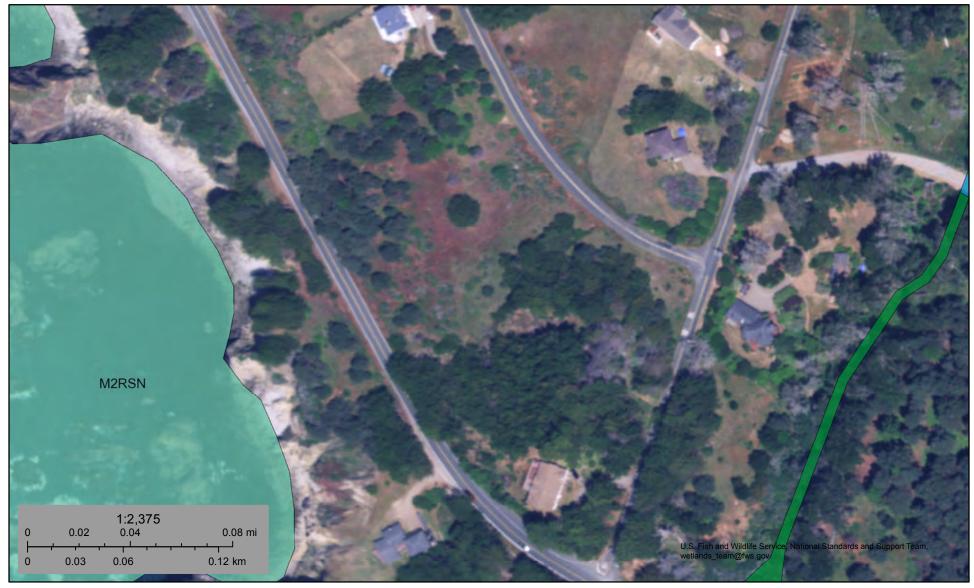
, Wetland Delineation, Lotis Blue Butterfly, Behren's Silverspot Butterfly & Botanical Survey Report Fukasawa NWI Wetlands Map October 21, 2019

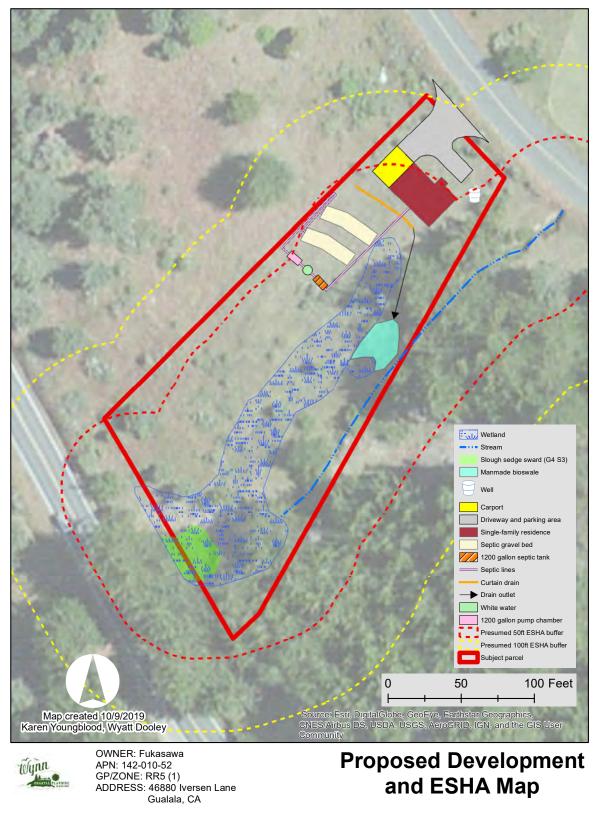
Figure 2. Presumed ESHAs documented onsite and the proposed development location.

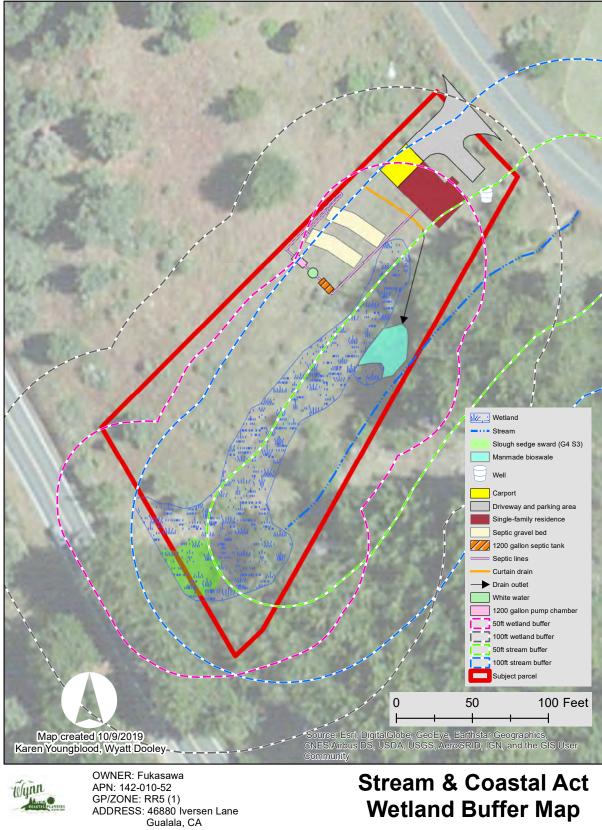
Figure 3. Proposed development and presumed buffers from each resource.

Approximate Square Footage of Proposed Development Within Buffers									
	Wetland			Stream					
	Sqft in 100ft buffer	Sqft in 50ft buffer	Within Wetland	Sqft in 100ft buffer	Sqft in 50ft buffer	Within Stream			
Single-family residence	20	962	0	982	77	0			
Driveway & parking	1,546	0	0	1,075	0	0			
Carport	384	220	0	384	0	0			
Septic lines (under assumption									
trenching is 1ft wide)	200	170	0	91	0	0			
Septic tank	50	50	0	50	0	0			
Pump chamber	51	41	0	28	0	0			
Leach field	762	762	0	716	C	0			
White water	34	34	0	34	0	0			
Curtain drain (under assumption									
trenching is 1ft wide)	49	49	0	49	C	0
