Mendocino County

ADA Comprehensive Access Plan for the County Maintained Road System

July 16, 2010

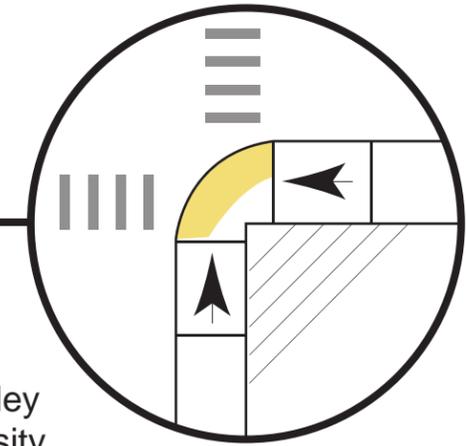
1: Sidewalk in this area is comprised of many different types and is generally not a continuous pedestrian system suitable for disabled access. Effort will be necessary to sort through the various conditions to improve this portion.

2: Sidewalk in this area is comprised of many different types and is generally not a continuous pedestrian system suitable for disabled access. Conditions for this portion involve very old walks and sidewalks that could be considered hazards, many curb ramps missing or not code compliant, and parking that severely interferes with developing a pedestrian walk system.

3: Crosswalk is recommended at this location due to distances between existing crossings. Markings, signage, and striping should be assessed on a warrant basis. Heavy bar striping with warning paddle signs is recommended for pedestrian safety crossing Highway 128.

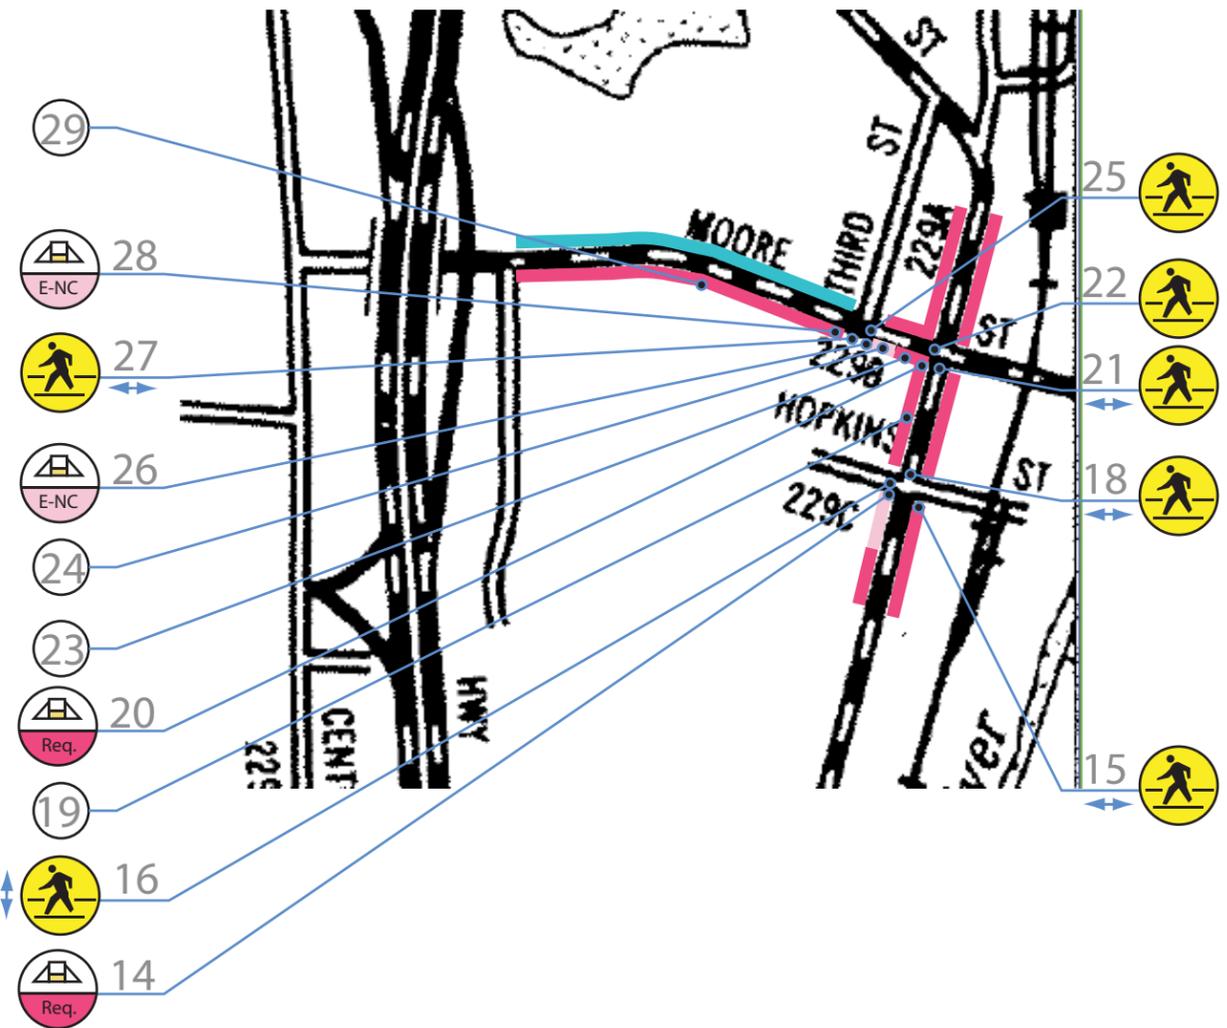
- 14: Curb ramp or blended transition is missing at this corner and is required to provide pedestrian travel path.
- 15 & 16: Crosswalk should be considered at this location due to traffic and children crossing during school times; this recommended crosswalk should be assessed on a warrant basis for safety and markings that afford better contrast and route recognition by visually impaired persons. Paving is quite rough and needs repair for pedestrian safety and disabled access compliance.

- 27: Crosswalk; recommend striping for pedestrian safety.
- 28: Curb ramp; undersized top landing, no detectable warnings, excessive ramp slope, lip at ramp bottom to gutter, excessive gutter slope.

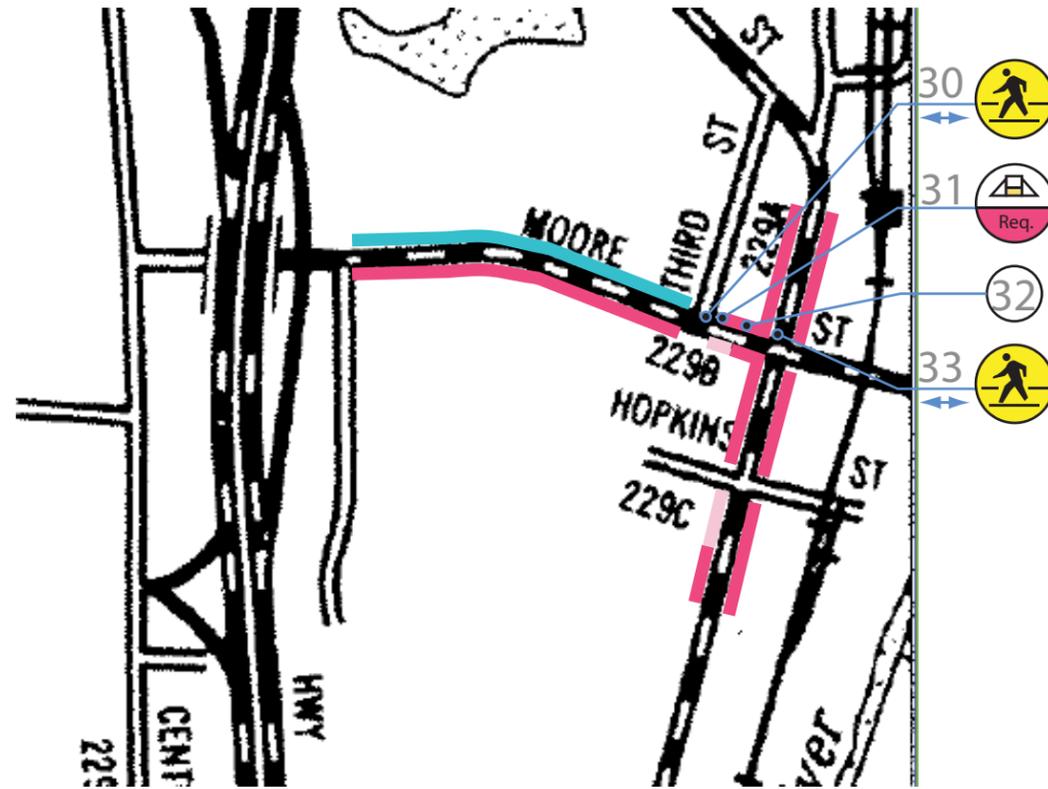
- 30: Crosswalk; recommend striping for pedestrian safety.
- 15 & 16: Crosswalk; recommend striping for pedestrian safety. Paving is quite rough and needs repair for pedestrian safety and disabled access compliance.

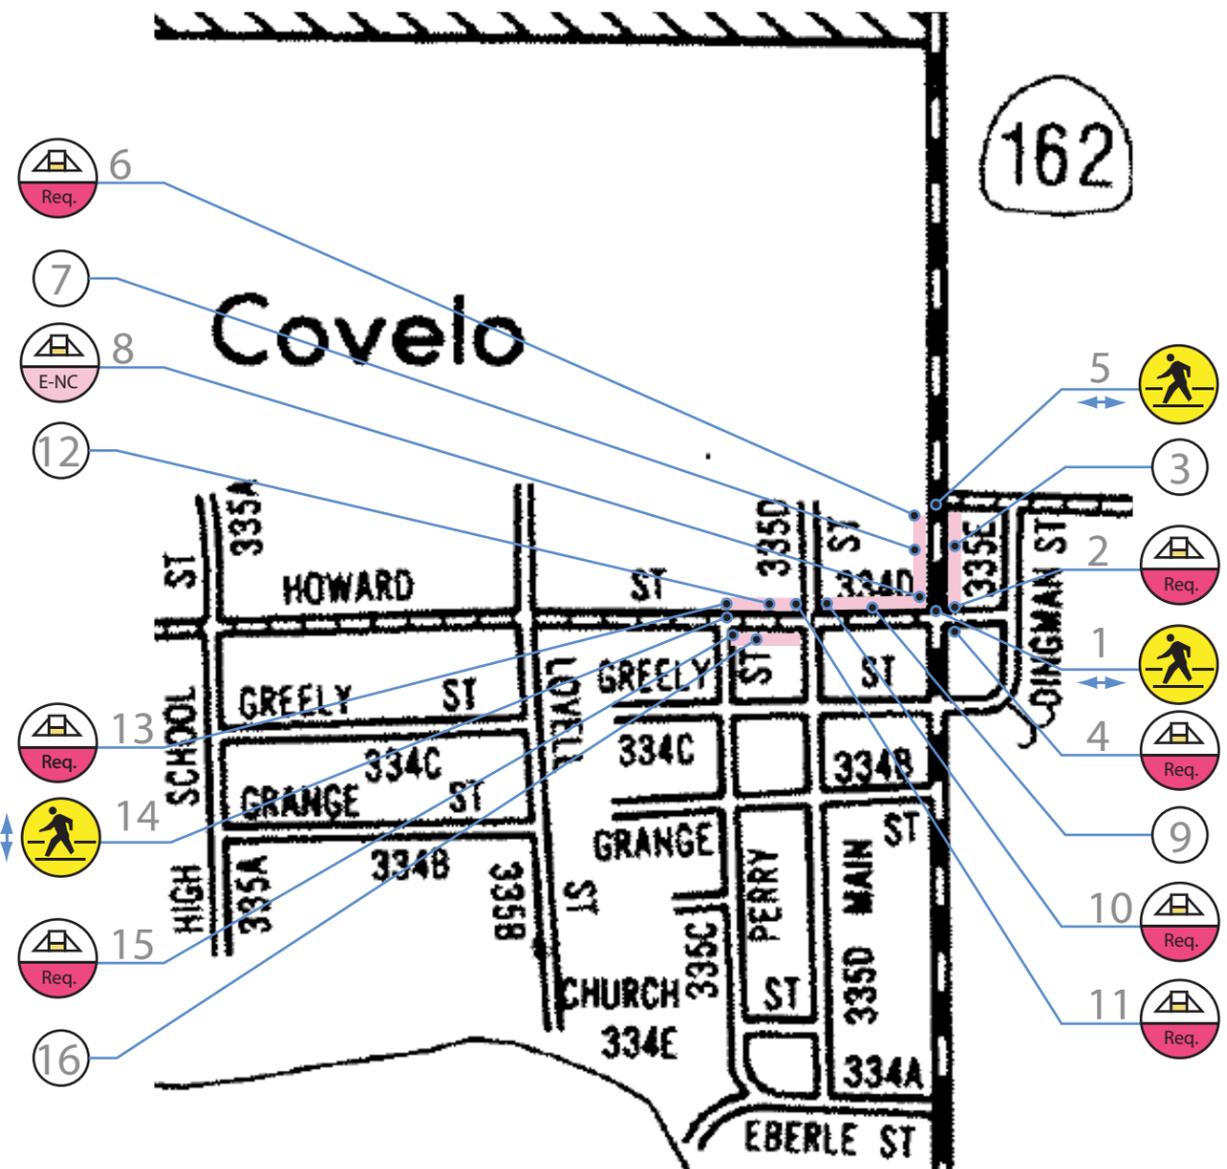
- 1: Crosswalk; rough pavement and ledges near corners, paving correction necessary.
- 2: Curb ramp or blended transition is missing at this corner and is required to provide pedestrian travel path.

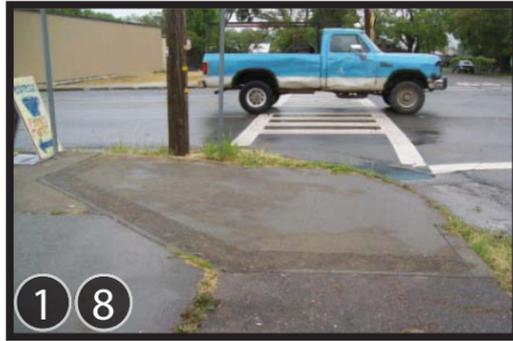
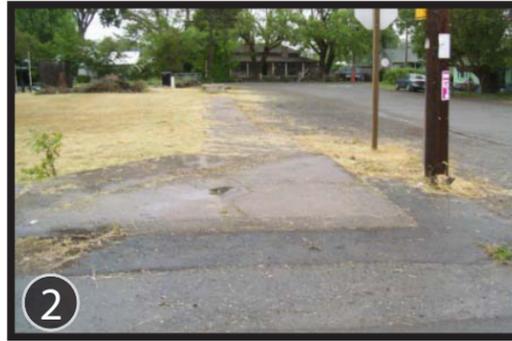
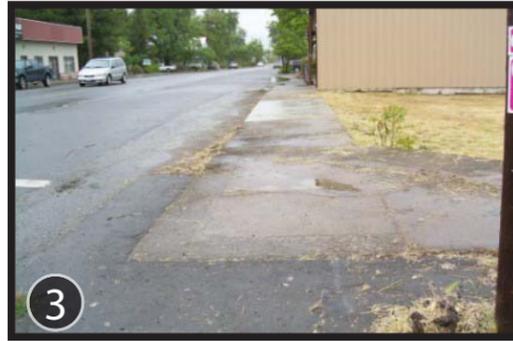
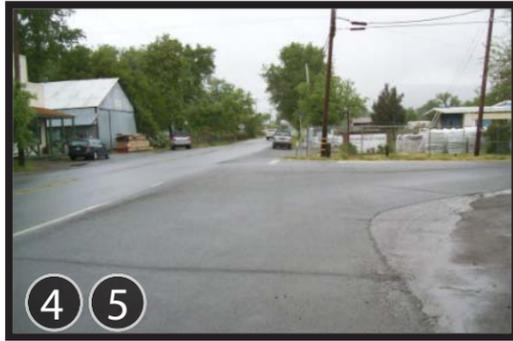
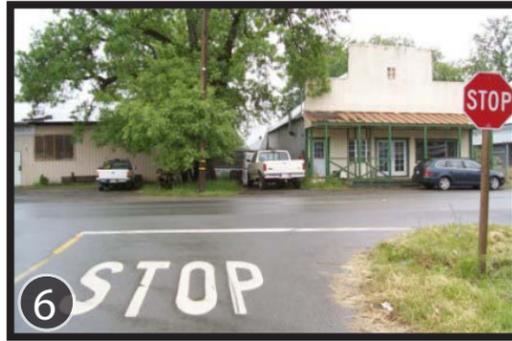
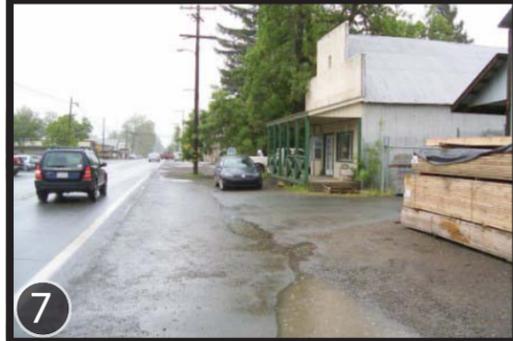
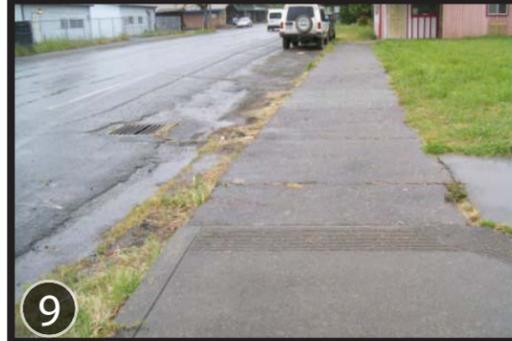
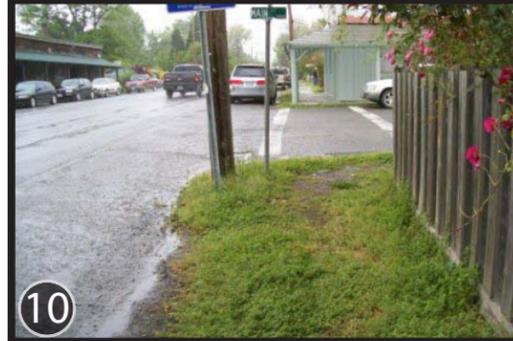
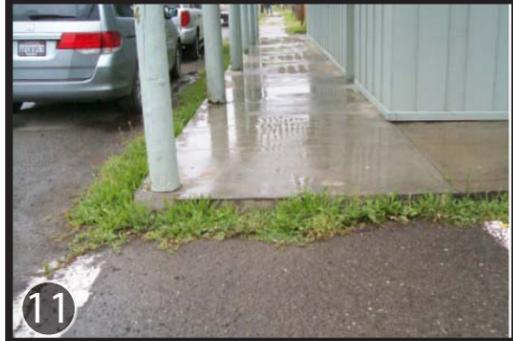
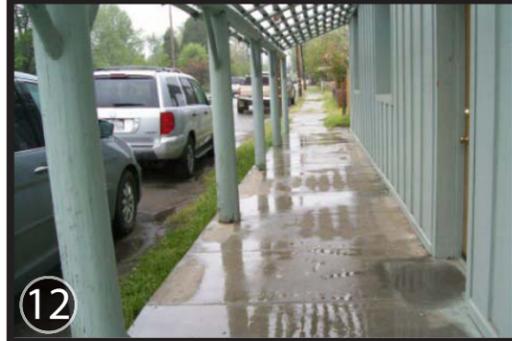
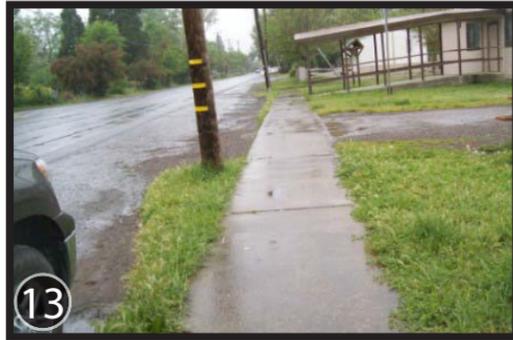
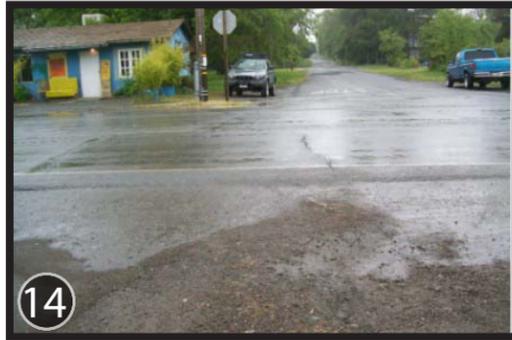
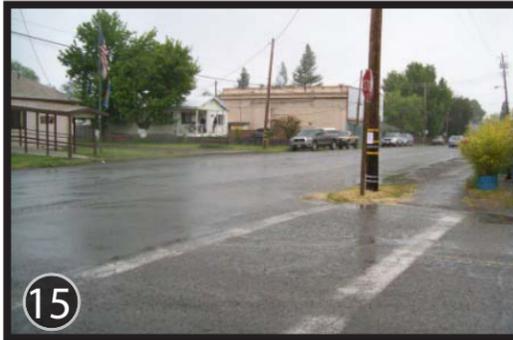
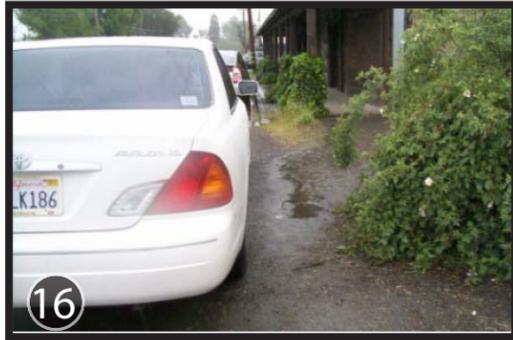
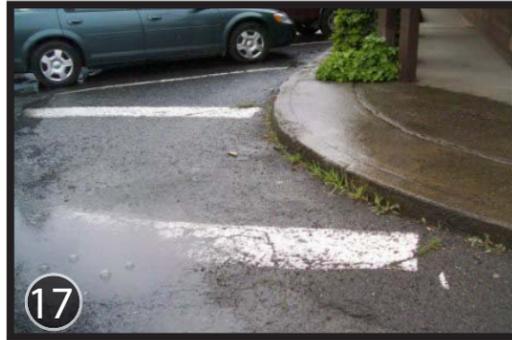
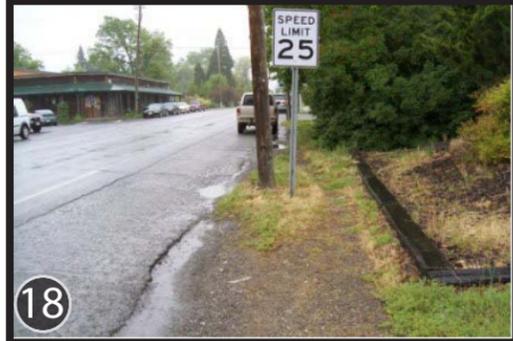
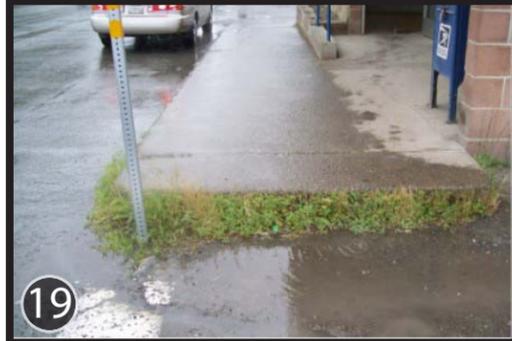
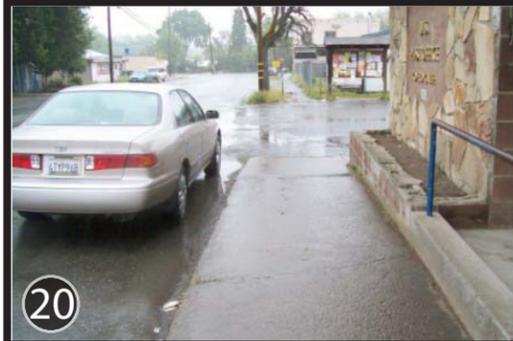
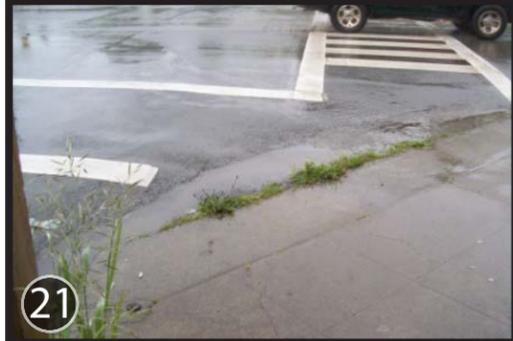
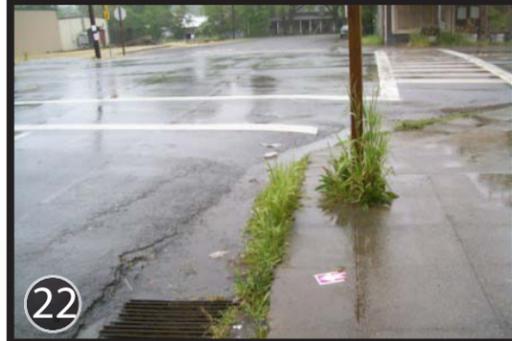
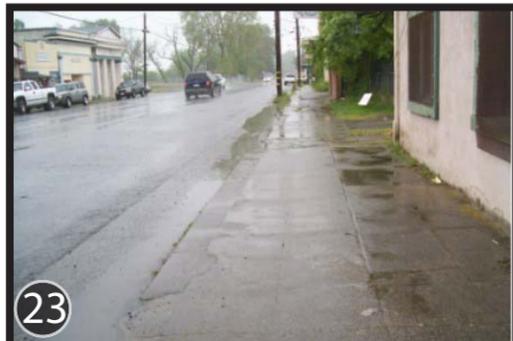
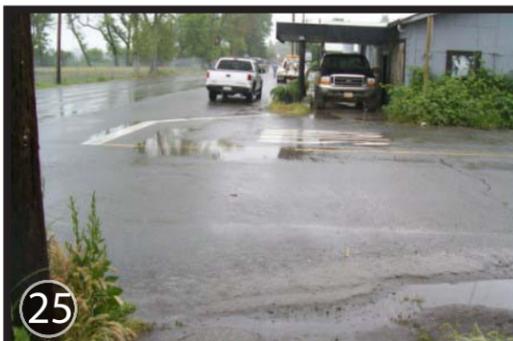
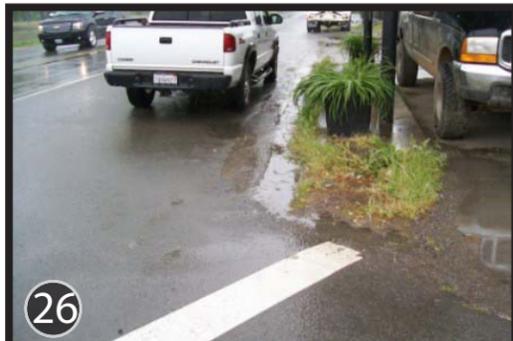
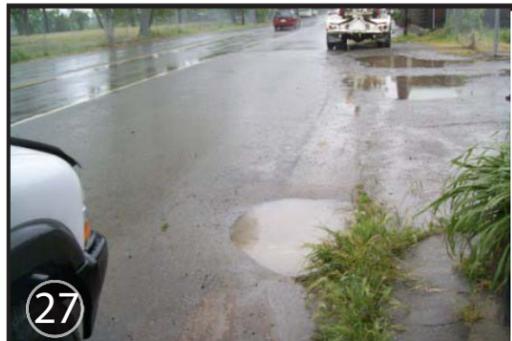
Covelo Photographs: Items 1 - 27

- 3: Sidewalk; excessive cross slope, ledges, and discontinuities. Travel path also includes asphalt adjacent to parking areas without clear designation for walk area. Asphalt may surface may be able to be developed into a pedestrian path if properly sloped. Surface water drainage needs to be accommodated in any future work for pedestrian walks. Striping recommended on asphalt to identify vehicle drives and walk lanes. Parking restrictions or designated vehicle parking lanes should be considered as well.

- 4: Curb ramp or blended transition is missing at this corner and is required to provide pedestrian travel path.
- 5: Crosswalk; recommend striping for pedestrian safety, due to highway traffic, heavy bar stripes recommended. Paving is quite rough near corners and road edges and needs repair for pedestrian safety and disabled access compliance.

- 6: Curb ramp or blended transition is missing at this "tee" intersection and is required to provide pedestrian travel path to Highway 162 west side.
- 7: Sidewalk is not continuous in this area. Pedestrian routes available are along the road shoulder and adjacent to buildings on older non compliant concrete sidewalks. Options may include asphalt if properly sloped with provisions for drainage and driveway access to properties. Durable striping to delineate the walk portion on pavement should also be provided. Parking restrictions or designated vehicle parking lanes should be considered as well.

- 9: Sidewalk is not continuous in this area, portions are on gravel road shoulder. Existing concrete has rough surfaces, broken sections, ledges, and constricted width at direction change. Parking restrictions or designated parking lane should be considered.

- 10 & 11: Curb ramp or blended transition is missing at this corner and is required to provide pedestrian travel path.
- 12: Existing sidewalk has very rough portions, excessive cross slopes, and ledges.

- 13: Curb ramp or blended transition is missing at this "tee" intersection and is required to provide pedestrian travel path across Howard Street.
- 14: Crosswalk; recommend striping for pedestrian safety. Paving is quite rough and needs repair for pedestrian safety and disabled access compliance.

17: Curb ramp or blended transition is missing at this corner and is required to provide pedestrian travel path.
-

18: Crosswalk; recommend striping for pedestrian safety. Paving is quite rough and needs repair for pedestrian safety and disabled access compliance.

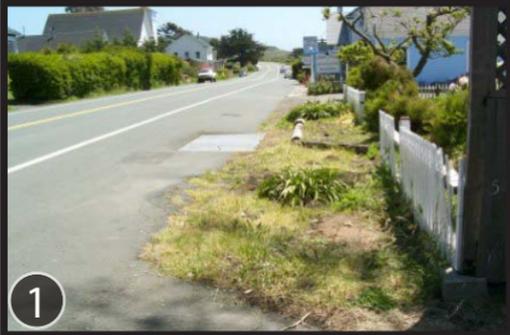
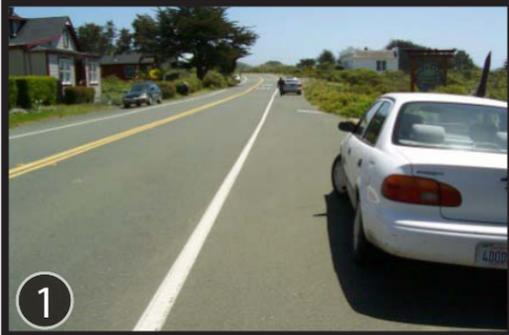
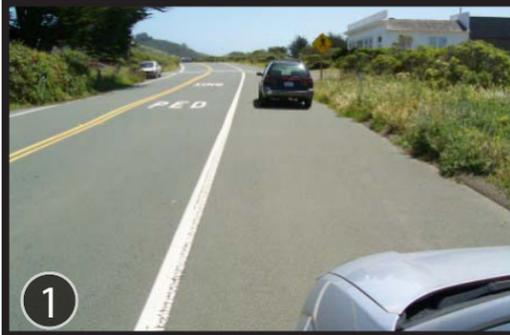
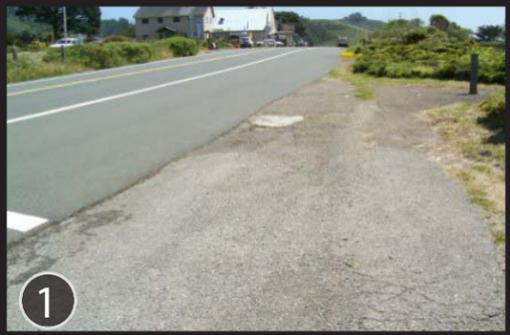
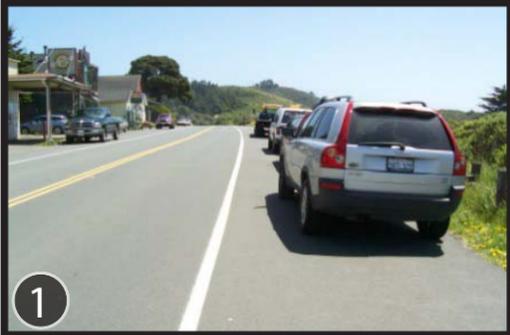
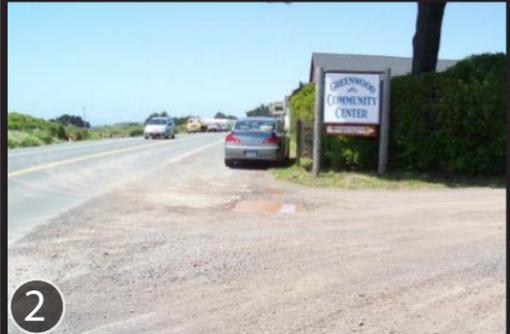
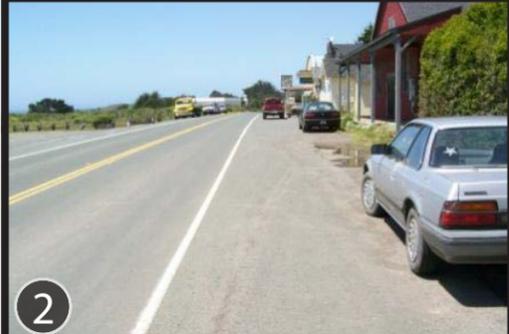
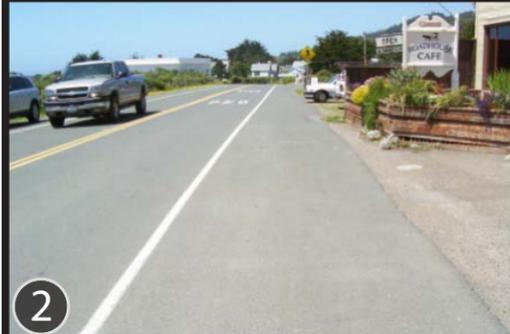
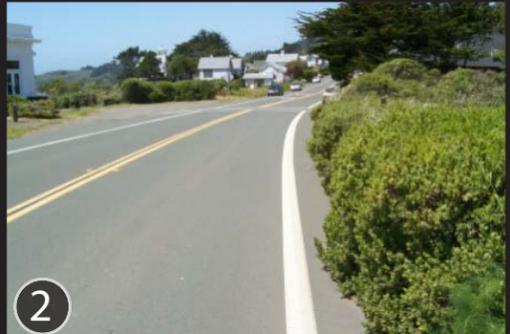
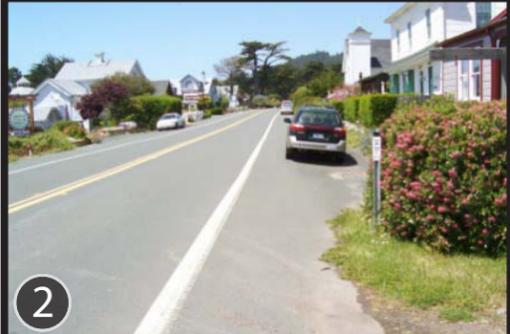
Elk Photographs: Items 1 - 2

1: Currently the available pedestrian walking path is along the asphalt road shoulder. Due to intense traffic, it is recommended to have a design that separates pedestrians from traffic lanes such as parking lane between walkway and road lane. Design for pedestrian improvements must consider how the pedestrian travel walkway will serve general travel along Highway 1, parked car interferences, vehicle driveways, walkway connections to adjacent business properties, and surface water drainage.

2: Currently the available pedestrian walking path is along the asphalt road shoulder and the village northern area is very narrow from road lane edge to paving edge. Due to intense traffic, it is recommended to have a design that separates pedestrians from traffic lanes such as parking lane between walkway and road lane. Design for pedestrian improvements must consider grading to create additional road shoulder width along Highway 1, parked car interferences, vehicle driveways, walkway connections to adjacent business properties, and surface water drainage.

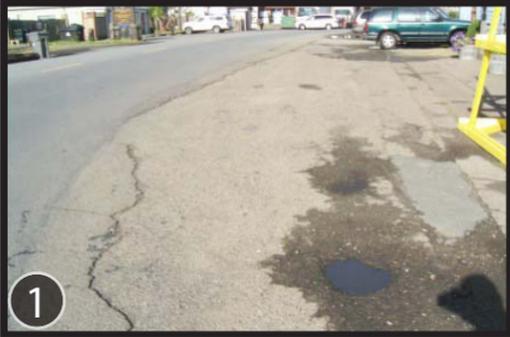
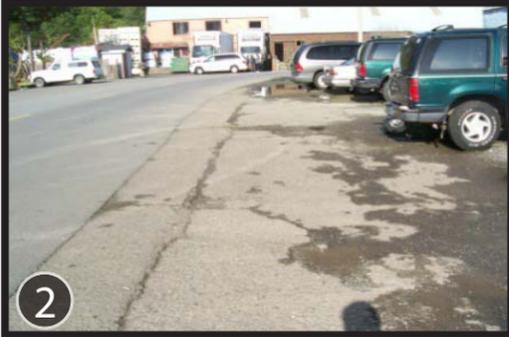
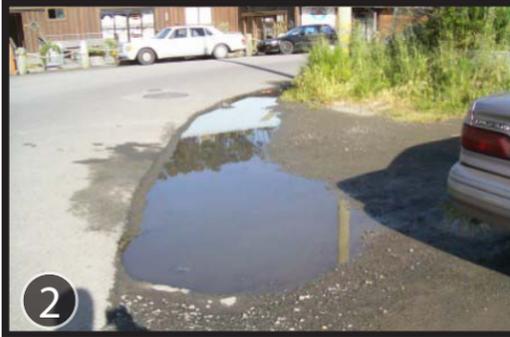
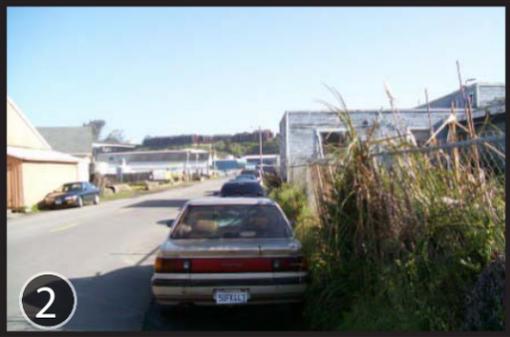
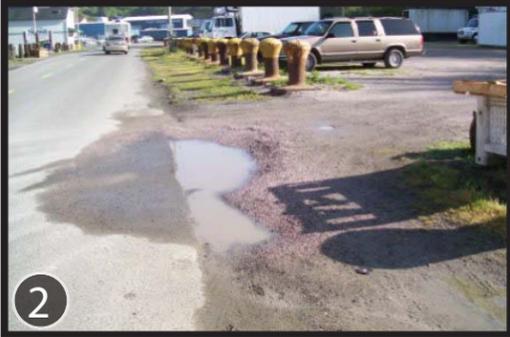
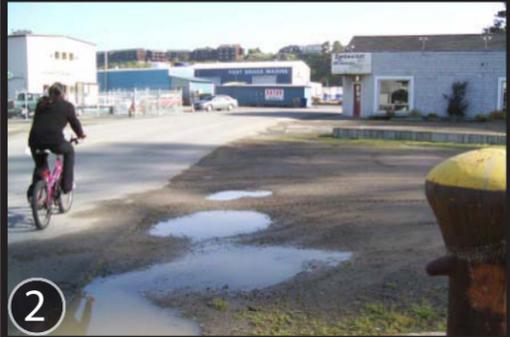
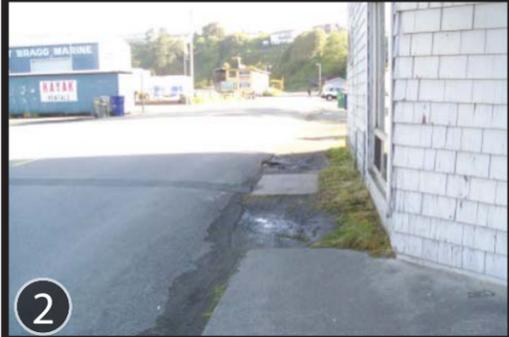
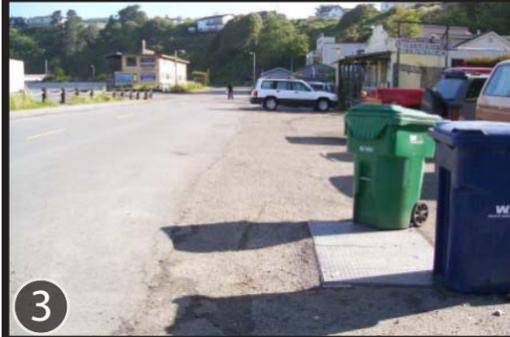
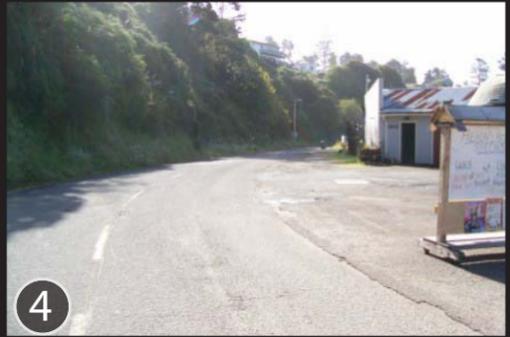
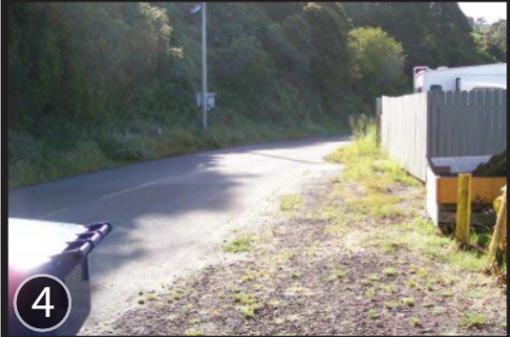
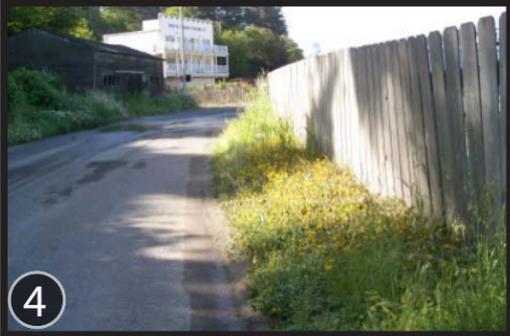
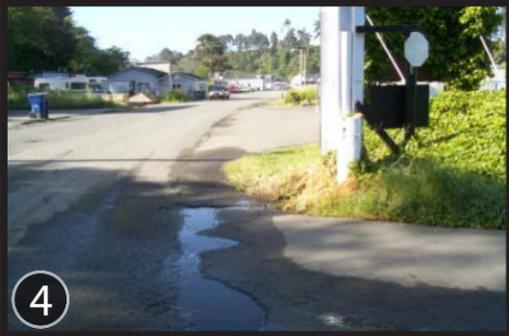
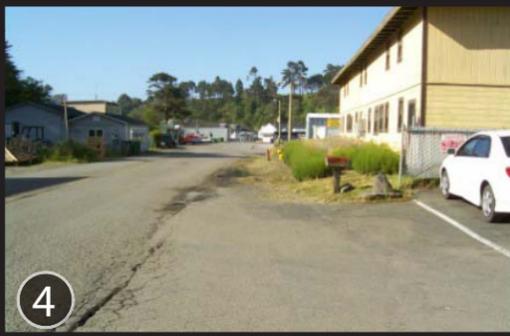
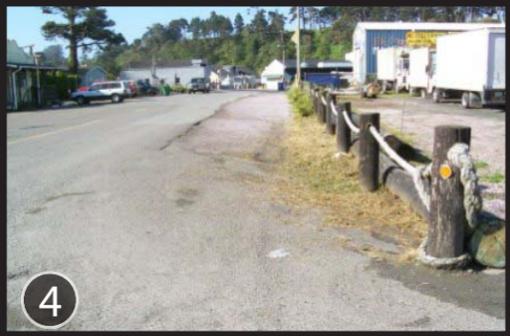
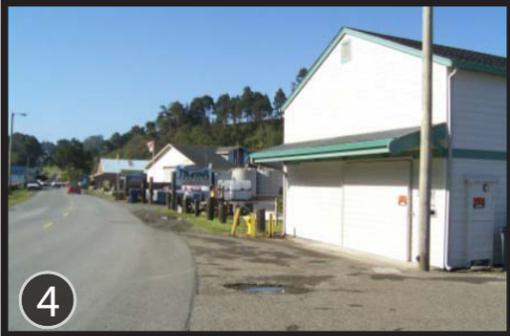
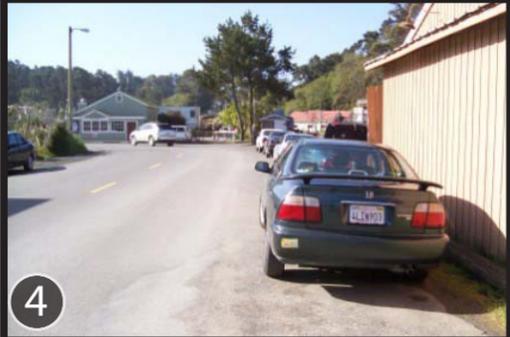
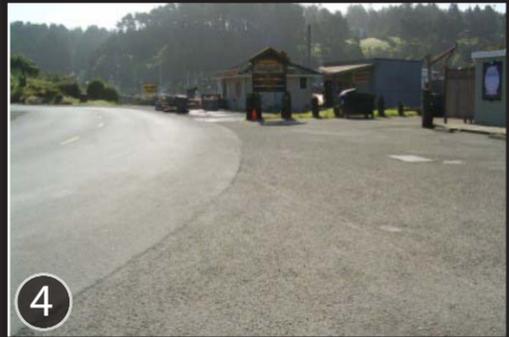
Fort Bragg Photographs: Items 1 - 4

1: Crosswalk recommended at this general location to connect businesses on each street side into a continuous pedestrian route system. This recommended crosswalk should be assessed on a warrant basis for pedestrian safety and markings that afford better contrast and route recognition by visually impaired persons.

3: Crosswalk recommended at this general location to connect businesses on each street side into a continuous pedestrian route system. This recommended crosswalk should be assessed on a warrant basis for pedestrian safety and markings that afford better contrast and route recognition by visually impaired persons.

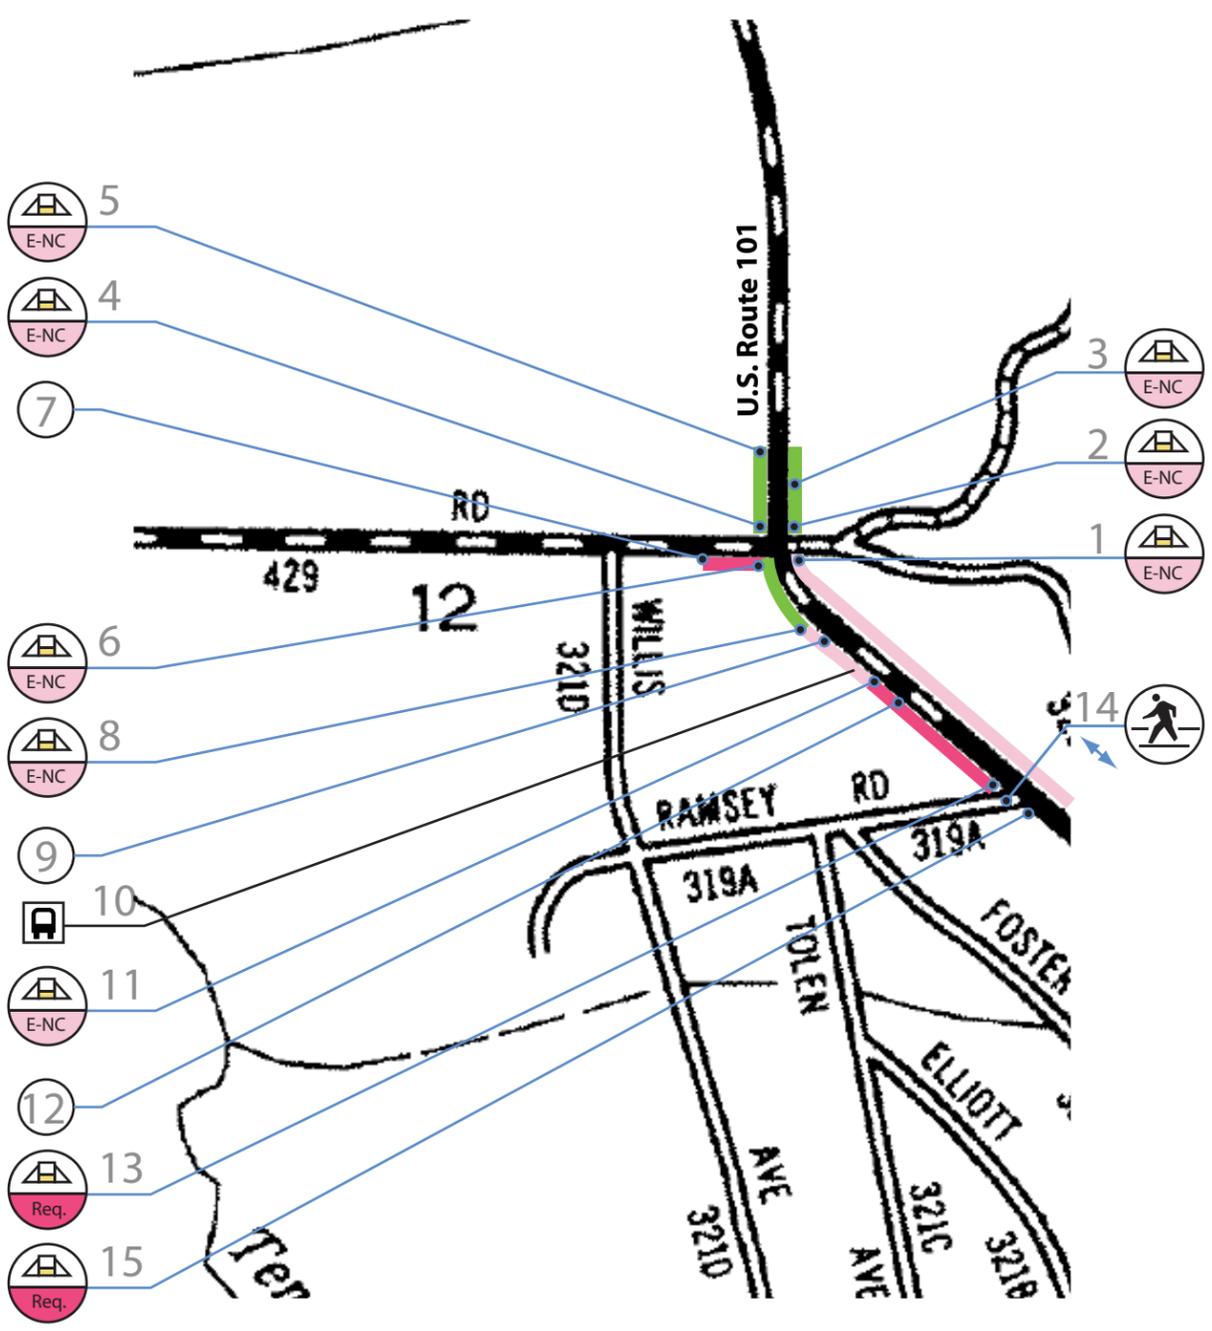
- 1: Curb ramp has silt and soil debris, slippery footing conditions; drainage needs corrected. Layout at this corner is more a blended transition than diagonal curb ramp as there is no sidewalk around the corner. Best practice is a perpendicular transition at curb ramp bottom, this ramp has a curved bottom transition from ramp surface to gutter that can cause uneven wheelchair wheel contact.

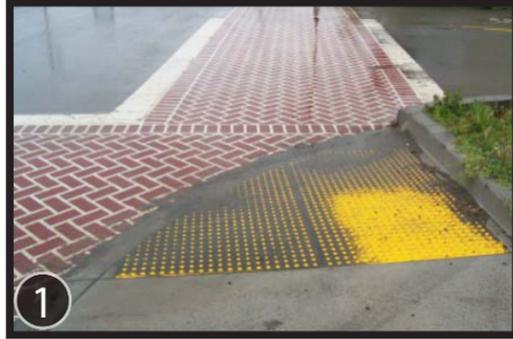
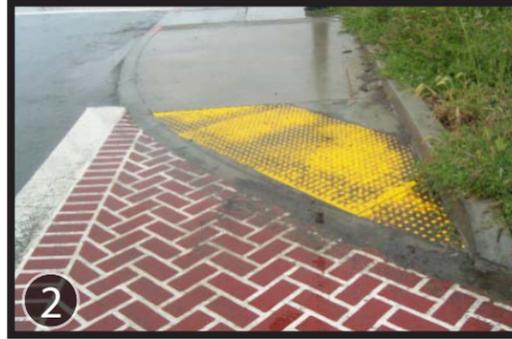
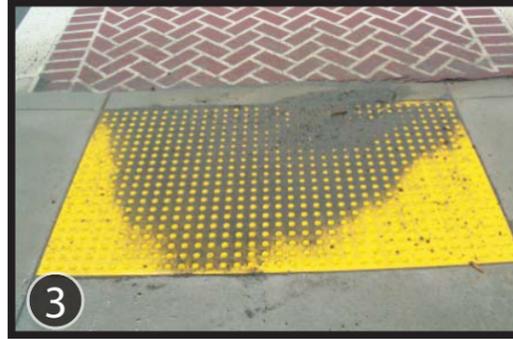
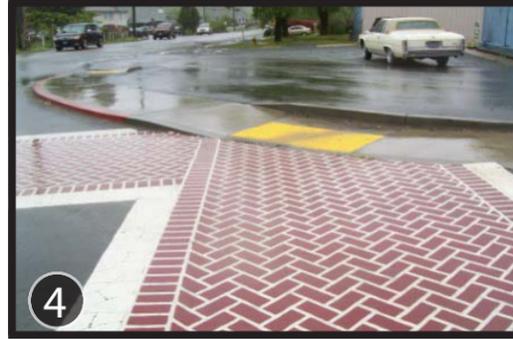
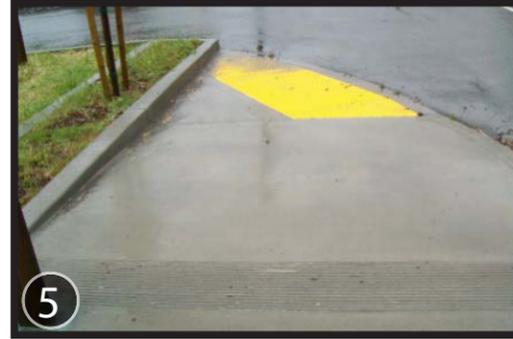
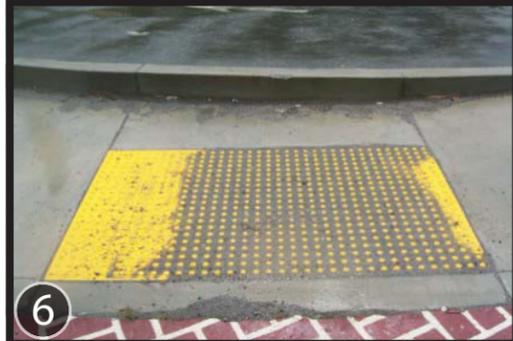
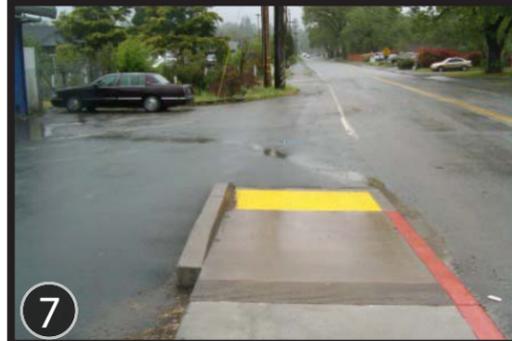
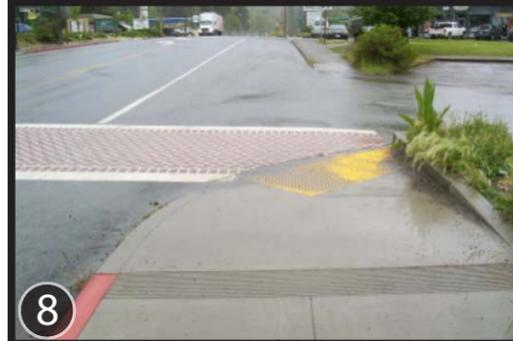
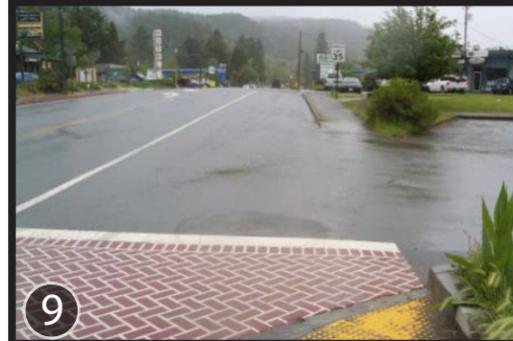
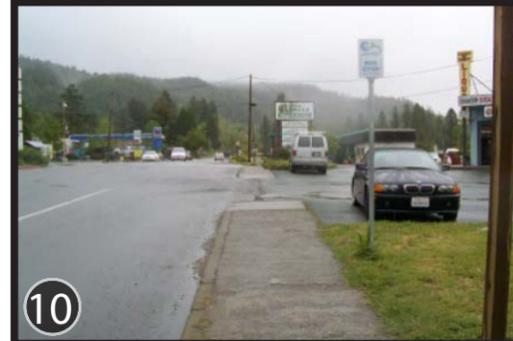
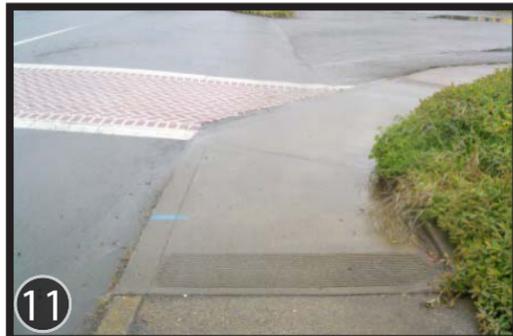
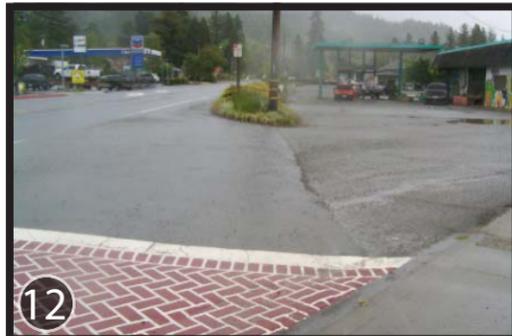
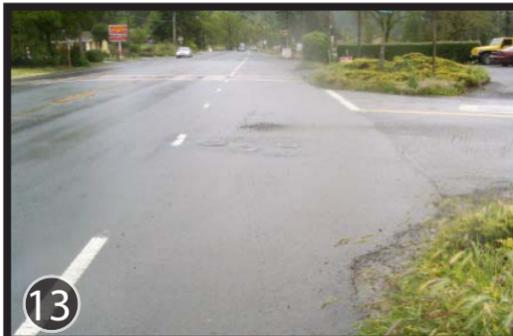
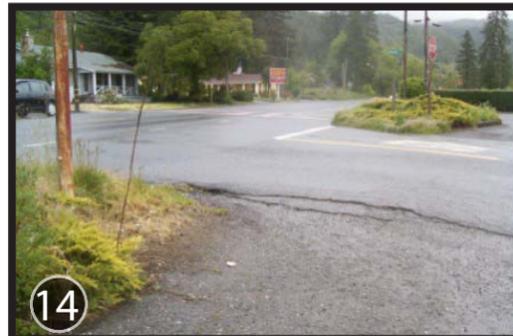
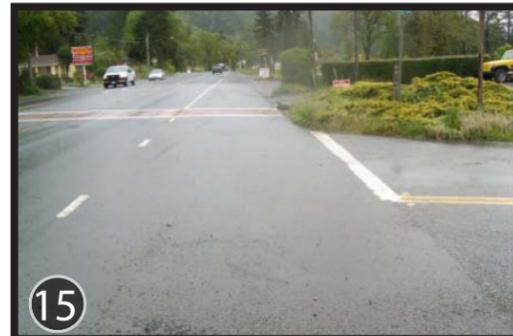
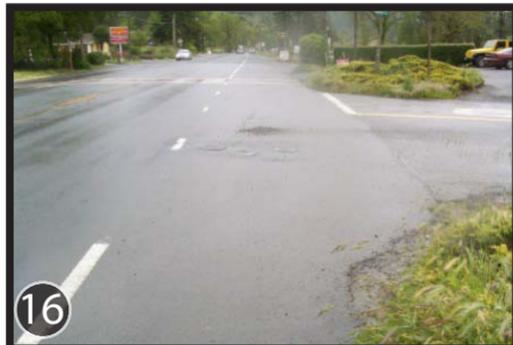
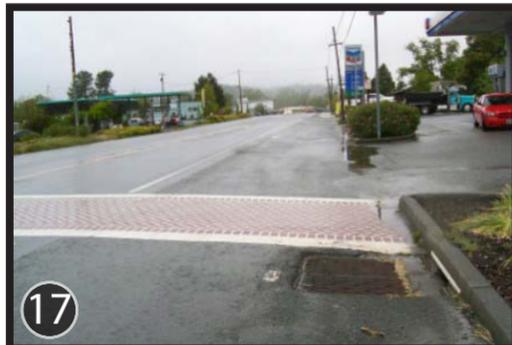
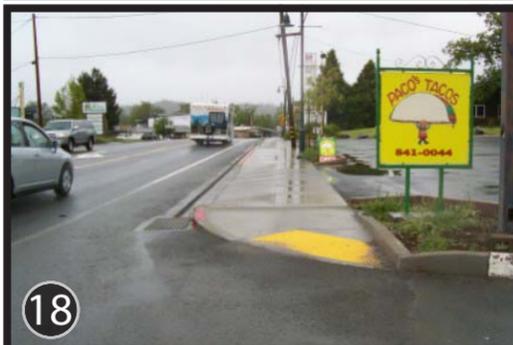
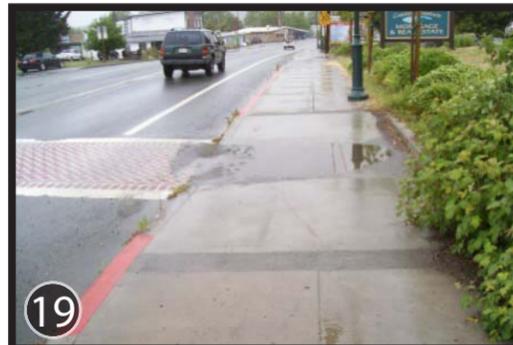
Laytonville Photographs: Items 1 - 19

- 2: Layout at this corner is more a blended transition than diagonal curb ramp as there is no sidewalk around the corner. Best practice is a perpendicular transition at curb ramp bottom, this ramp has a curved bottom transition from ramp surface to gutter that can cause uneven wheelchair wheel contact.

- 3: Curb ramp has silt and soil debris, slippery footing conditions; drainage needs corrected. Ledge at curb to crosswalk brick paving.
- 4: Curb ramp has silt and soil debris, slippery footing conditions; drainage needs corrected.

- 5: Layout at this corner is more a blended transition than diagonal curb ramp as there is no sidewalk around the corner. Best practice is a perpendicular transition at curb ramp bottom, this ramp has a curved bottom transition from ramp surface to gutter that can cause uneven wheelchair wheel contact.

- 6: Curb ramp has silt and soil debris, slippery footing conditions; drainage needs corrected. Ledge at curb to crosswalk brick paving.
- 7: Sidewalk or pedestrian path required on this street side to connect the health center with the urban density travel paths. Current path is along the asphalt road shoulder without a designated walkway. Pedestrian path can be along the asphalt road shoulder if there is sufficient width and proper slopes. Durable striping recommended to delineate vehicle driveways and walk areas.

- 8: Curb ramp has silt and soil debris, slippery footing conditions; drainage needs corrected. Ledge at curb to crosswalk brick paving.
- 9: Sidewalk is not continuous, existing concrete is not in good condition, asphalt portions have excessive cross slopes, transitions from concrete to asphalt are excessive steep.

- 12: Sidewalk or pedestrian path required on this street side. Current path is along the asphalt road shoulder without a designated walkway. Pedestrian path can be along the asphalt road shoulder if there is sufficient width and proper slopes. Since the shoulder is higher than adjacent properties, an alternate is to develop the pedestrian path along right of way boundary at lower level. Durable striping recommended to delineate vehicle driveways and walk areas.

- 13: Curb ramp or blended transition is missing at this corner and is required to provide a continuous pedestrian and disabled access travel path.
- 14: Crossing; striping recommended due to high side road traffic. This recommended crosswalk should be assessed on a warrant basis for pedestrian safety and markings that afford better contrast and route recognition by visually impaired persons.

- 15: Curb ramp or blended transition is missing at this corner and is required to provide a continuous pedestrian and disabled access travel path.

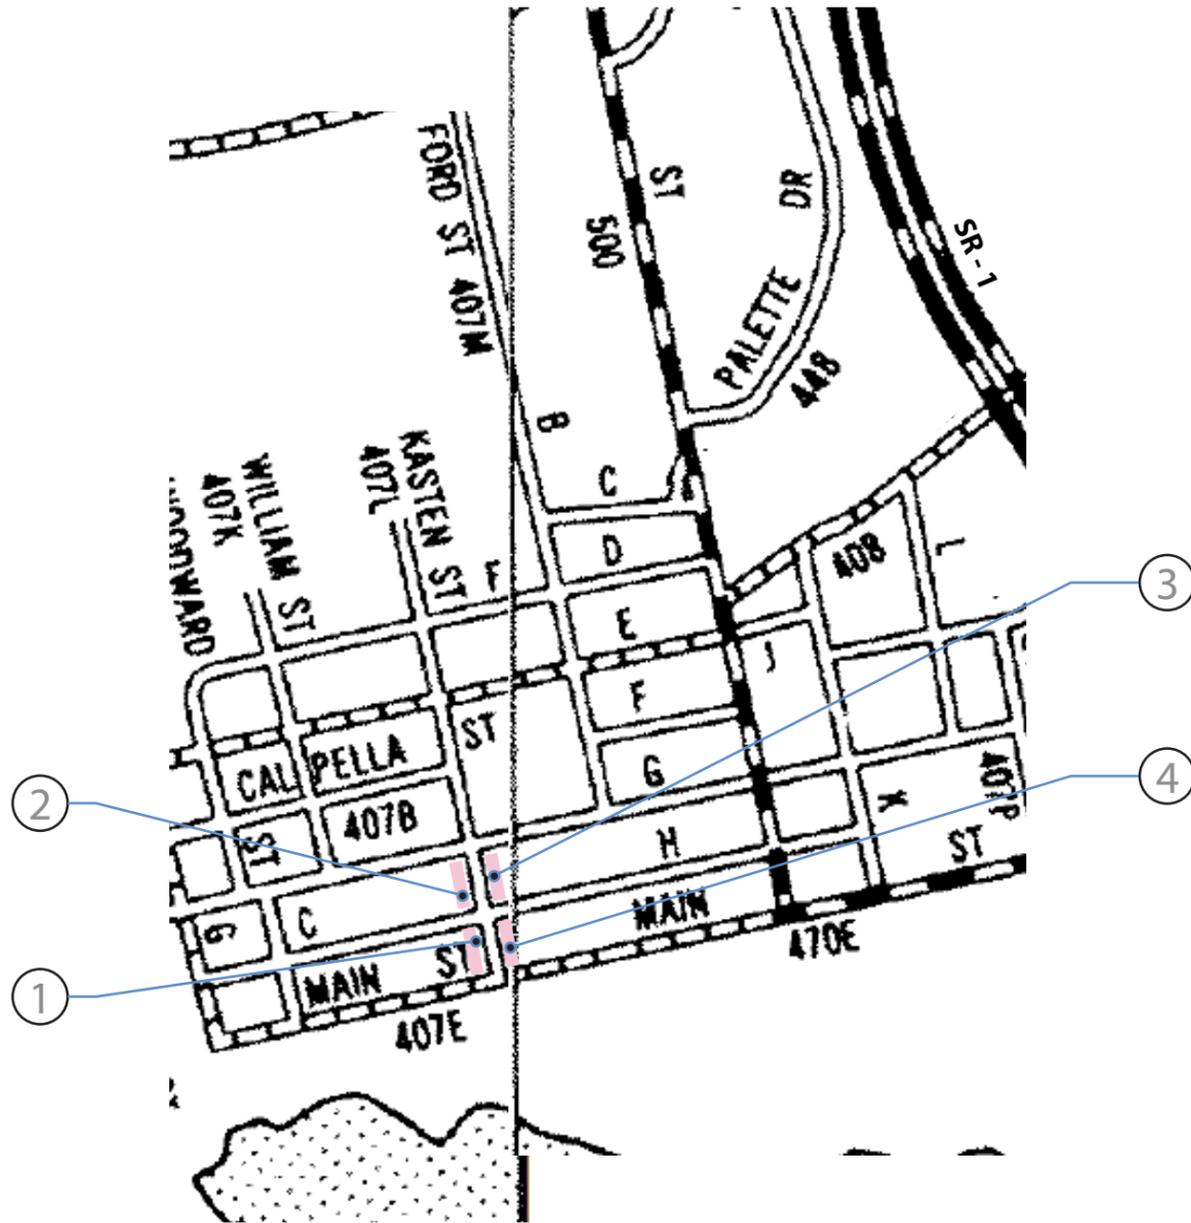
- 1: Between Main and Albion, there are moderate to steep sidewalk slopes; persons with mobility impairments should be directed to another route. Sidewalk surface has some irregular surfaces at cracks that will require maintenance soon and portions with excessive cross slopes that should be corrected to direct water away from buildings.

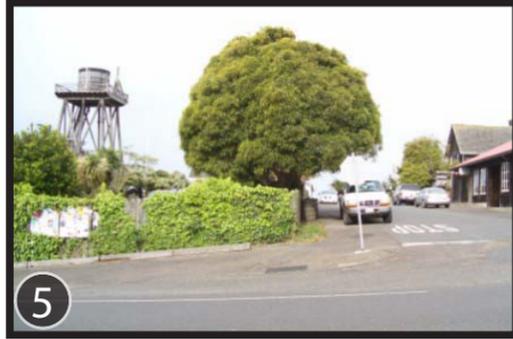
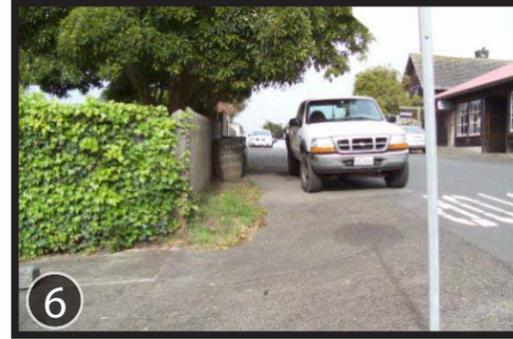
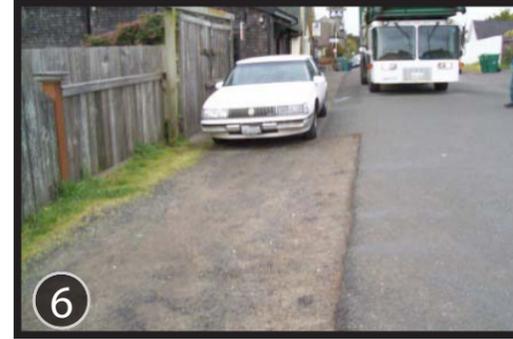
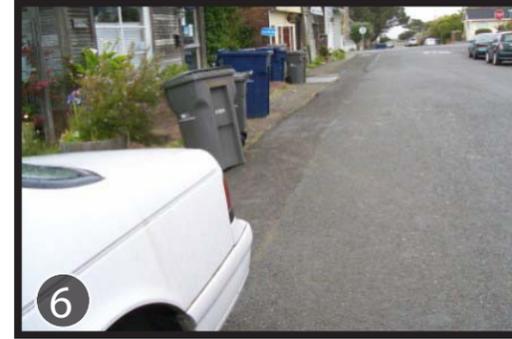
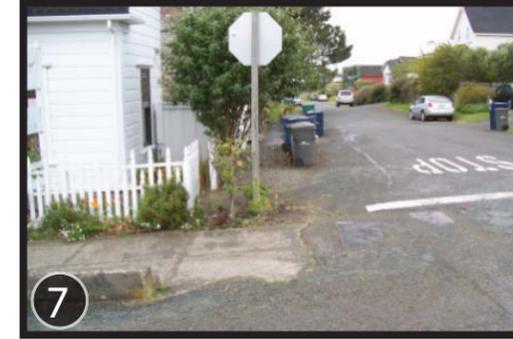
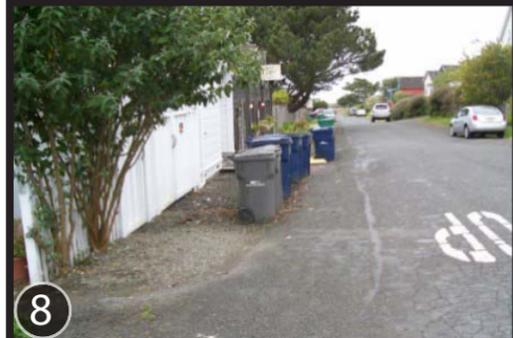
Town of Mendocino Photographs: Items 5 - 12 Albion Street

7: Curb ramps or blended transitions are not code compliant at these corners for continuous pedestrian travel path. Repair or reconstruction required.

10: Existing sidewalk; is in aged condition requiring corrective work, not continuous, not wide enough for code compliance, portions have excessive cross slope, is obstructed by parallel parking, is not firm stable and slip resistant, has a wood surface portion in poor condition, and right-of-way may not be wide enough to afford vehicle parking.
