Mendocino County

ADA Comprehensive Access Plan for the County Maintained Road System

July 16, 2010

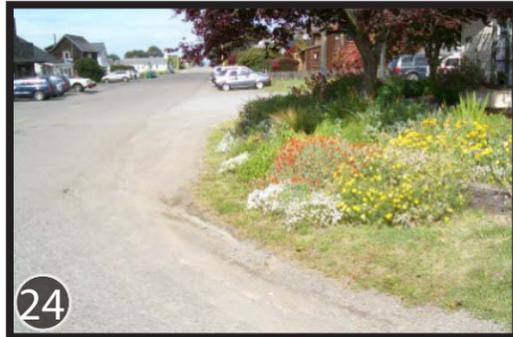
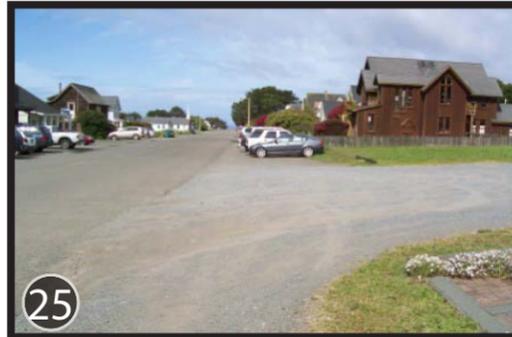
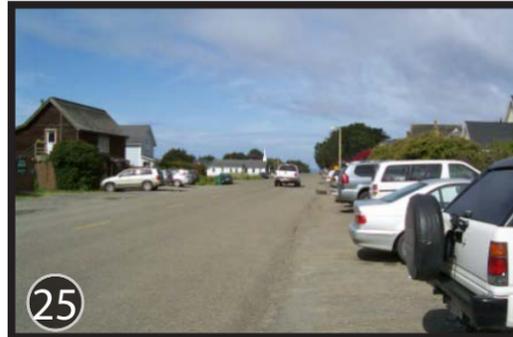
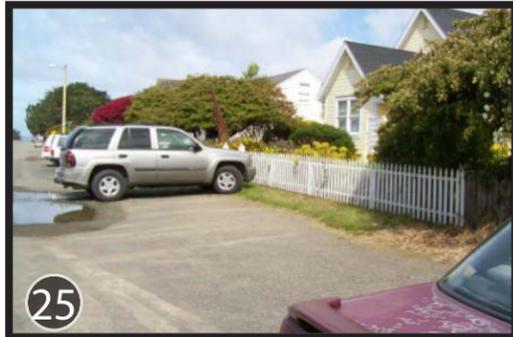
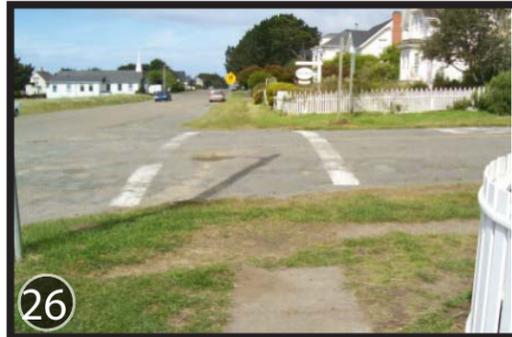
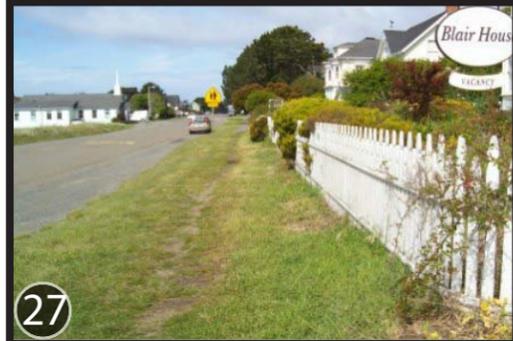
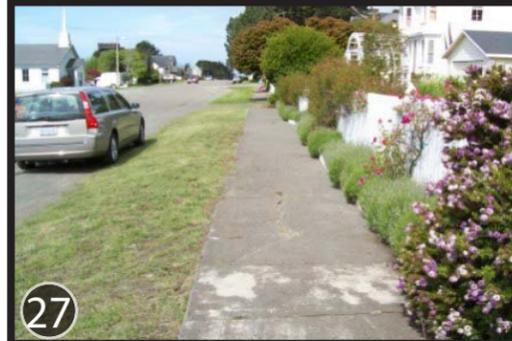
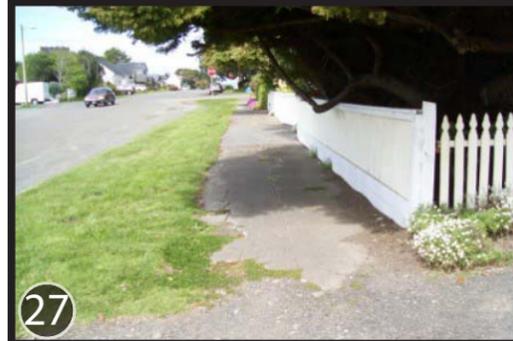
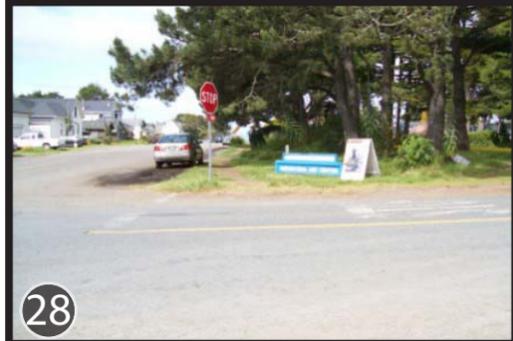
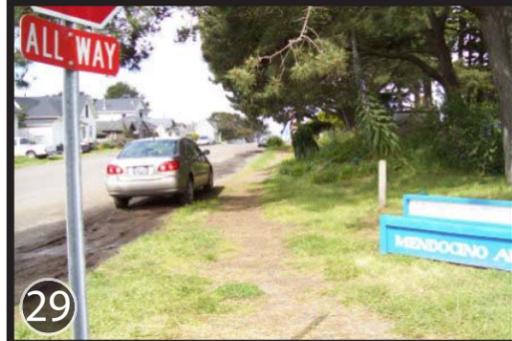
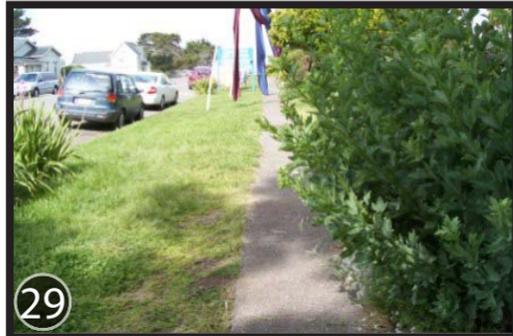
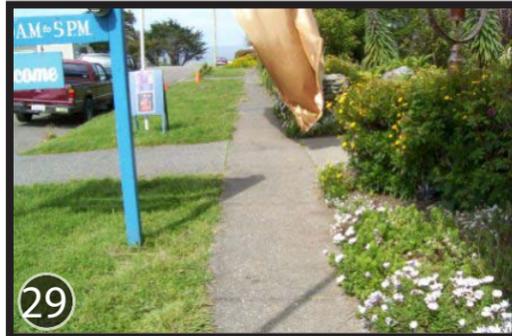
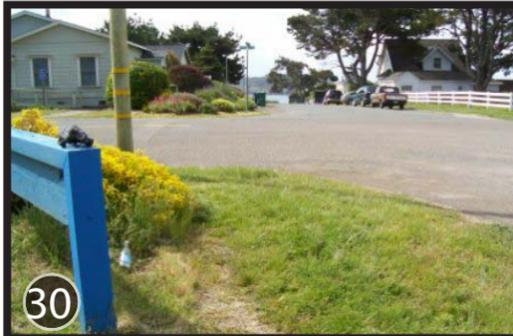
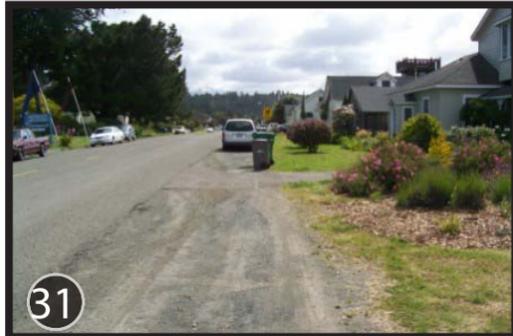
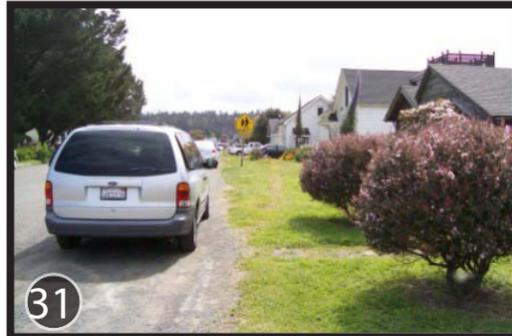
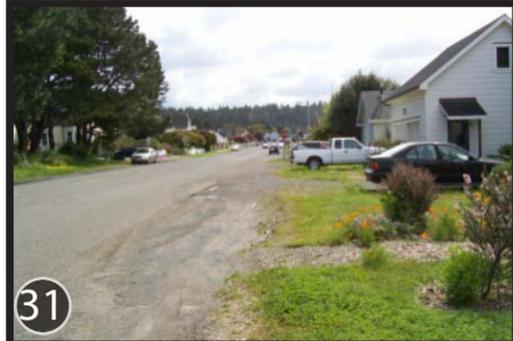
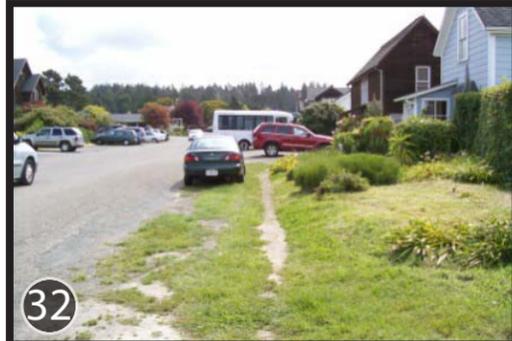
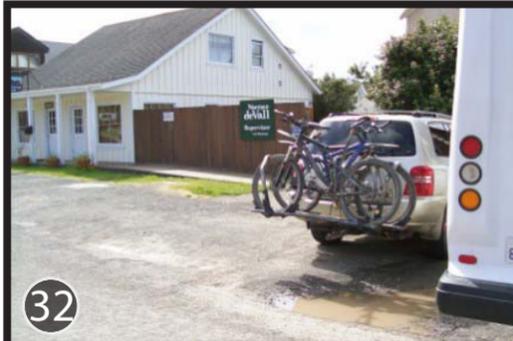
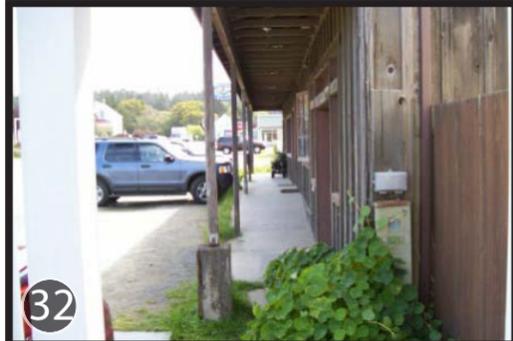
Town of Mendocino Photographs: Items 24 - 32 Little Lake Street

- 26: Curb ramps or blended transitions are required at these corners for continuous pedestrian travel path.
- 27: Sidewalk is required along this block to provide a continuous pedestrian travel path. The available walking route is obstructed by parking, is mostly undeveloped, and existing concrete walks are in poor condition.

- 28: Curb ramps or blended transitions are required at these corners for continuous pedestrian travel path.
- 29: Sidewalk is required along this block to provide a continuous pedestrian travel path. The available walking route is obstructed by parking, is partly undeveloped, and existing concrete walks are in poor condition.

- 32: Sidewalk is required along this block to provide a continuous pedestrian travel path. The available walking route is obstructed by parking, is partly undeveloped, and existing walks are either not compliant or in poor condition.

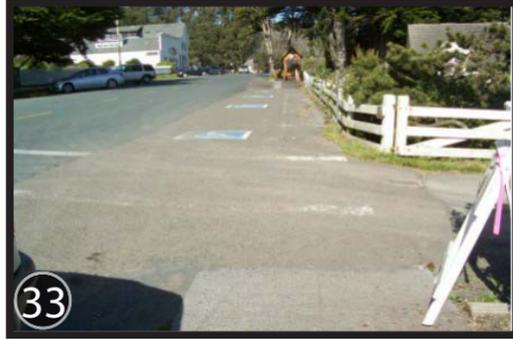
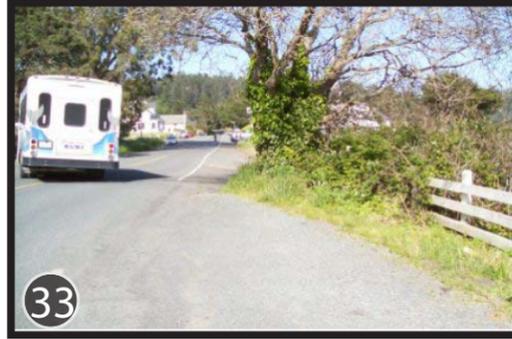
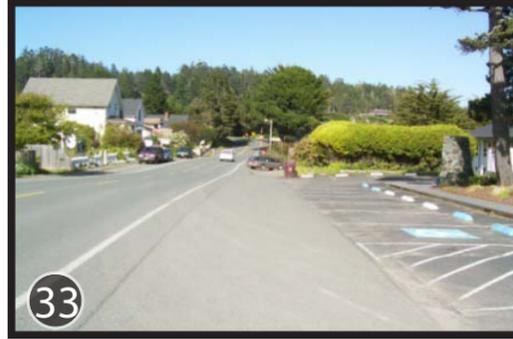
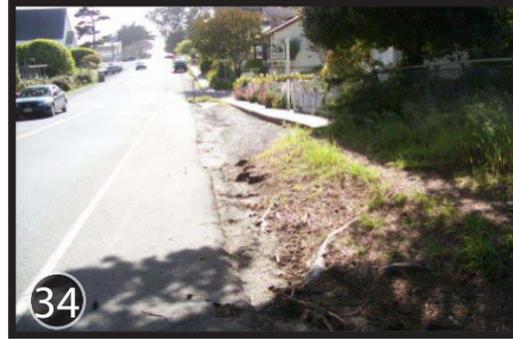
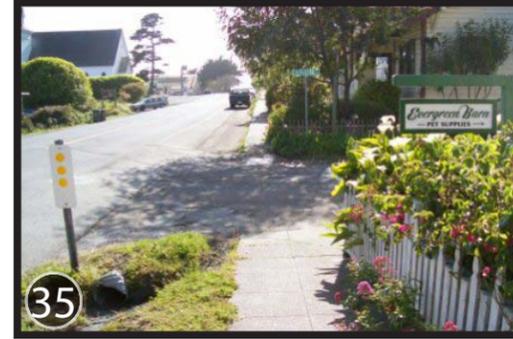
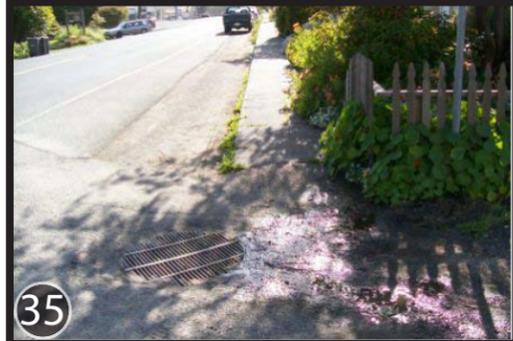
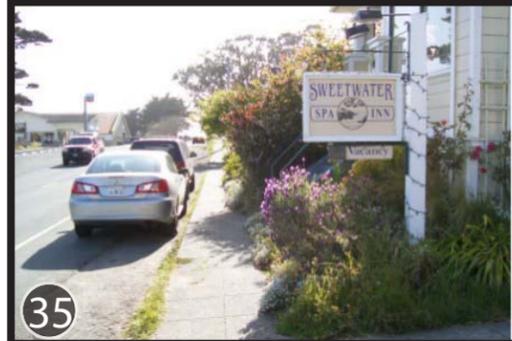
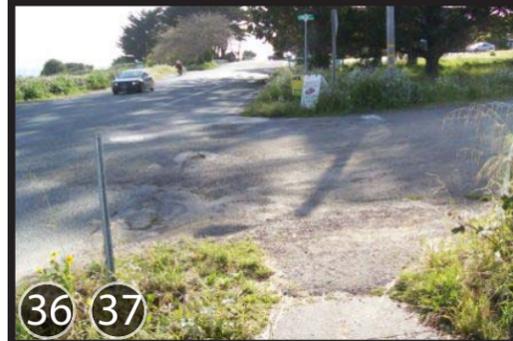
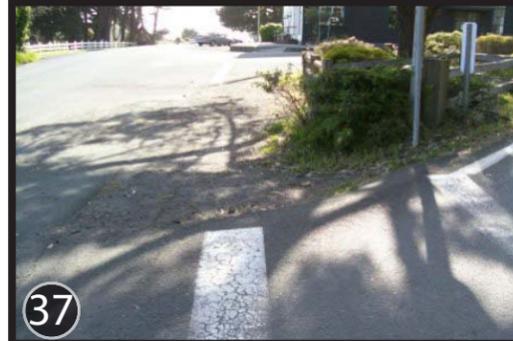
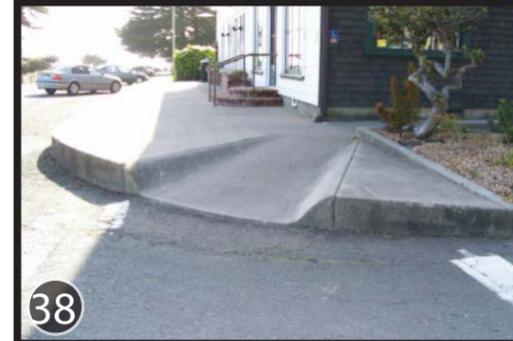
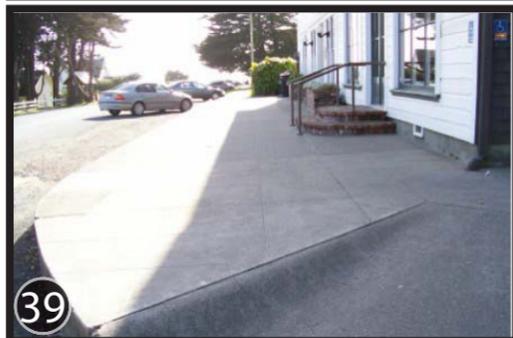
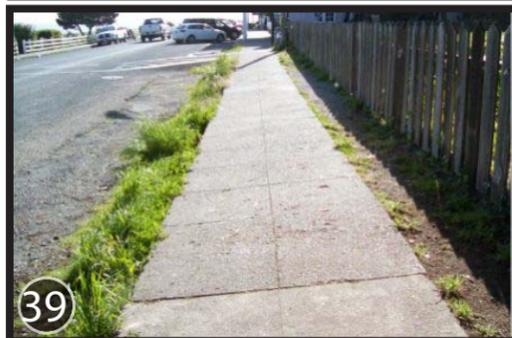
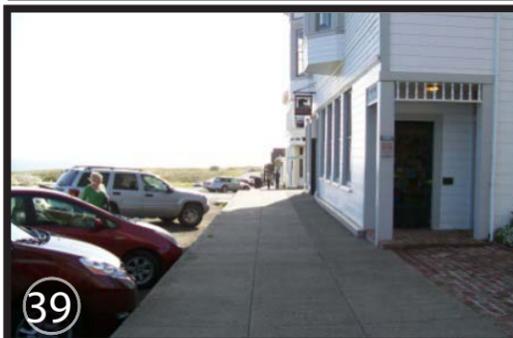
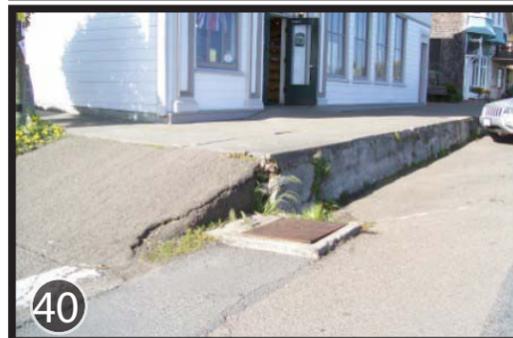
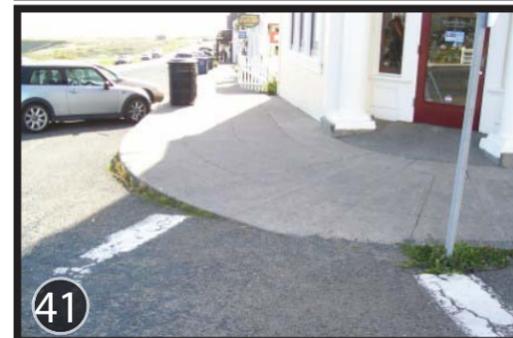
Town of Mendocino Photographs: Items 33 - 41 Main Street

33: Sidewalk is required along this block to provide a continuous pedestrian travel path. Disabled street parking is not code compliant for surface conditions, surface slopes, and unloading space size. The available walking route is obstructed by parking, is partly undeveloped, existing walks are either not compliant or in poor condition, and road shoulder portions have excessive cross slope.

35: Sidewalk is required along these blocks to provide a continuous pedestrian travel path. Existing concrete walks are in poor condition.

39: Existing sidewalk has excessive cross slope for most of the length along the block, portions are in poor condition.

40: This corner is a hazard for mobility impaired persons and should be rebuilt for disabled access. Curb is excessively high, road grade versus sidewalk grades need to be reconciled.

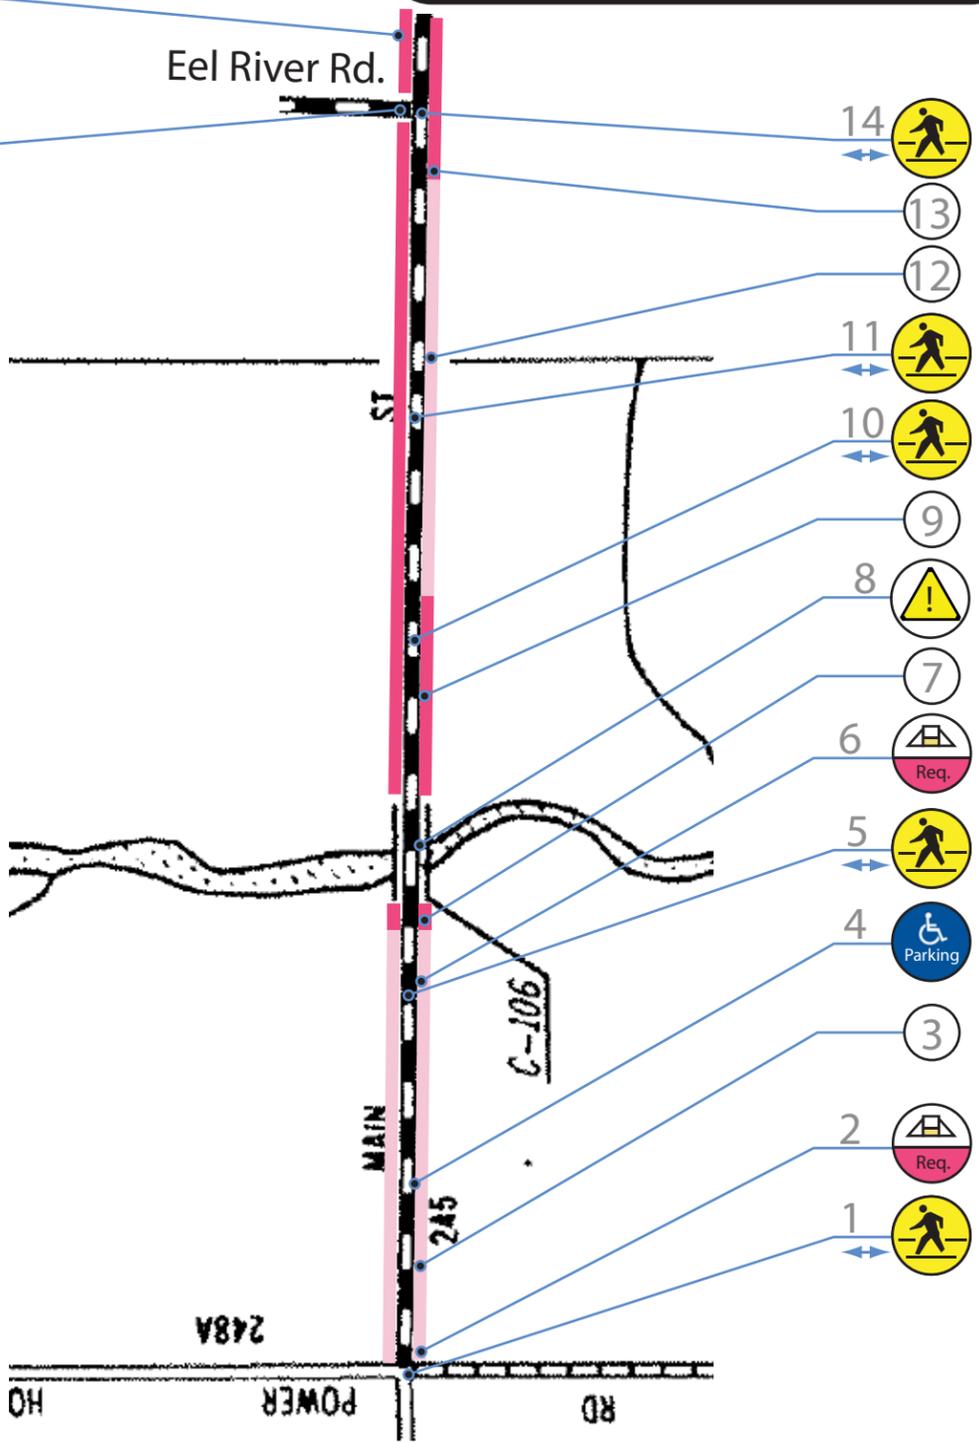
Eel River Rd.

1: Crossing; recommend striping for pedestrian safety. This recommended crosswalk should be assessed on a warrant basis for pedestrian safety and markings that afford better contrast and route recognition by visually impaired persons.

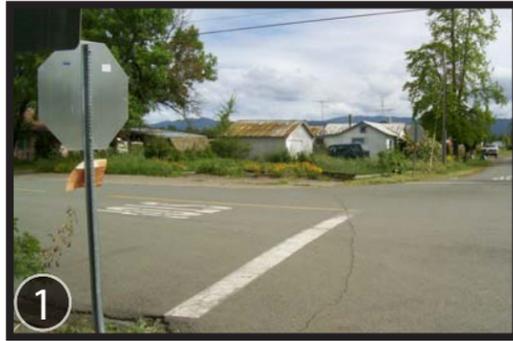
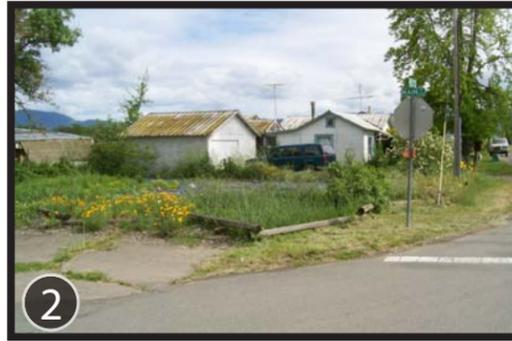
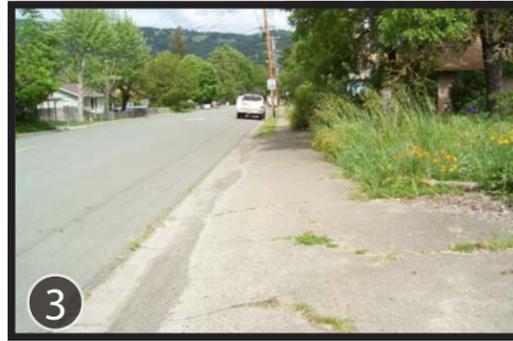
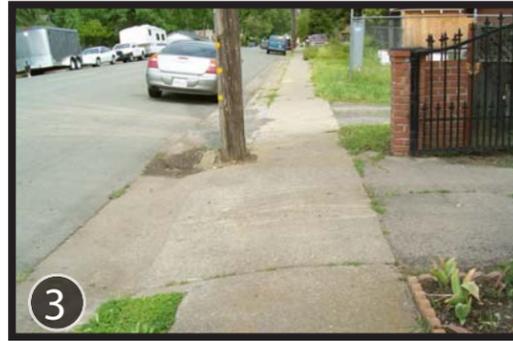
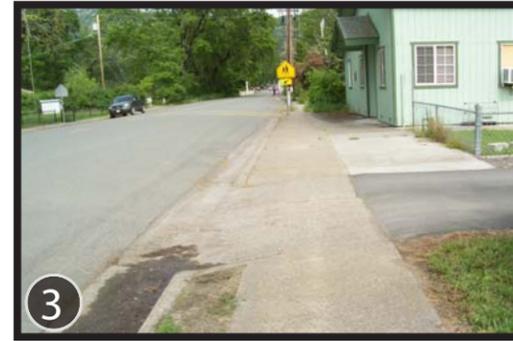
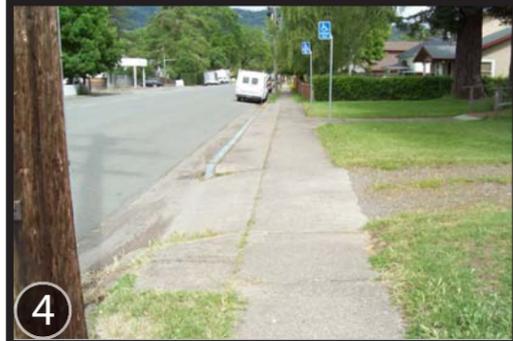
Potter Valley: Items 1 - 20

2: This corner is currently developed and in deteriorated condition for disabled access and for general pedestrian safety. Corrective work should be done to provide safe pedestrian surface conditions. This corner is also a designated MTA bus stop, travel path conditions from the actual bus stop location need to be verified for code compliance as there is no recognizable signage for the bus stop.

3: Pedestrian travel path is on asphalt with undefined boundaries for travel direction. There are no designated entry lanes for vehicles. Generally surfaces are smooth enough for disabled access compliance and some areas may have cross slope exceeding 2%. Minor paving corrections will make the walk area code compliant. It is recommended to provide durable high contrast striping to define the walk area and vehicle entry/exit lanes to enhance pedestrian safety. Travel path should end before the walkway running slope exceeds 5%. Walkway should also afford opportunity for the property owner to provide a connecting route to the building from the right of way.

4: Pedestrian travel path is on asphalt with undefined boundaries for travel direction. There are no designated entry lanes for vehicles. Generally surfaces are smooth enough for disabled access compliance and some areas may have cross slope exceeding 2%. Minor paving corrections will make the walk area code compliant. It is recommended to provide durable high contrast striping to define the walk area and vehicle entry/exit lanes to enhance pedestrian safety. Since parking is nose in to building on the south building wing, the pedestrian travel path should stop before the nose in parking and have opportunity for the property owner to provide a connecting route to the building from the right of way.

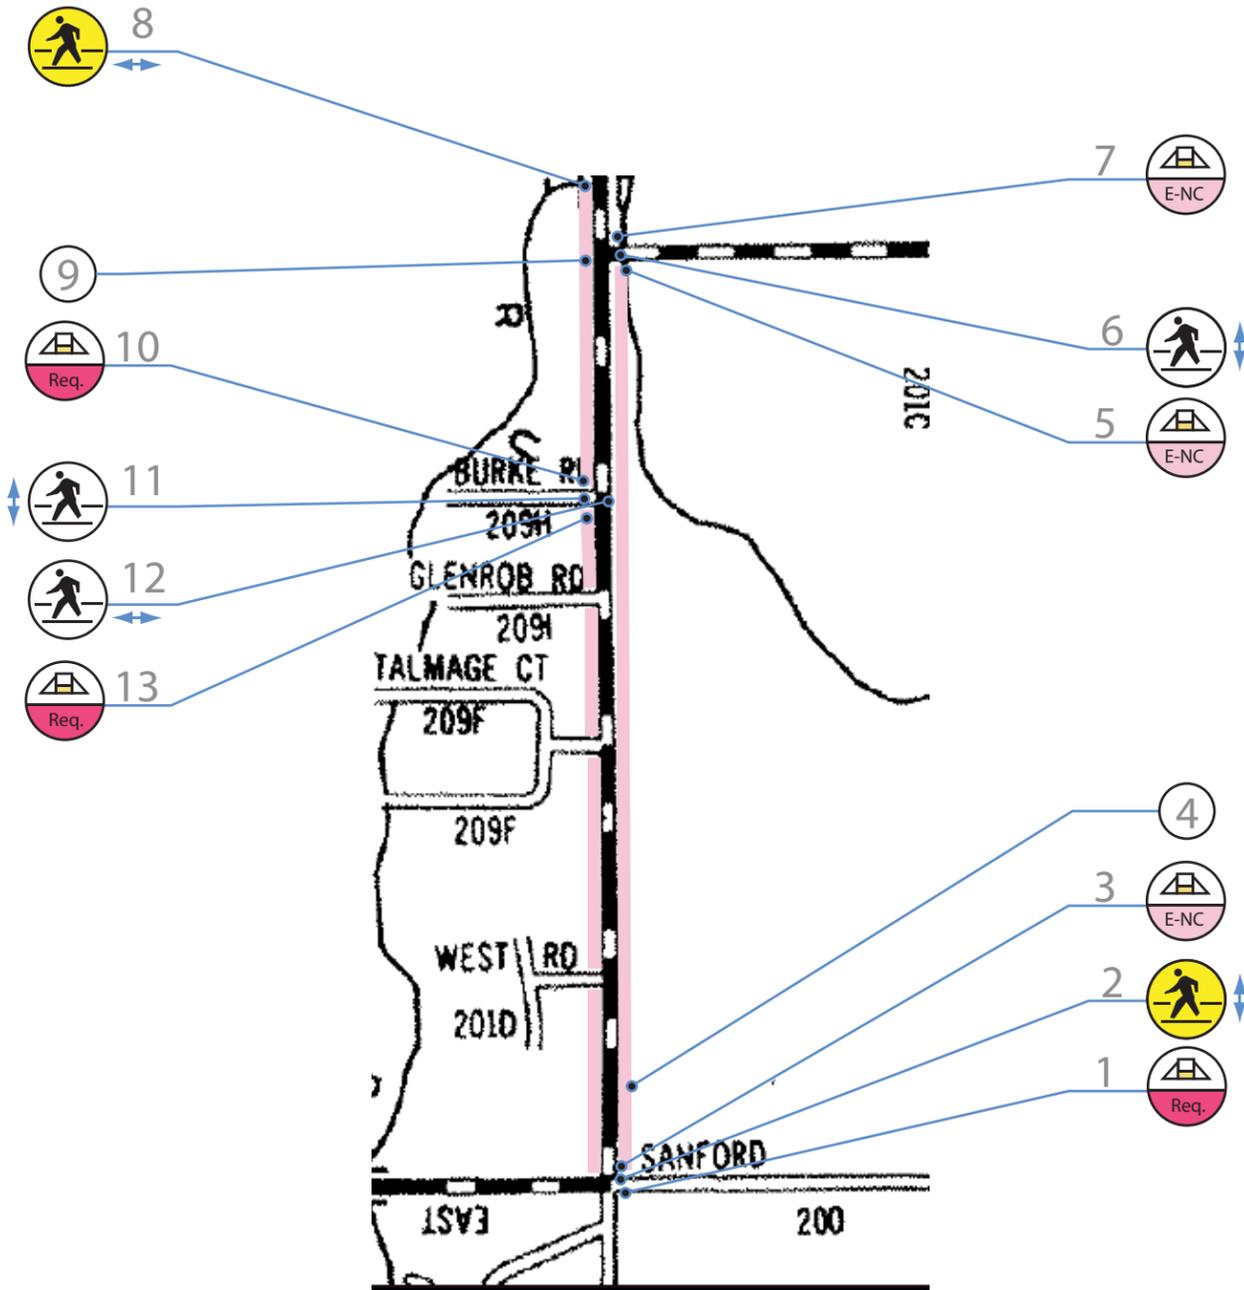
- 1: Curb ramp or blended transition is missing at this corner and is required for continuous pedestrian and disabled compliant travel path.
- 2: Existing crosswalk; rough paving in patches with paving edge ledges and minor potholes; resurfacing required for disabled compliant surface.

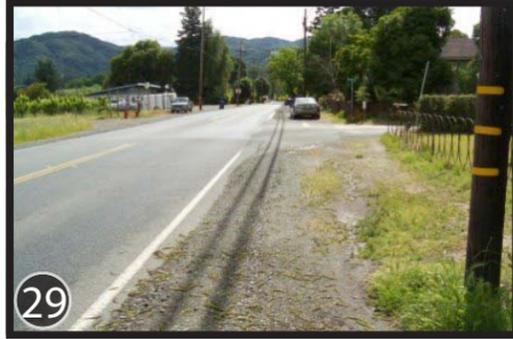
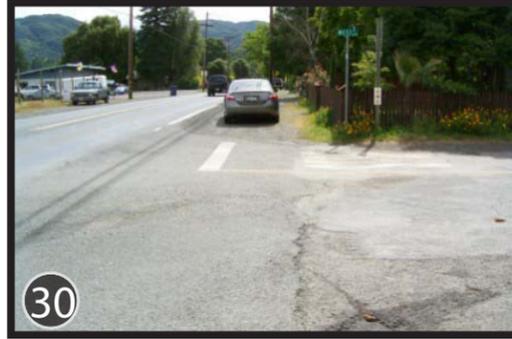
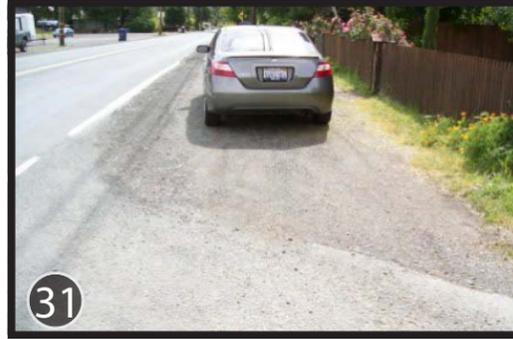
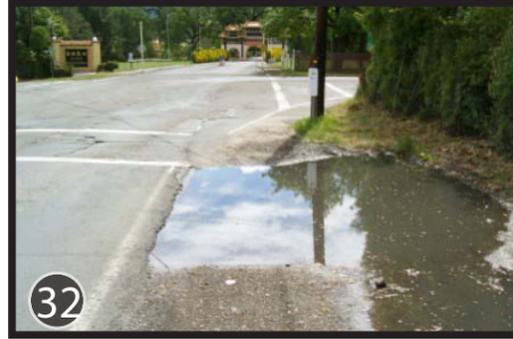
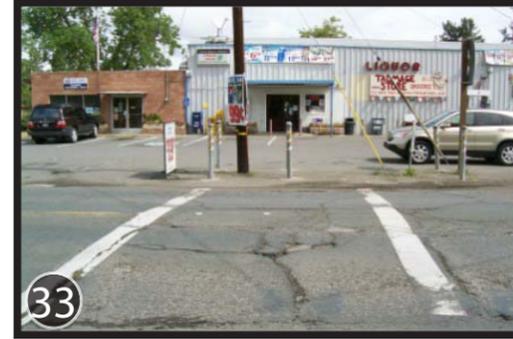
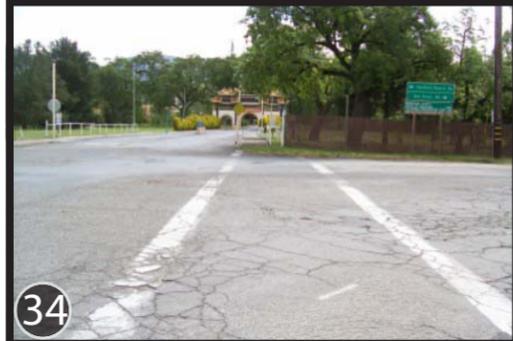
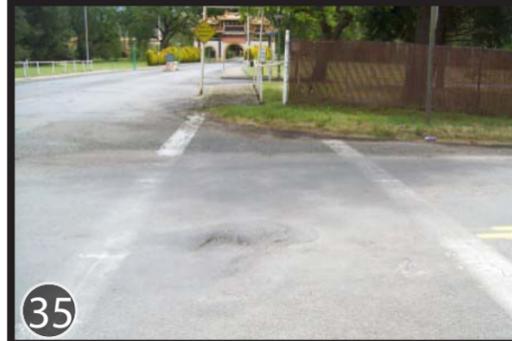
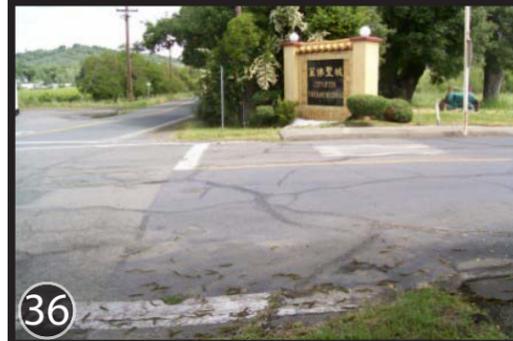
Talmage Photographs: Items 29 - 36

33: Existing crosswalk: Pavement is rough in places, has minor potholes, and should be overlaid to provide smooth pedestrian and disabled compliant travel path. Due to high traffic it is recommended to have heavy cross bar markings in the crosswalk with high visibility pedestrian paddle signs.

34: Existing crosswalk: Pavement is rough in places, has minor potholes, and should be overlaid to provide smooth pedestrian and disabled compliant travel path. Due to high traffic it is recommended to have heavy cross bar markings in the crosswalk with high visibility pedestrian paddle signs.

35: Curb ramp or blended transition is missing at this corner and is required for continuous pedestrian and disabled compliant travel path.
-

36: Crossing: Striping recommended. This recommended crosswalk should be assessed on a warrant basis for pedestrian safety and markings that afford better contrast and route recognition by visually impaired persons. Pavement is rough in places, has minor potholes, and should be overlaid to provide smooth pedestrian and disabled compliant travel path.

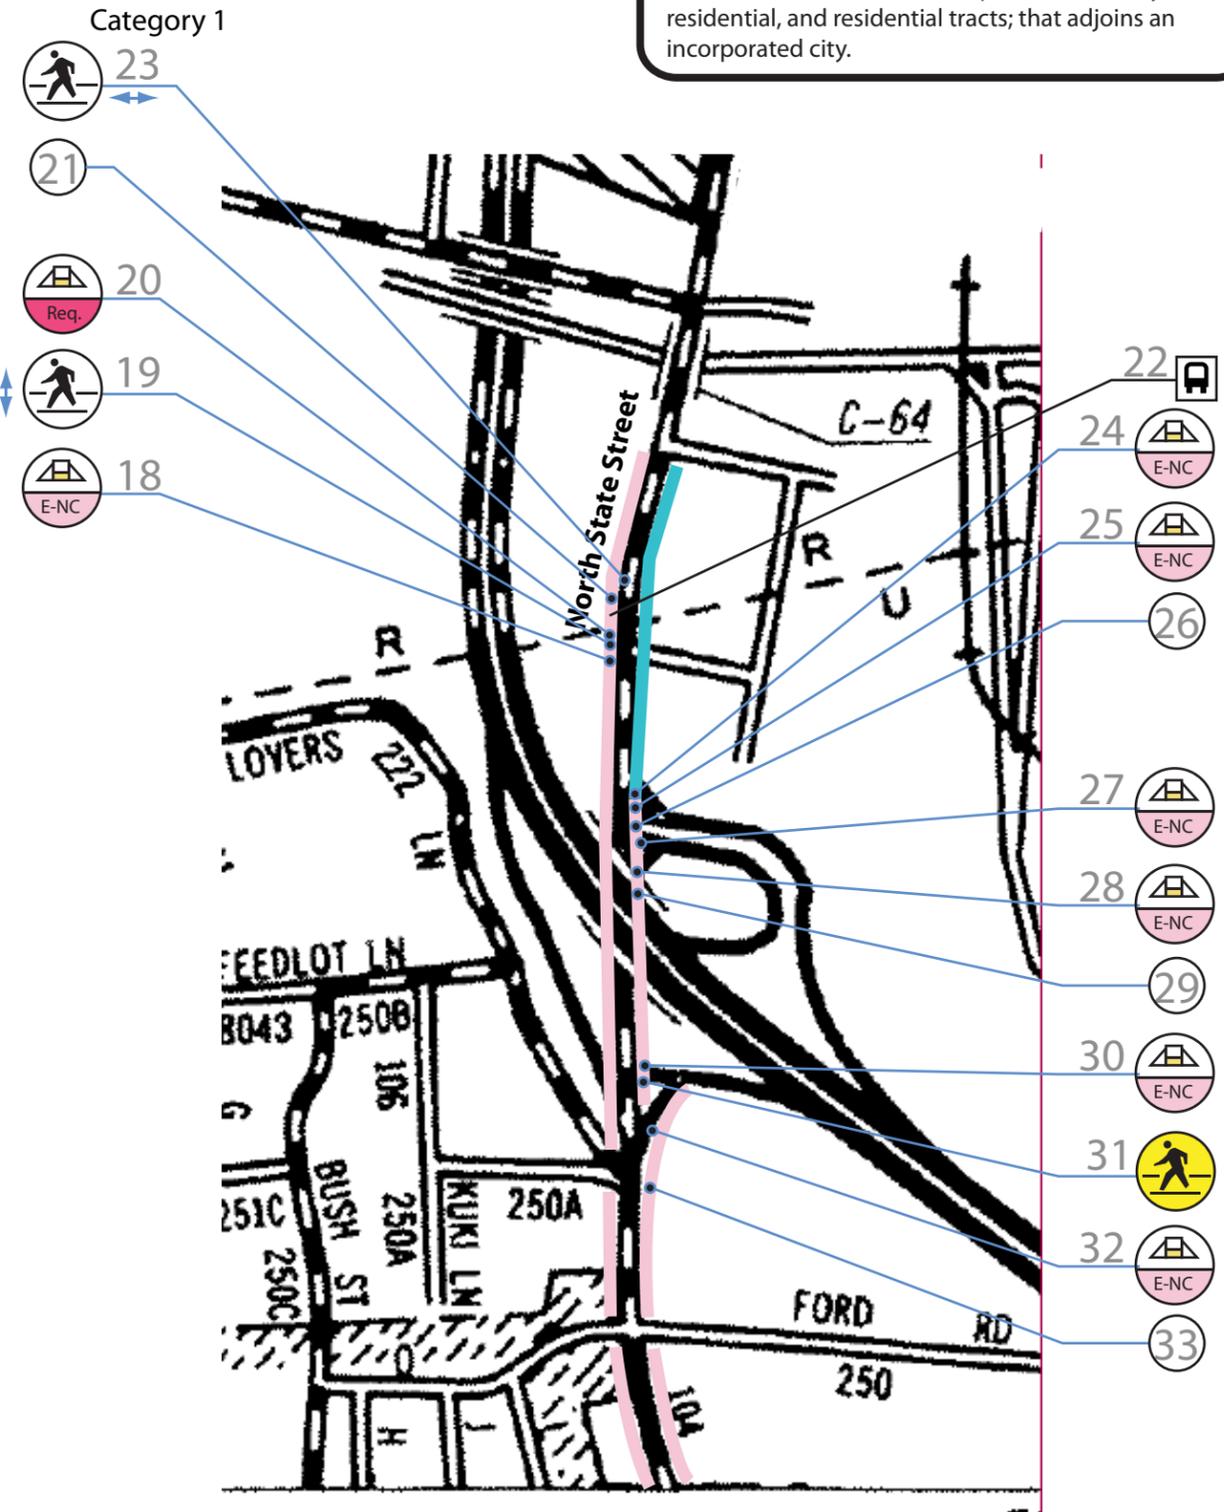
- 18: Curb ramp; no side protection to keep wheelchair from dropping off curb in travel direction, no detectable warnings, excessive gutter run slope, ramp bottom lip at gutter. Reconstruction required.

- 19: Crossing; excessive rough, paving correction required. Recommend striping.
- 20: Curb ramp or blended transition is missing at this corner and is required for continuous pedestrian and disabled compliant travel path.

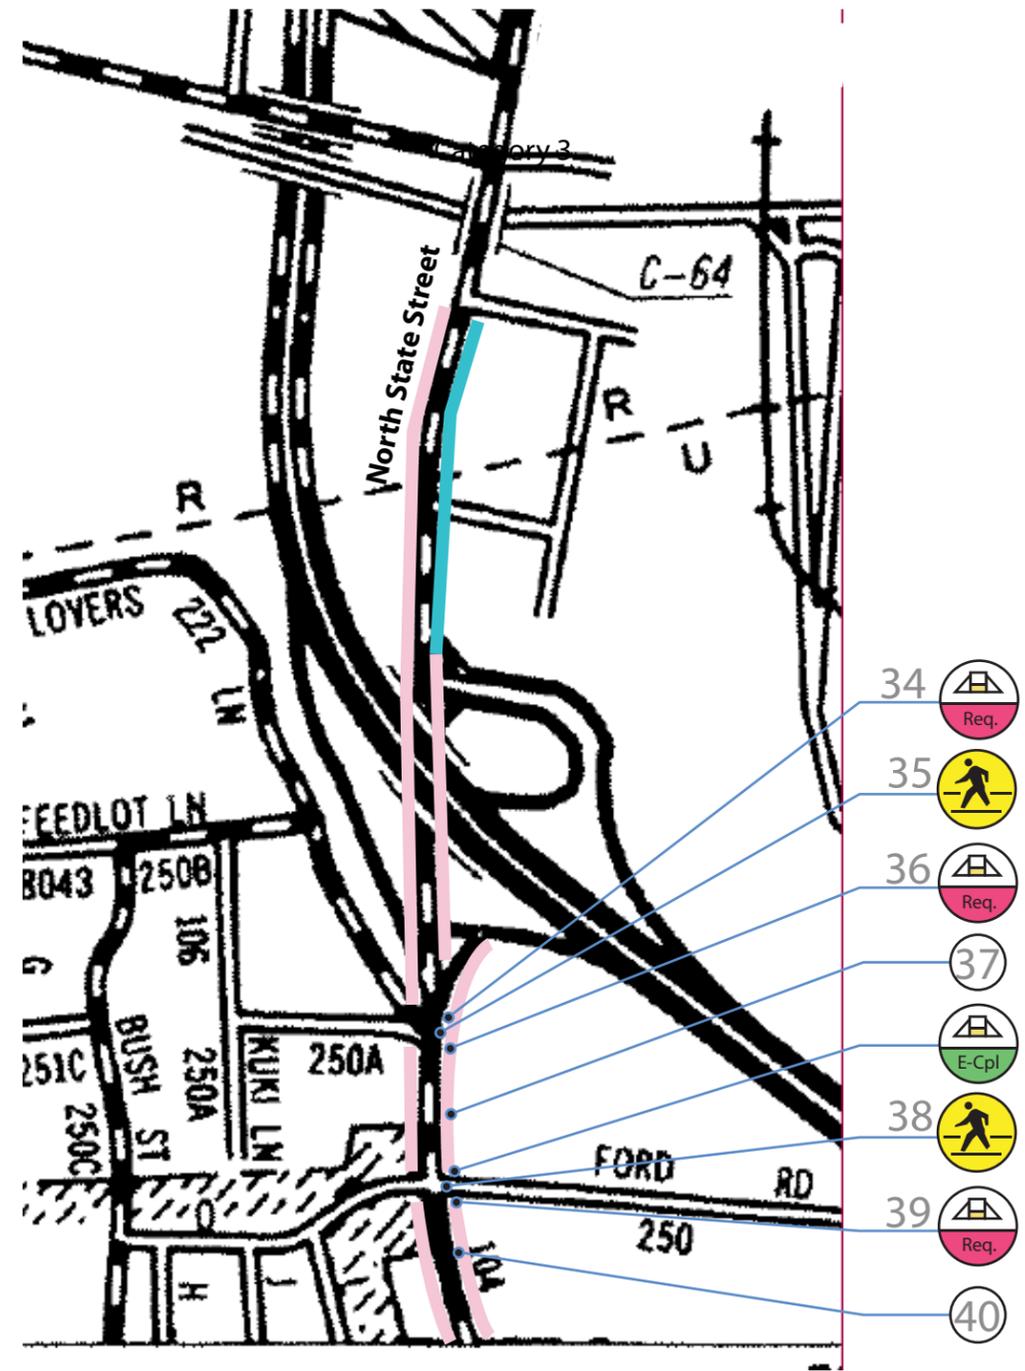
- 34: Curb ramp or blended transition is missing at this corner and is required for continuous pedestrian and disabled compliant travel path. Underground infrastructure coordination required to upgrade this corner.

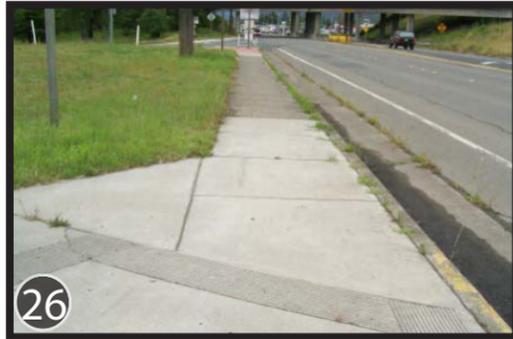
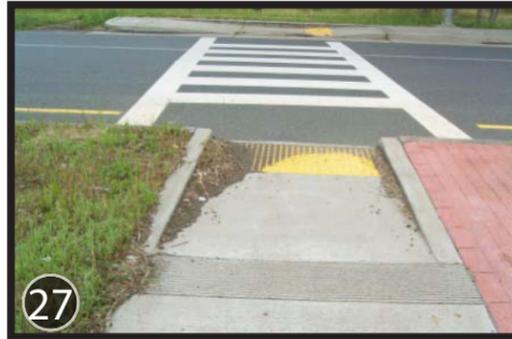
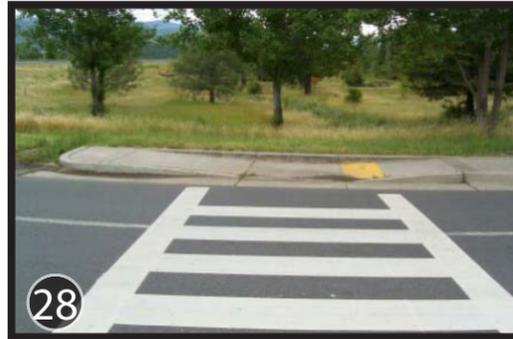
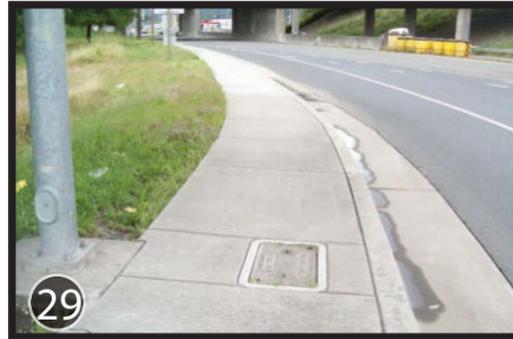
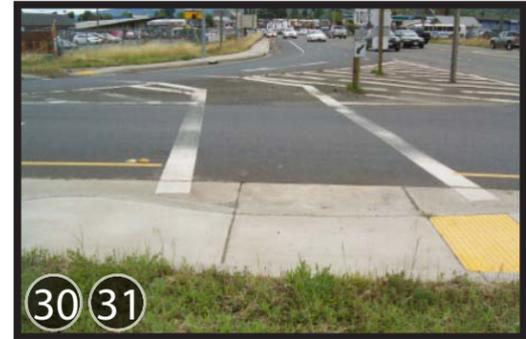
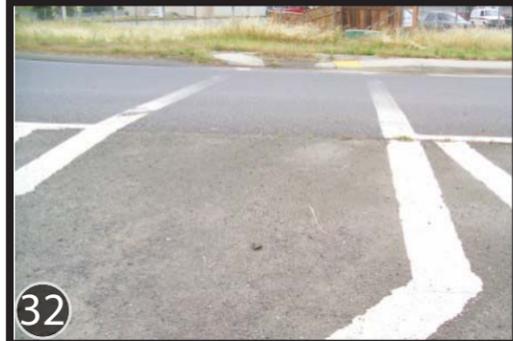
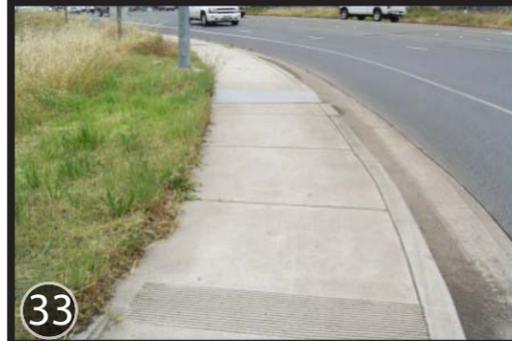
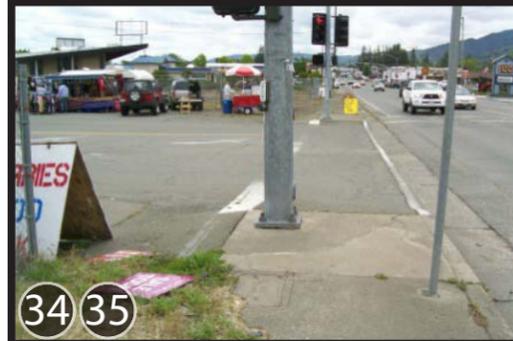
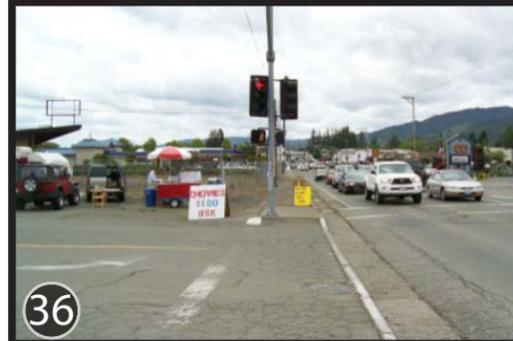
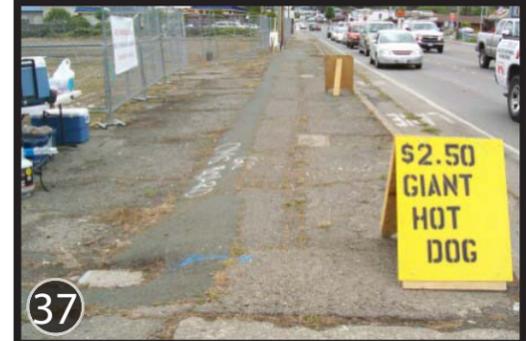
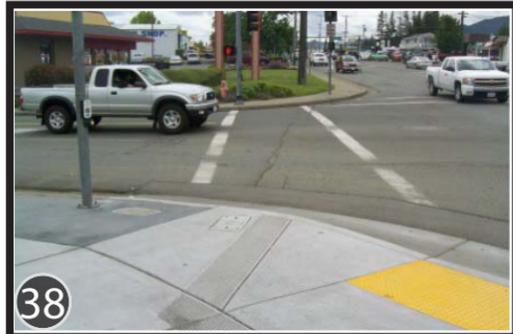
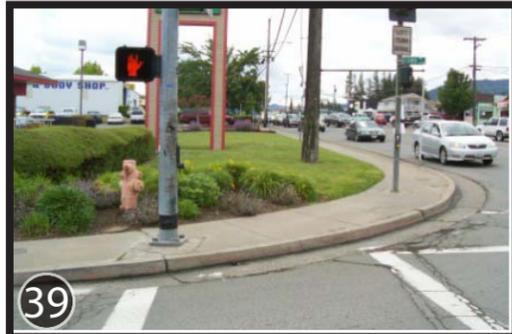
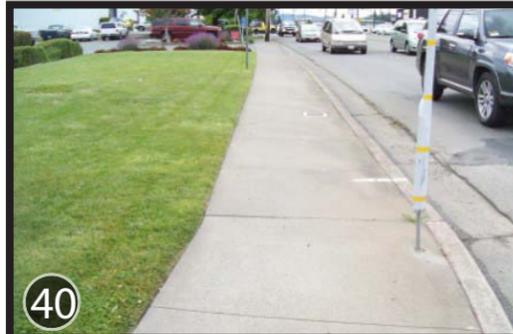
Ukiah, North Photographs: Items 26 - 40

- 35: Existing crosswalk; rough paving, striping faded, need integrated to curb ramp installation.
- 36: Curb ramp or blended transition is missing at this corner and is required for continuous pedestrian and disabled compliant travel path. Nearby existing curb ramp is non compliant and is close enough to this corner to require an integrated design for pedestrian crossings. Underground infrastructure coordination required to upgrade this corner.

- 37: Sidewalk; asphalt and concrete sections are in poor condition and need replaced for safety and disabled access.
- 38: Existing crosswalk; rough paving, striping fading, excessive crown run slope, striping not aligned for curb ramp bottom maneuvering.

- 39: Curb ramp or blended transition is missing at this corner and is required for continuous pedestrian and disabled compliant travel path. Underground infrastructure coordination required to upgrade this corner.

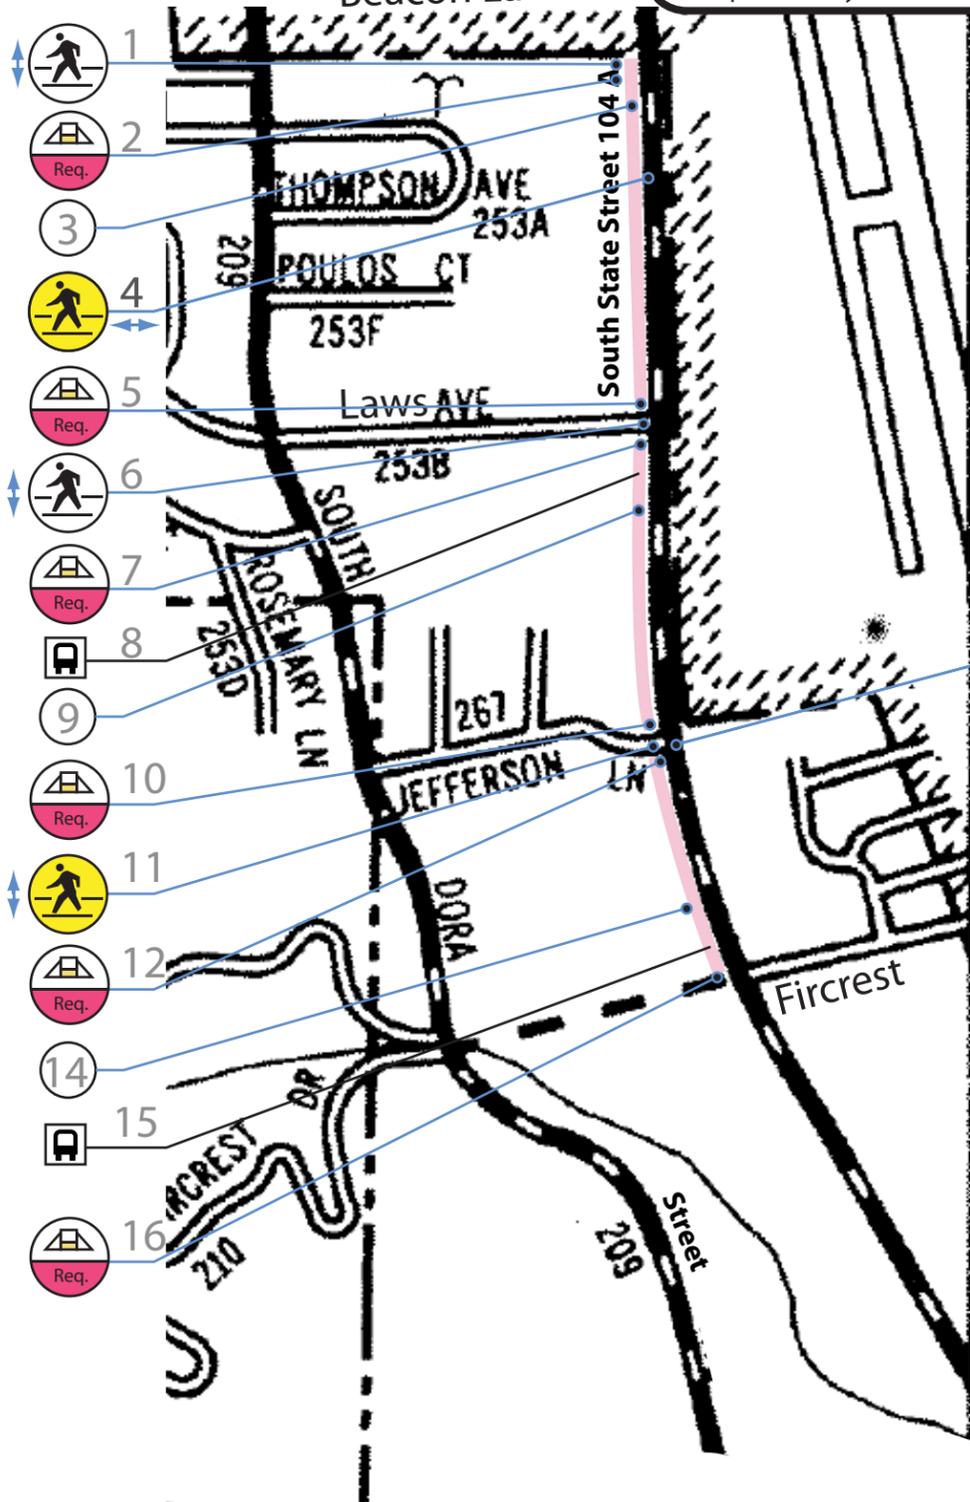
- 1: Crossing; striping recommended in alignment with City curb ramp at northwest of this tee intersection. This recommended crosswalk should be assessed on a warrant basis for pedestrian safety and markings that afford better contrast and route recognition by visually impaired persons.

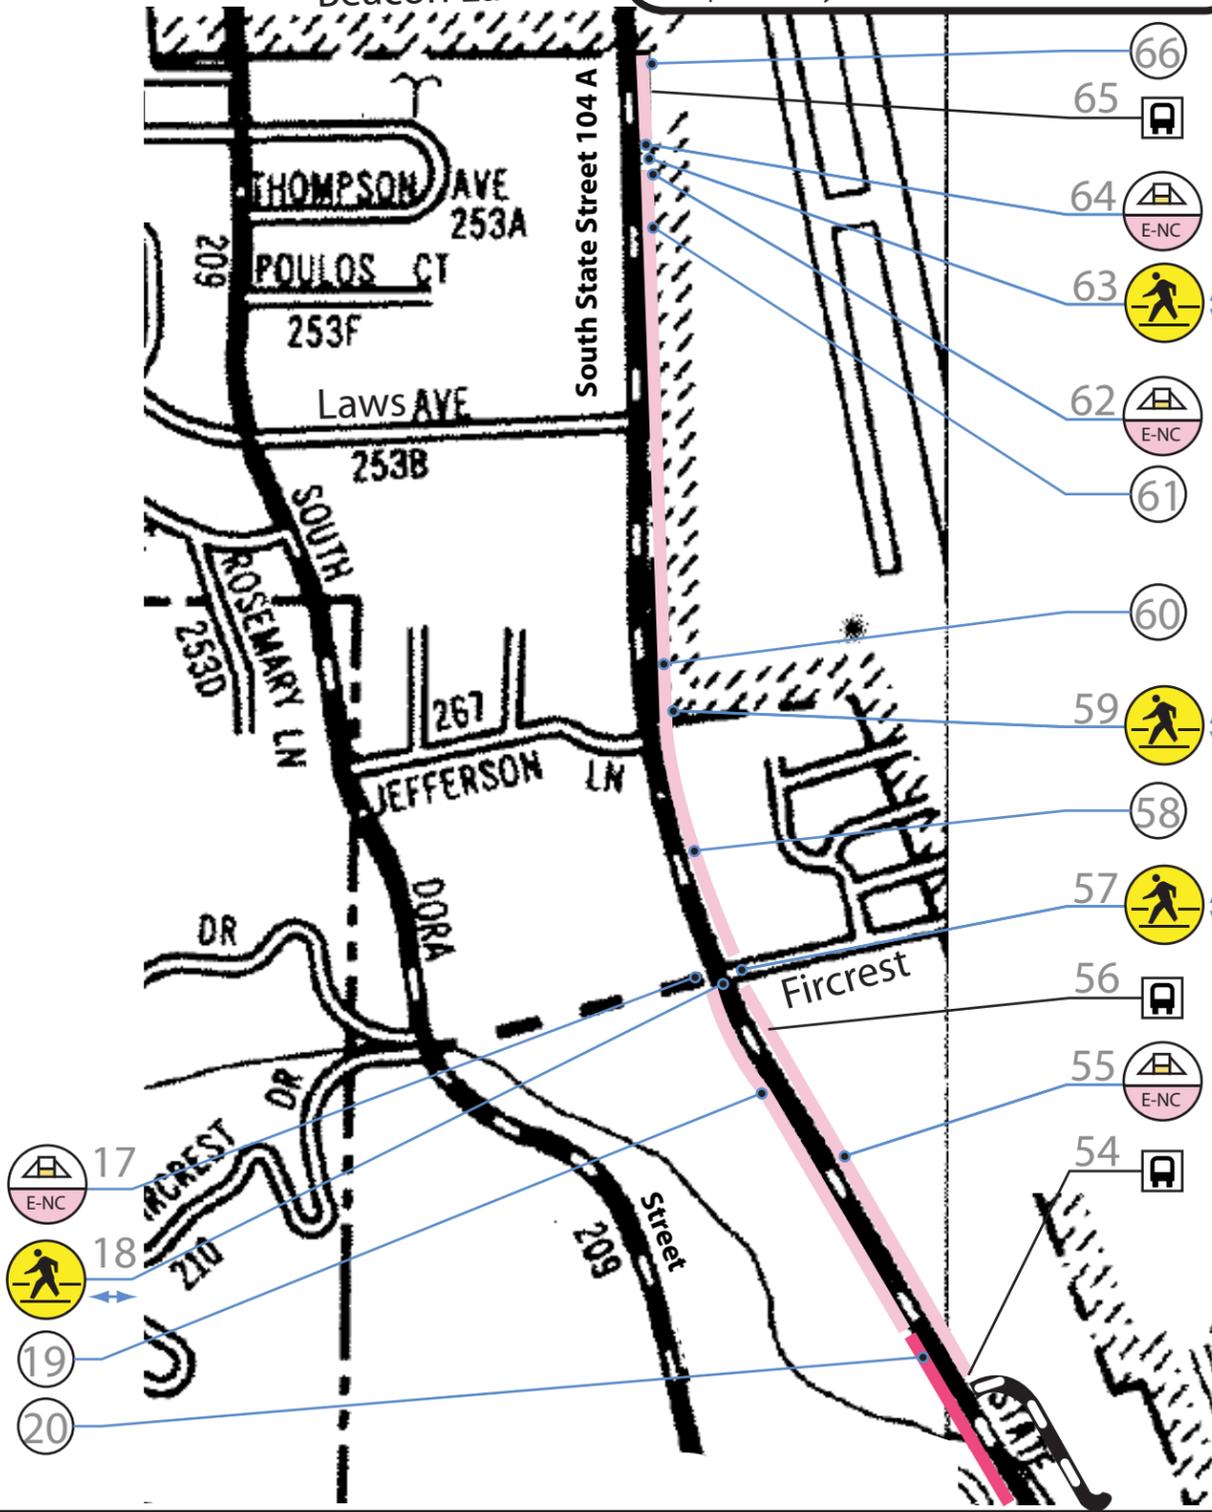
- 17: Curb ramp; water ponds at ramp gutter and into crosswalk, mud deposits in standing water can cause slippery footing; drainage flow needs corrected.
