Mendocino County

ADA Comprehensive Access Plan for the County Maintained Road System

July 16, 2010

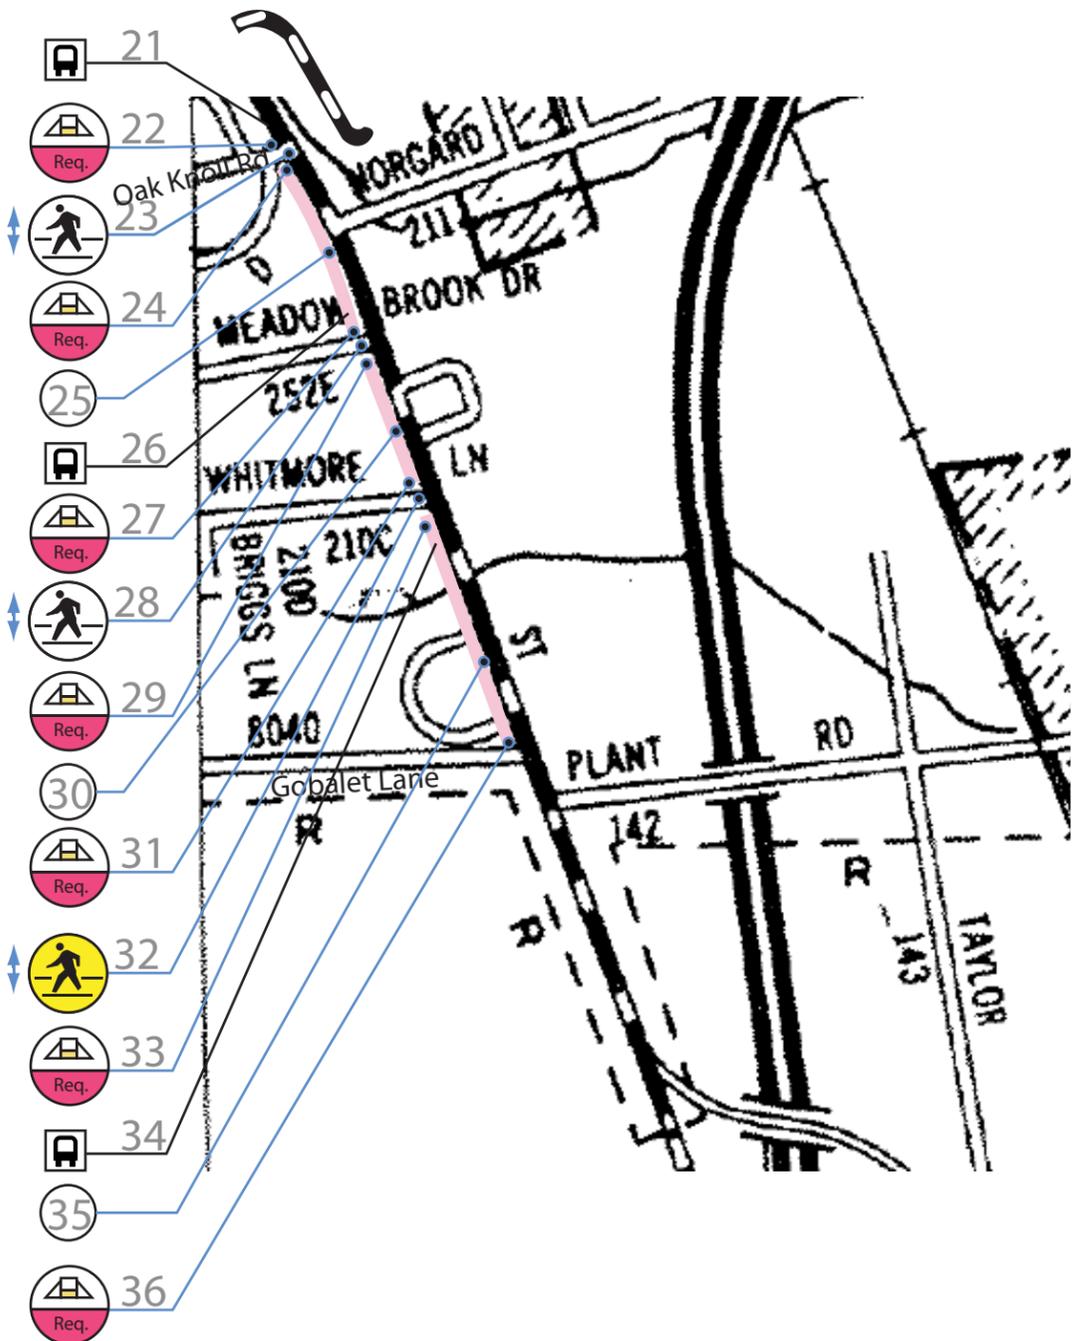
- 21: Bus stop; no provisions for disabled loading, unloading, or connection to compliant travel path; paving improvements required.
- 22: Curb ramp or blended transition is missing at this corner and is required for continuous pedestrian and disabled compliant travel path.

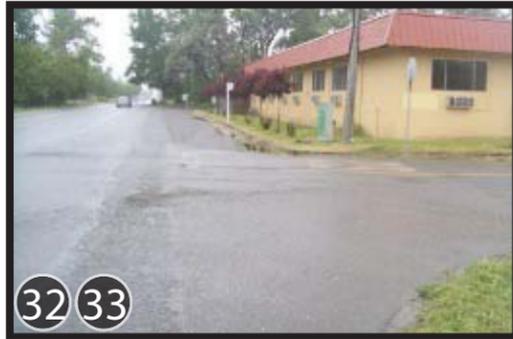
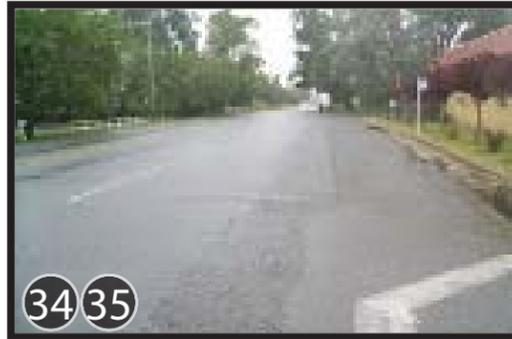
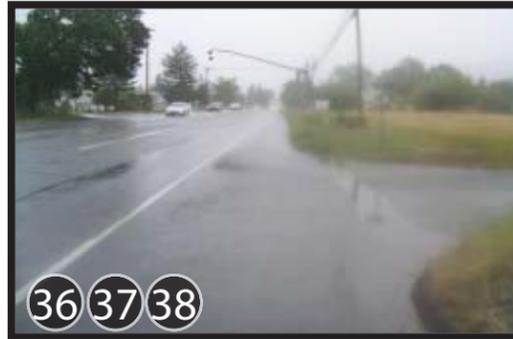
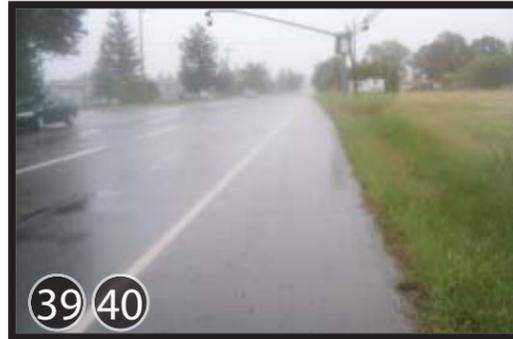
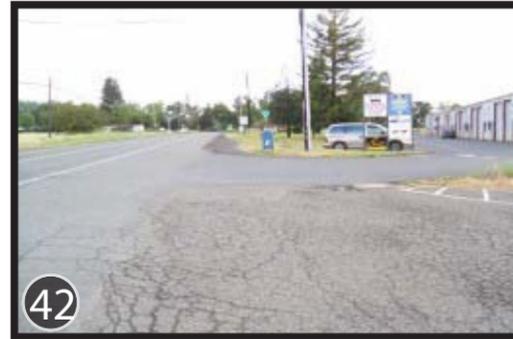
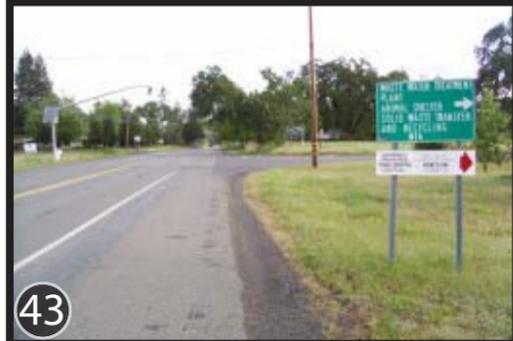
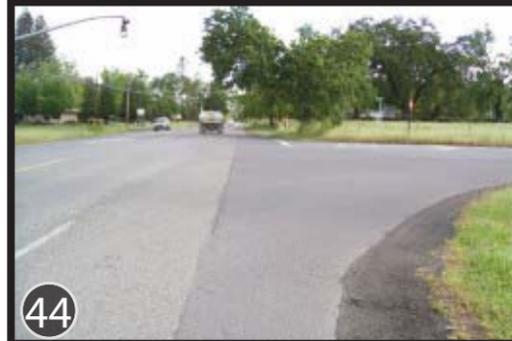
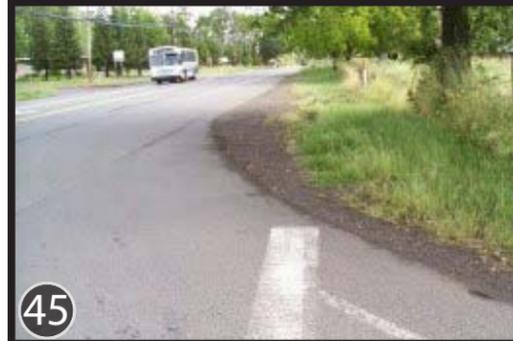
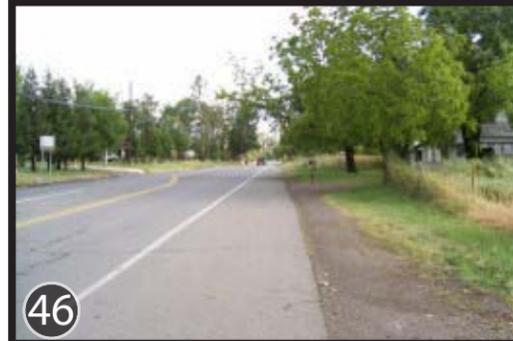
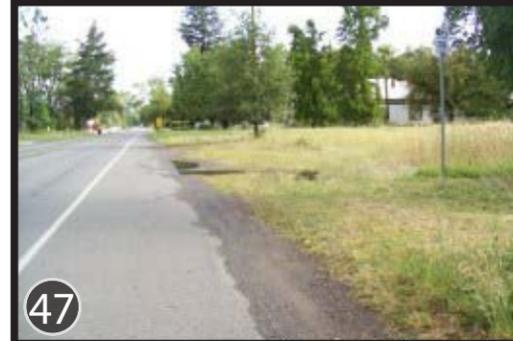
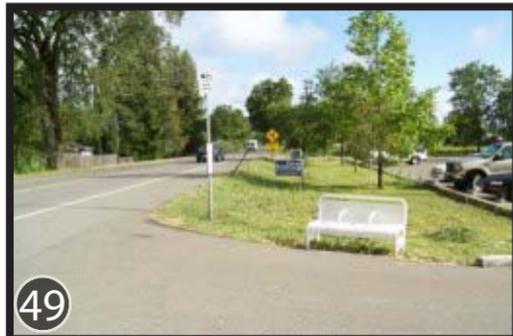
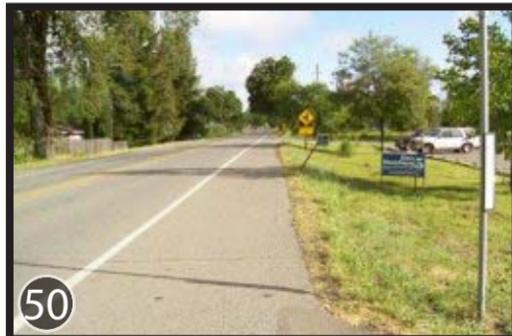
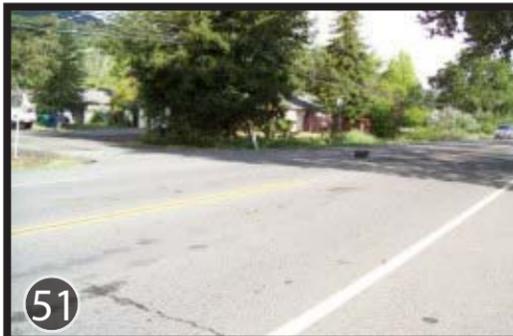
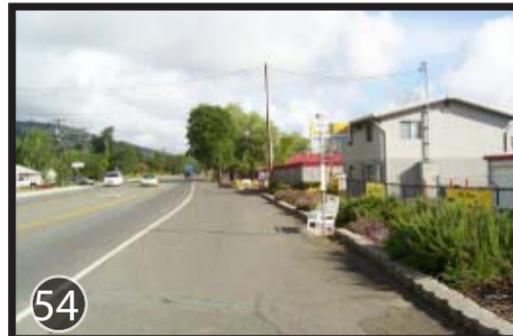
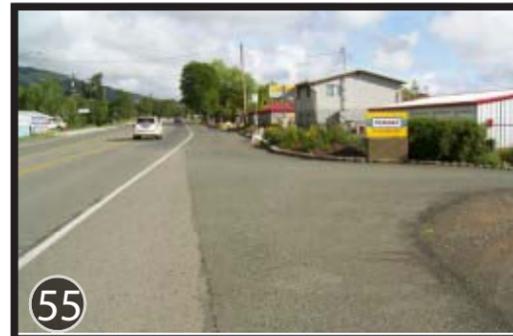
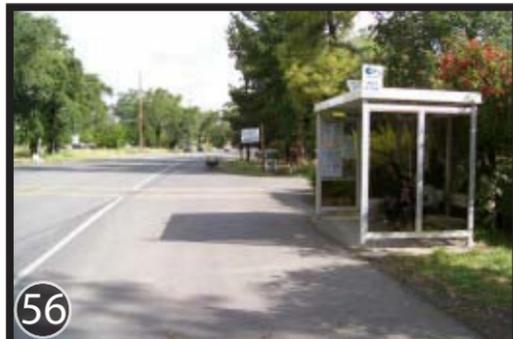
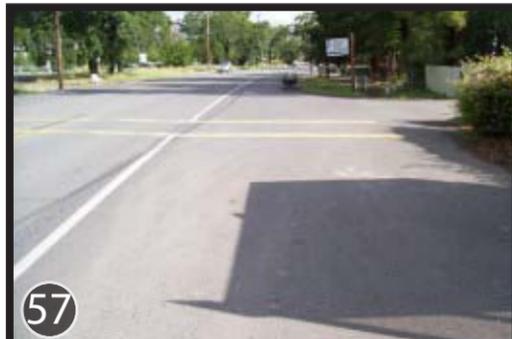
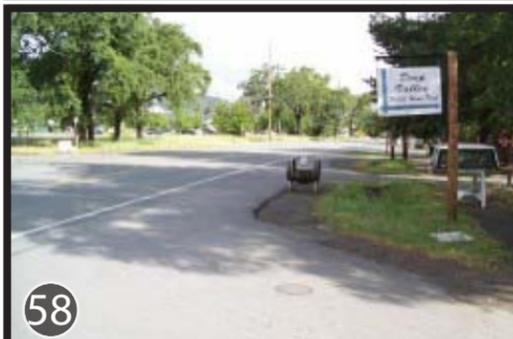
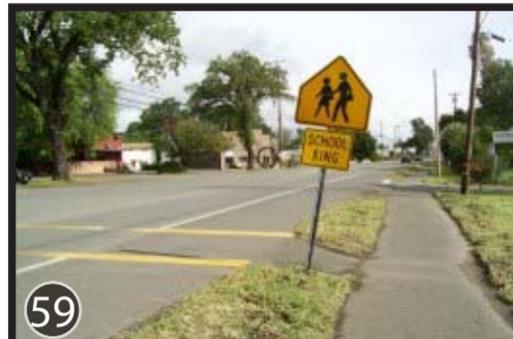
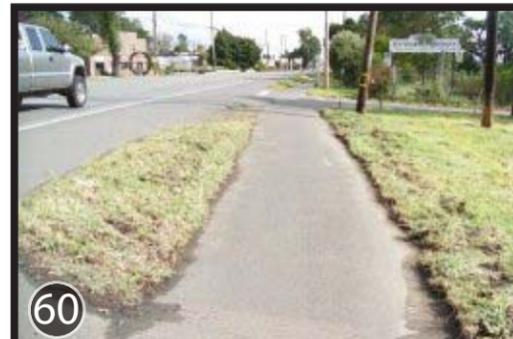
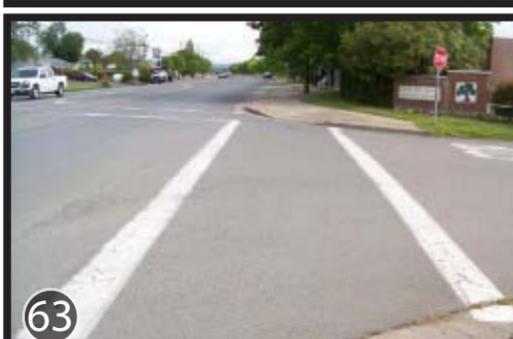
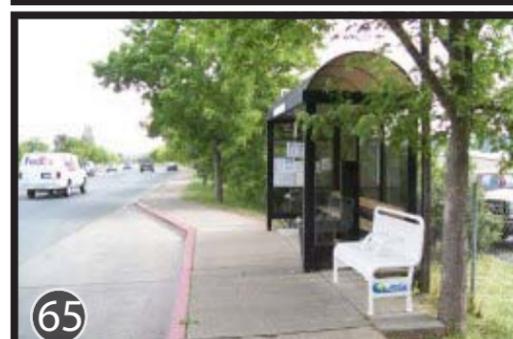
Ukiah, South Photographs: Items 32 - 65

43: Curb ramp or blended transition is missing at this corner and is required for continuous pedestrian and disabled compliant travel path.
-

44: Crossing; when curb ramps or blended transitions installed at corners, striping recommended. This recommended crosswalk should be assessed on a warrant basis for pedestrian safety and markings that afford better contrast and route recognition by visually impaired persons.

45: Curb ramp or blended transition is missing at this corner and is required for continuous pedestrian and disabled compliant travel path.
-

51: Crosswalk should be installed for connection to southbound MTA bus stop across the road. This recommended crosswalk should be assessed on a warrant basis for pedestrian safety and markings that afford better contrast and route recognition by visually impaired persons. Due to high traffic it is recommended to have heavy cross bar markings in the crosswalk with high visibility pedestrian paddle signs.
-

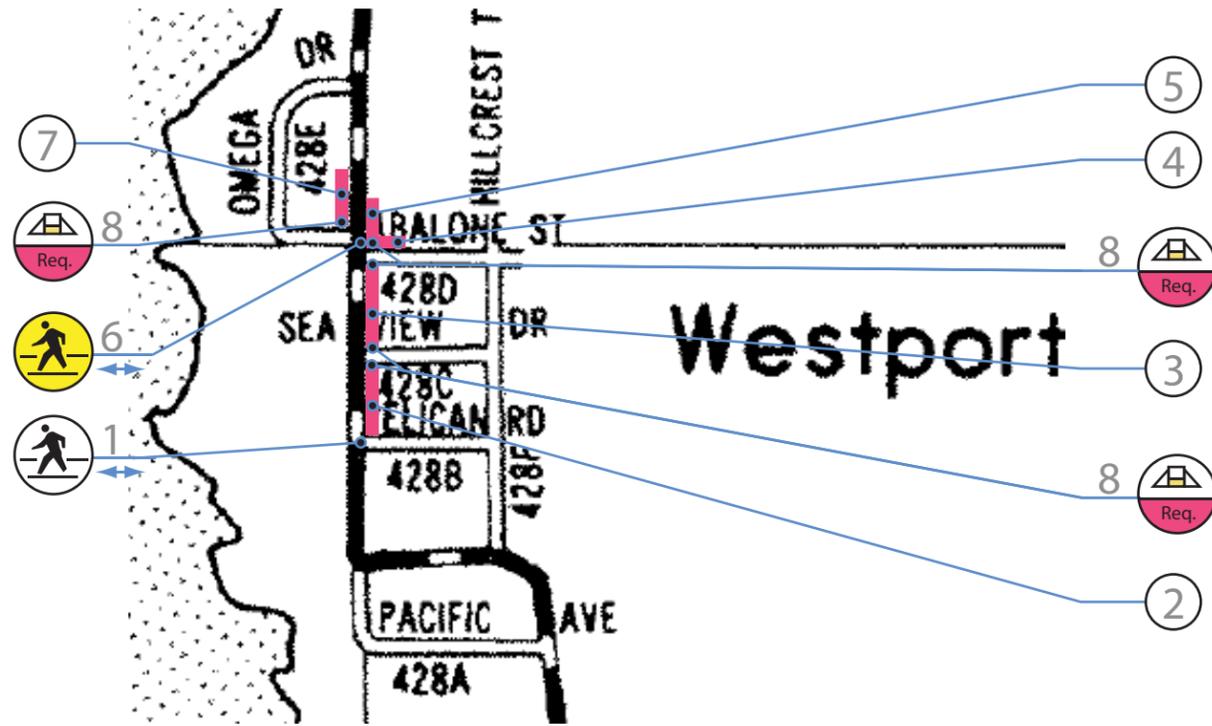
- 1: Crosswalk is recommended at this intersection to connect pedestrian travel paths with the natural interest site on Highway 1 west side. This recommended crosswalk should be assessed on a warrant basis for pedestrian safety and markings that afford better contrast and route recognition by visually impaired persons. Since there is high traffic during peak tourism times, heavy bar marking with high visibility paddle signs recommended as well.

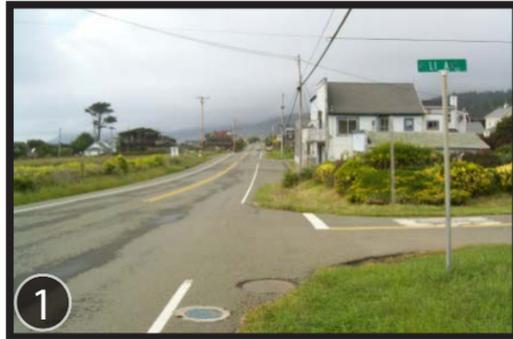
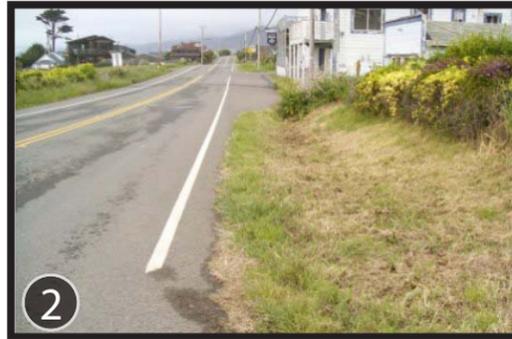
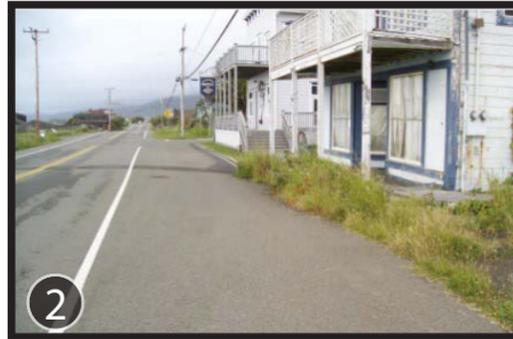
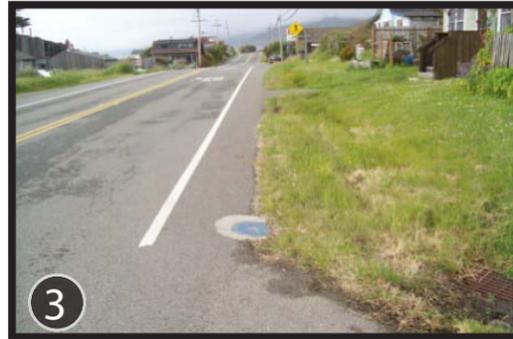
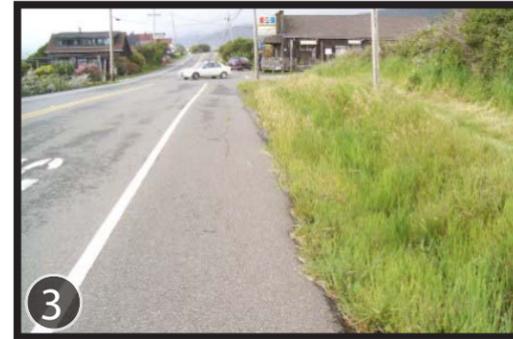
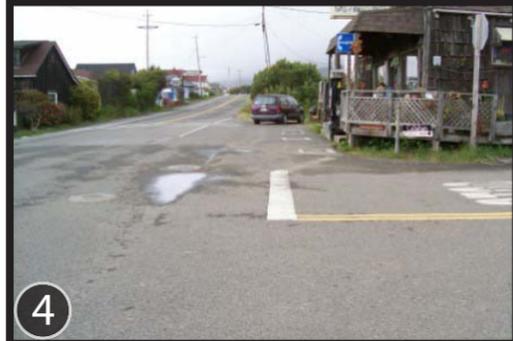
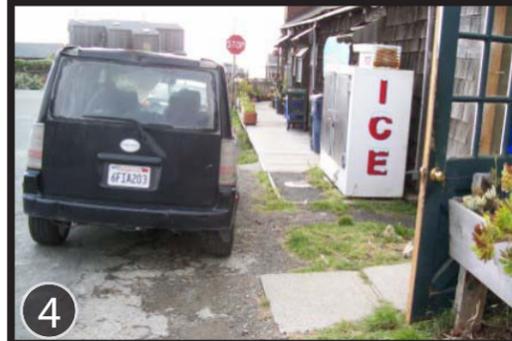
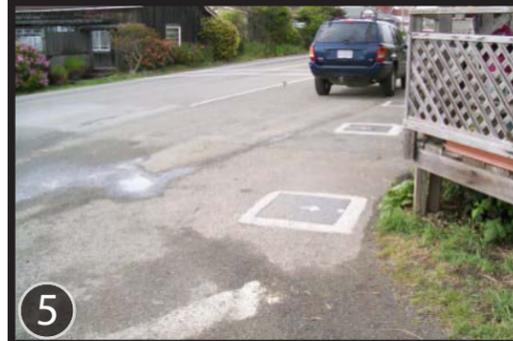
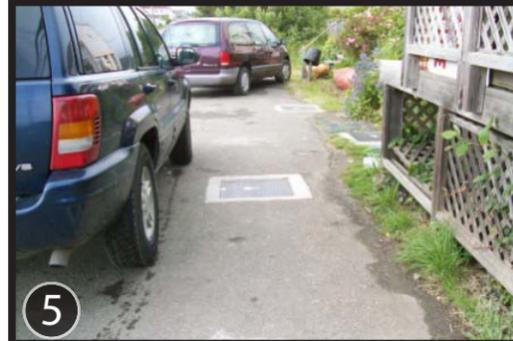
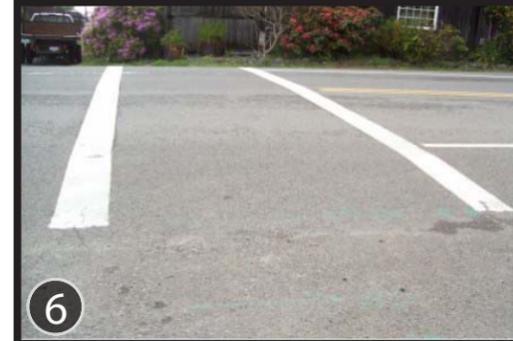
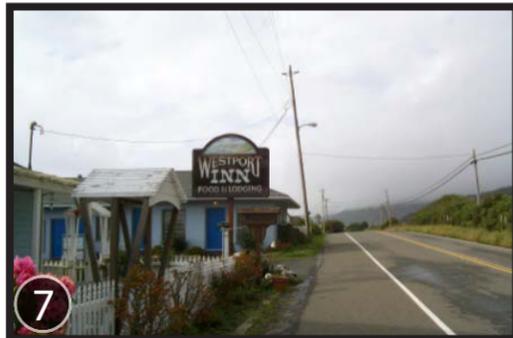
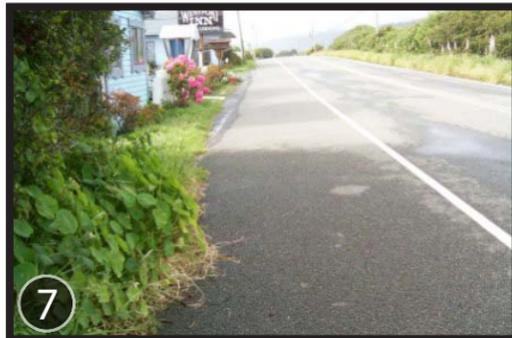
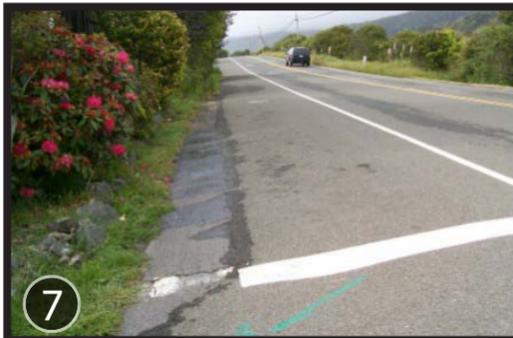
Potter Valley: Items 1 - 7

- 2: Currently the available pedestrian walking path is along the asphalt highway shoulder and has a length with constricted width requiring additional paving. Due to crowded traffic, it is recommended to have a design that separates pedestrians from traffic lanes such as parking lane between walkway and road lane. Design for pedestrian improvements must consider how the pedestrian travel walkway will serve general travel along Highway 1, parked car interferences, vehicle driveways, walkway connections to adjacent business properties, and surface water drainage

- 3: Currently the available pedestrian walking path is along the asphalt highway shoulder with very narrow width from road lane edge to paving edge requiring additional paving. Due to traffic concerns, it is recommended to have a design that separates pedestrians from traffic lanes such as parking lane between walkway and road lane. Design for pedestrian improvements must consider grading to create additional road shoulder width along Highway 1, parked car interferences, vehicle driveways, walkway connections to adjacent properties, and surface water drainage

- 6: Existing crosswalk; heavy cross bar markings and high visibility paddle signs recommended for this crosswalk due to Highway 1 traffic.
- 7: The pedestrian walking path is along the asphalt highway shoulder. It appears there is sufficient width for a walking lane if parking along this stretch from the corner to the small hotel is either restricted or will have a designated parking lane. Design for pedestrian improvements must consider cross slope grade correction along Highway 1, parked car interferences, vehicle driveways, walkway connections to adjacent properties, and surface water drainage
