PRE-RENOVATION HAZARDOUS MATERIALS ASSESSMENT
FOR
ASBESTOS AND LEAD CONTAINING MATERIALS

County of Mendocino
Administration Center – South Wing Roof and HVAC Replacement
851 Low Gap Road
Ukiah, CA 95482

November 16, 2017

Project No. 3084.2002

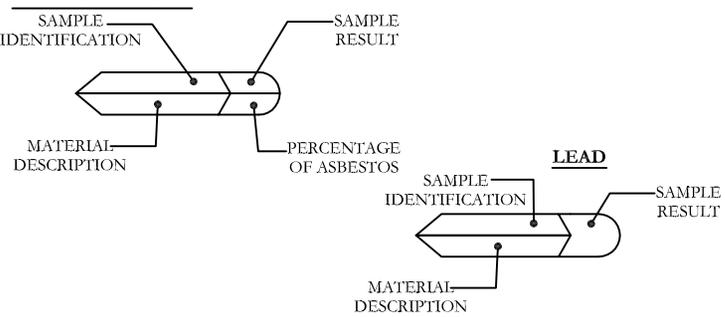
SCALE: N.T.S.	FOR	ADMINISTRATION CENTER- SOUTH WING ROOF AND HVAC REPLACEMENT
DATE: 11/16/17	TITLE	SAMPLE LOCATION PLAN
DRWN: BG	APPROVED:	JOB NO. 3084.2002
CHECKED: JV		DWG. NO. FIGURE-1

171111-14.26 <100
WOOD PPM

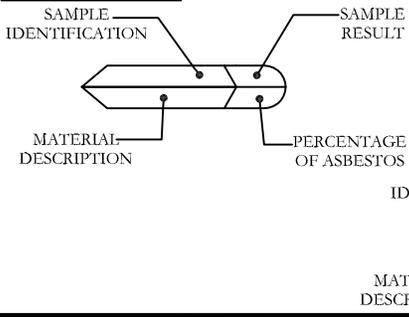
SCALE: N.T.S.	FOR	ADMINISTRATION CENTER- SOUTH WING ROOF AND HVAC REPLACEMENT
DATE: 11/16/17	TITLE	SAMPLE LOCATION PLAN
DRWN: BG	APPROVED:	JOB NO. 3084.2002
CHECKED: JV		DWG. NO. FIGURE-2

171111-14.28
WOOD ROOF, BEIGE <100 PPM
