MENDOCINO HISTORICAL REVIEW BOARD STAFF REPORT

JULY 1, 2019 MHRB_2016-0018

APPLICANT/AGENT:	COLLIN MAXWELL 9393 EAST PALO BREA UNIT 1052 SCOTTSDALE, ARIZONA 85255		
OWNER:	PNP LLC 2021 RIGGS ROAD LAKEPORT, CA 95453		
PROJECT DESCRIPTION:	A Mendocino Historical Review Board Permit request to demolish, reconstruct, and/or construct the Ferro House, garage, tower, fencing, driveway and other structures. Note: Mendocino Town Plan Appendix 1 lists the site as a Category IIa Historic Resource.		
STREET ADDRESS:	45270 Albion Street, Mendocino (APN: 119-217-06)		
PARCEL SIZE:	80 ft. by 76 ft. or 6,080 sq. ft.		
ENVIRONMENTAL DETERMINATION:	A Class 31 Categorical Exemption from the California Environmental Quality Act for restoration of a historical resource following the Secretary of the Interior's Guidelines for Preservation and Restoration of Historic Resources		
HISTORIC STRUCTURES:	On Site: Ferro Residence Category IIa North: Pimentel House Category I South: None listed East: Not Historic Category IVa West: Marcellino House Category I

A Cultural Resources Investigation of a Single-Family Residence Totaling 0.19 Acres "Ferro Residence" Located at 45270 Albion St (APN 119-217-06) Mend

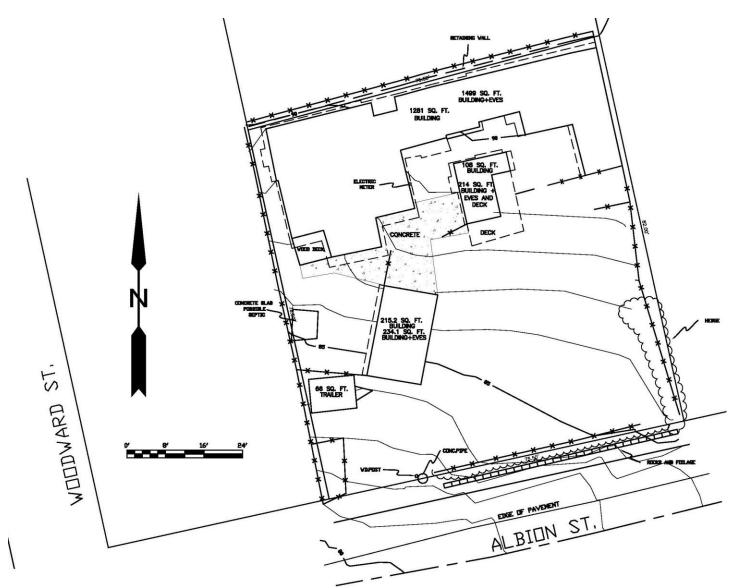
Figure 4: Detail of 2016 survey by Forrest Francis of 45270 Albion St (APN 119-217-06). Modified to include scale and north arrow.

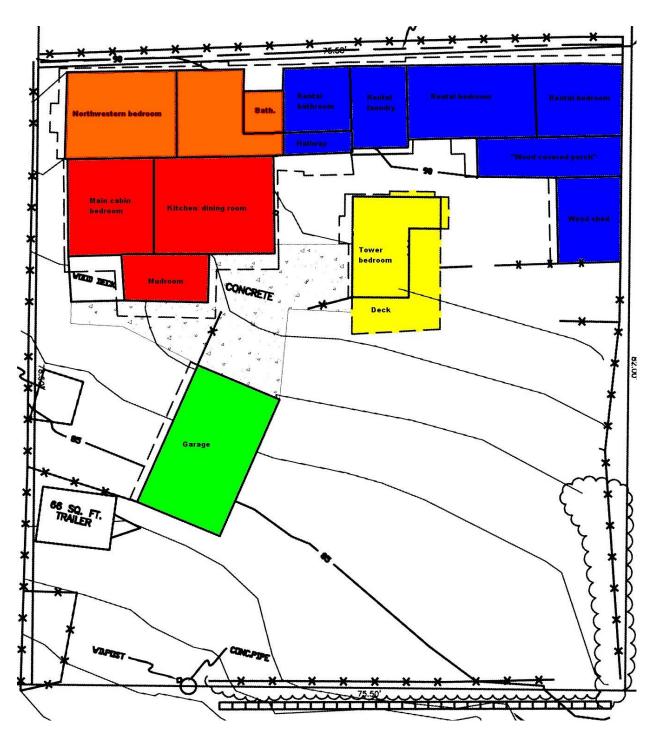
Figure 5: Modified version of Francis' survey, indicating rooms and additions. Red indicates the main cabin. Orange indicates the northern additions. Blue indicates the eastern additions. Yellow indicates the 'tower' structure. Green indicates the garage.

The three-section residential complex consists of a two-room cabin with multiple historic additions to the north and west. For the sake of clarity, these structures have been named and subdivided into three sections, indicated on page 10, figure 5. Please note that relatively few records and no photographs of the property exist, given the socioeconomic status of most of the tenants of the property. Descriptions are as accurate as possible given limited information.

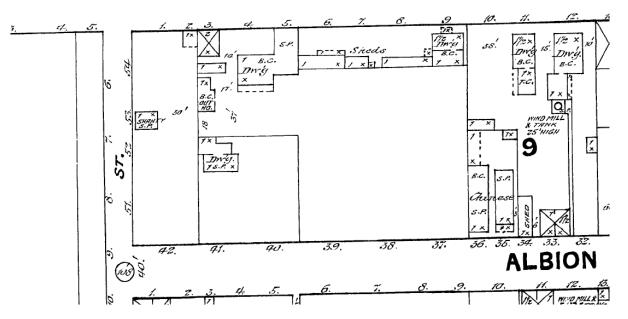
Figure 6: 1890 Sanborn Insurance map of Mendocino depicting 45270 Albion St.and surrounding properties. Note the existence of only the main cabin and northern additions.

The northern additions to the main cabin, measuring approximately 26' x 11', were added soon after the initial construction of the main cabin. These additions are indicated on the 1890 Sanborn insurance map, but were clearly additions. The northeastern room seems to have been added first, with a matching gabled roof built over the main cabin's roof. The subsequently added northwestern addition has a flat roof, which was incorrectly sloped and allowed for the accumulation of water. This roof was cut open by vagrants for access, allowing water damage and plant life into the interior of the building. These additions have concrete foundations, retrofit against the concrete foundation of the main cabin.

Both of these rooms are indicated by Sanborn maps as early as 1890. The interior of the northwestern room has been sided with modern plywood, suggesting extensive repairs since its construction. The condition of these rooms is poor.

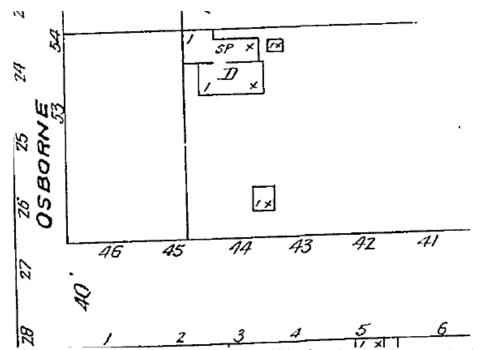
Figure 7: 1898 Sanborn Insurance map of Mendocino depicting 45270 Albion St and surrounding properties. Note the existence of two additional structures to the east and south of the main cabin.

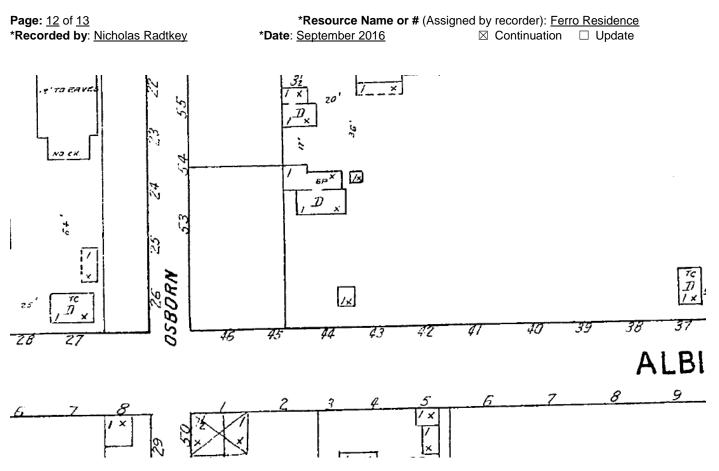
Figure 8: 1909 Sanborn Insurance map depicting 45270 Albion St and surrounding properties. No changes have been recorded since the 1898 Sanborn map..

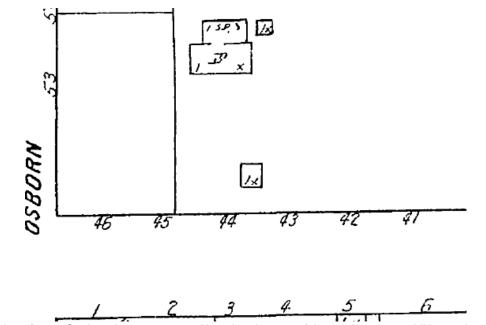
Figure 9: 1929 revision of 1909 Sanborn Insurance map. Note the absence of the northwestern addition to the main cabin. This may be a surveyor's error.
