**MENDOCINO HISTORICAL REVIEW BOARD
STAFF REPORT**

**JULY 1, 2019
MHRB_2016-0018**

PROJECT DESCRIPTION: A Mendocino Historical Review Board Permit request to demolish, reconstruct, and/or construct the Ferro House, garage, tower, fencing, driveway and other structures. Note: Mendocino Town Plan Appendix 1 lists the site as a Category IIa Historic Resource.

STREET ADDRESS: 45270 Albion Street, Mendocino (APN: 119-217-06)

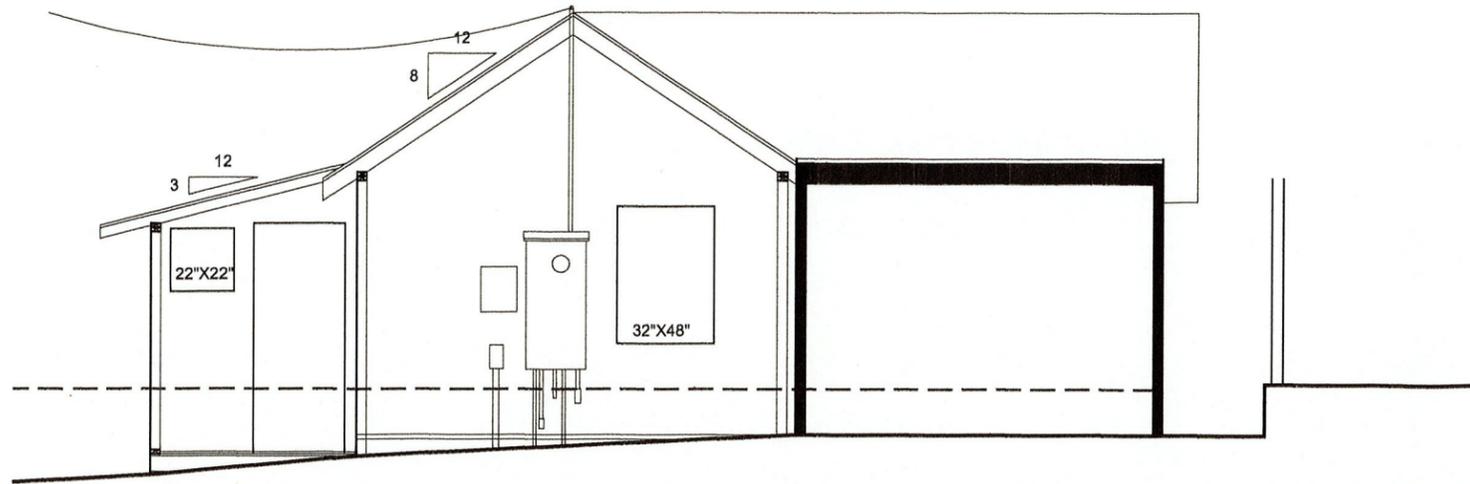
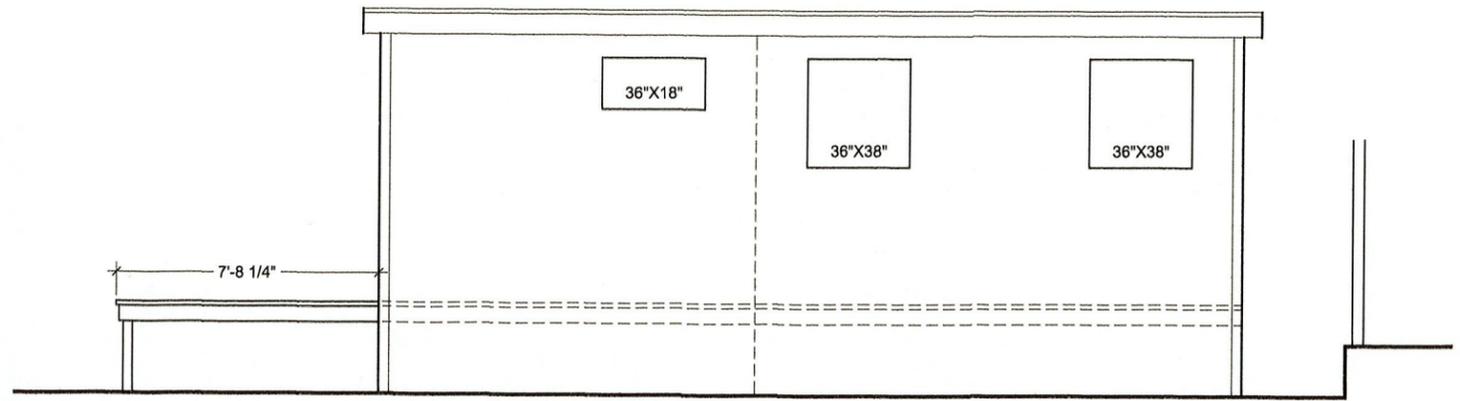
(E) INNER-EAST ELEVATION
SCALE: 1/4" = 1'-0"

The prior to 1975 eastern additions to the cabin appear to have been constructed from west to east. (Sanborn maps do not depict the additions as late as 1929; however, appraisal records from 1975 indicate their existence.) There are six rooms in the eastern additions each having an exterior door, and all linked together by interior doors. From west to east they are a community bathroom, a laundry room and two bedrooms. South of the bedrooms are two rooms that are listed in a 1975 appraisal as a wood shed and wood covered porch.

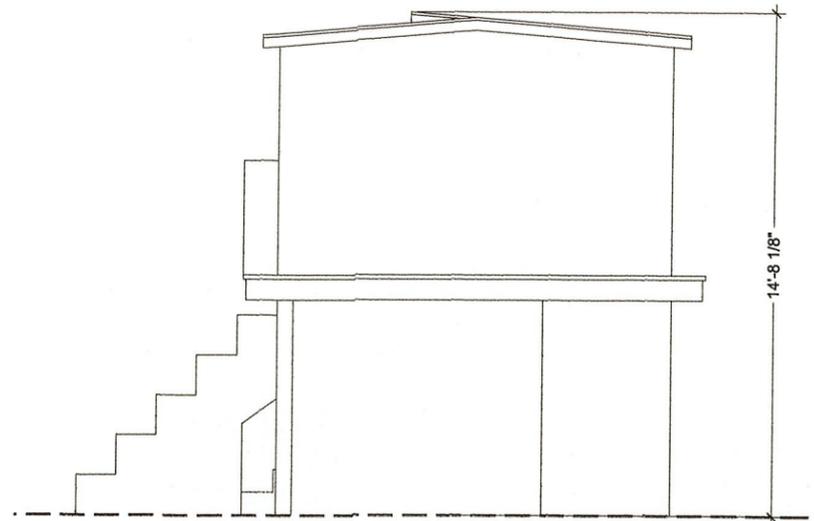
SHEET NAME:
**TOWER NORTH & EAST ELEVATIONS -
EXISTING & PROPOSED**

Existing Tower. The circa 1900 water tower is 14 feet in height and irregularly shaped (See Sheet No.'s A6 and A7 Tower Elevations). It has a footprint of approximately 200 square feet and has three entrances, two on the primary level, and one on the second level, with both interior and exterior stair cases to the second level. The overall condition of the tower is poor (CHRC 2016).

The original shed has a post foundation with concrete flooring poured after construction. The adjacent kitchen and upper bedroom are supported by a pier block foundation integrated into the concrete flooring. The posts supporting the outside deck appear to have no piers, but have been surrounded by historic concrete pours. Most of the joists in this building are rotted through, either by water exposure or insect infestation. The overall condition of the 'tower' is poor.

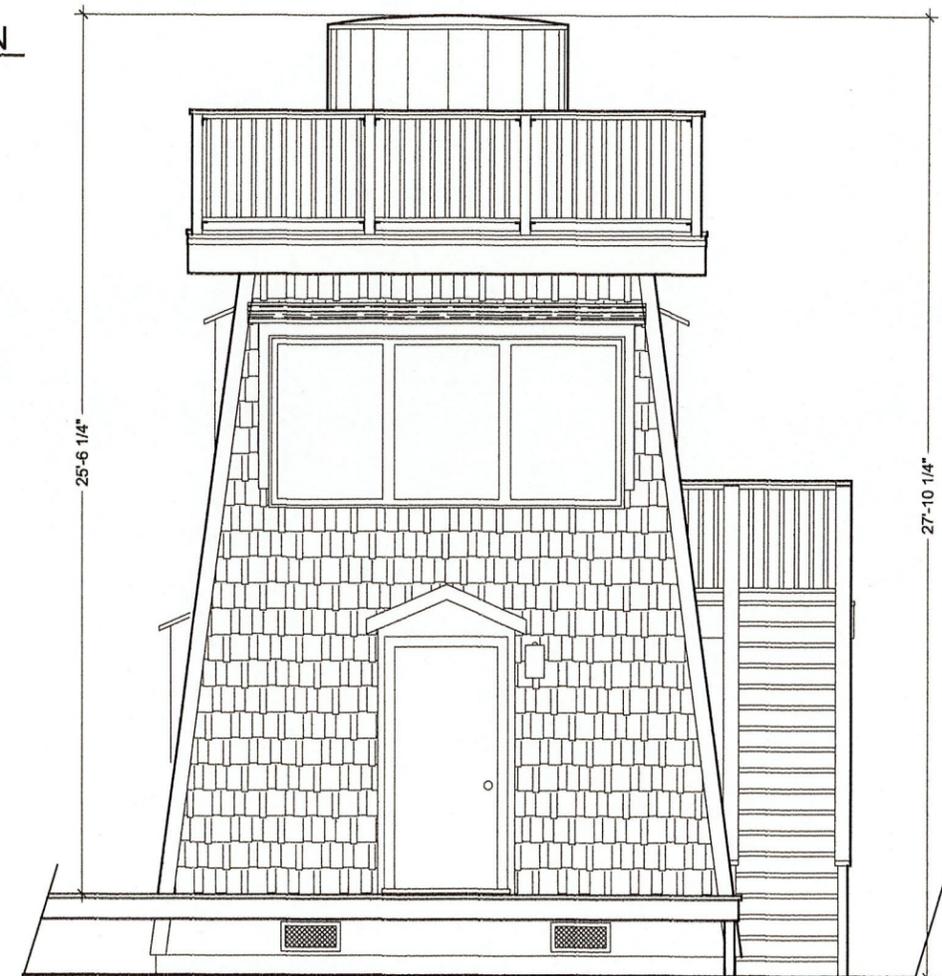
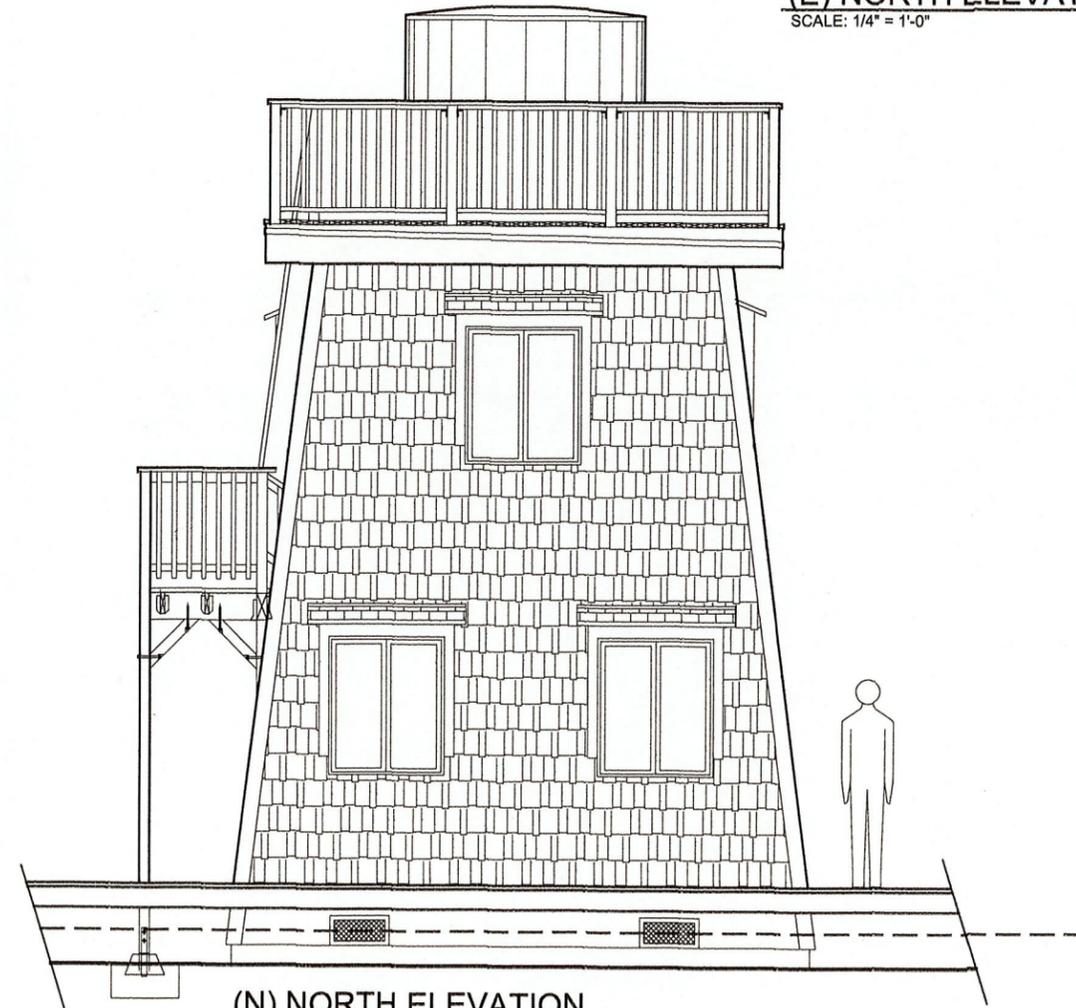
Proposed Tower. The applicant proposes to demolish the existing tower and to construct a new tower rebuilt in the same location but with a larger footprint (See Site Plan and illustrative elevation drawing).

As an accessory structure, the proposed 28 foot tall tower footprint would be 290 square feet. The siding on the tower would be cedar and the trim would be painted forest green. The tower would have an exterior door on each level with an external staircase projecting from the building footprint. A new 2,800-gallon water storage tank would be located atop the tower. The proposed water storage tank exterior would be lined with redwood slats and enclosed with metal bands. The proposed tower would be 28 feet in height above grade including the additional height of the water storage tank.

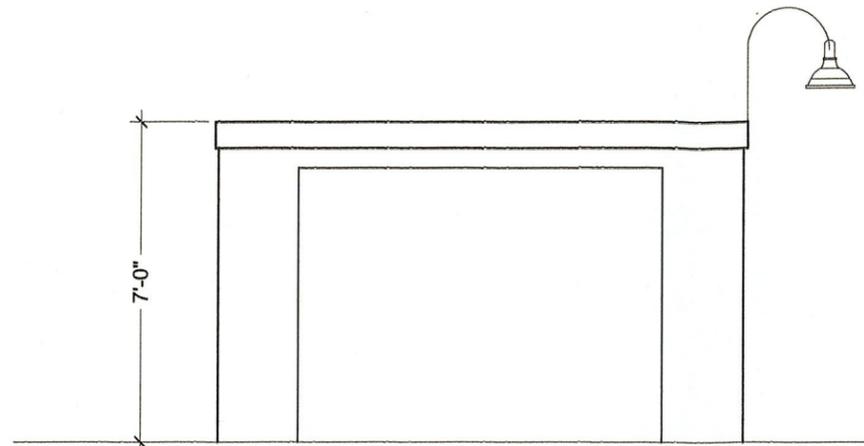
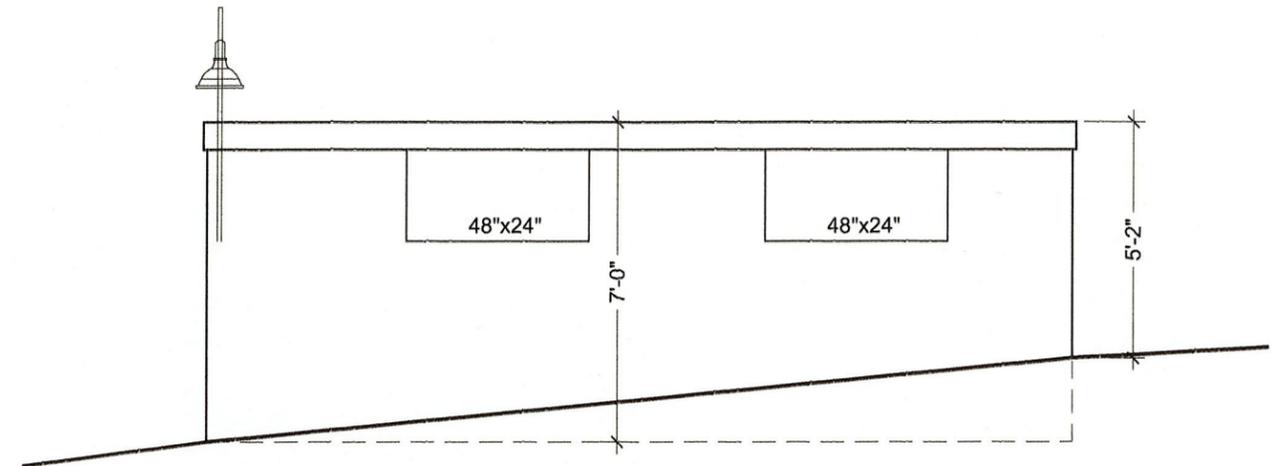
(E) & (N) GARAGE PLAN

Existing Garage. The garage is approximately 12 feet by 20 feet and is built with a mixture of 2 inch by 12 inch wood boards, plywood, and corrugated metal siding (See Sheet No. A8 Garage Elevations and Floorplan). The south elevation is 7 feet tall; the north wall varies between 5.3 feet and 5.6 feet tall. It has a flat, sheet-metal roof covered in tar. The garage stands on a post foundation and has a dirt floor. A large, now defunct concrete lined well has been dug into the center of the floor. Wooden framework around the well has rotted extensively and has exposed tunneling below the floor. The garage door is composed of vertical 2 inch by 12 inch on-gate hinges. A rectangular window opening on the east wall has been covered by corrugated fiberglass paneling. The overall condition of the garage is poor (CHRC 2016).

The garage lies south of the main cabin. Approximately 12' x 20', the garage is composed of a mixture of 2"x12"s, plywood and corrugated metal siding. The flat roof is composed of sheet metal covered in tar. The garage stands on a post foundation and has a dirt floor. A large, now-defunct concrete-lined well has been dug into the center of the floor. Wooden framework around the well has rotted extensively and has exposed tunneling below the floor. The garage door is composed of vertical 2"x12"s on gate hinges. A rectangular window opening on the east wall has been covered by corrugated fiberglass paneling. The overall condition of the garage is poor.

Proposed Garage Restoration. The siding on the garage would be cedar shingles with redwood trim painted forest green (See Sheet No. A8 Garage Elevations and Floorplan). The flat roof of the garage would be rebuilt to the same shape and style. The floor of the garage would have the pit and tunneling removed and then covered with a cement slab. Windows on the garage would be replaced with multipane wood windows as shown on the elevations.
